**RI 9231**

# In Situ Measurements and Preliminary Design Analysis for Deep Mine Shafts in Highly Stressed Rock

By M. P. Board and M. J. Beus

BUREAU OF MINES

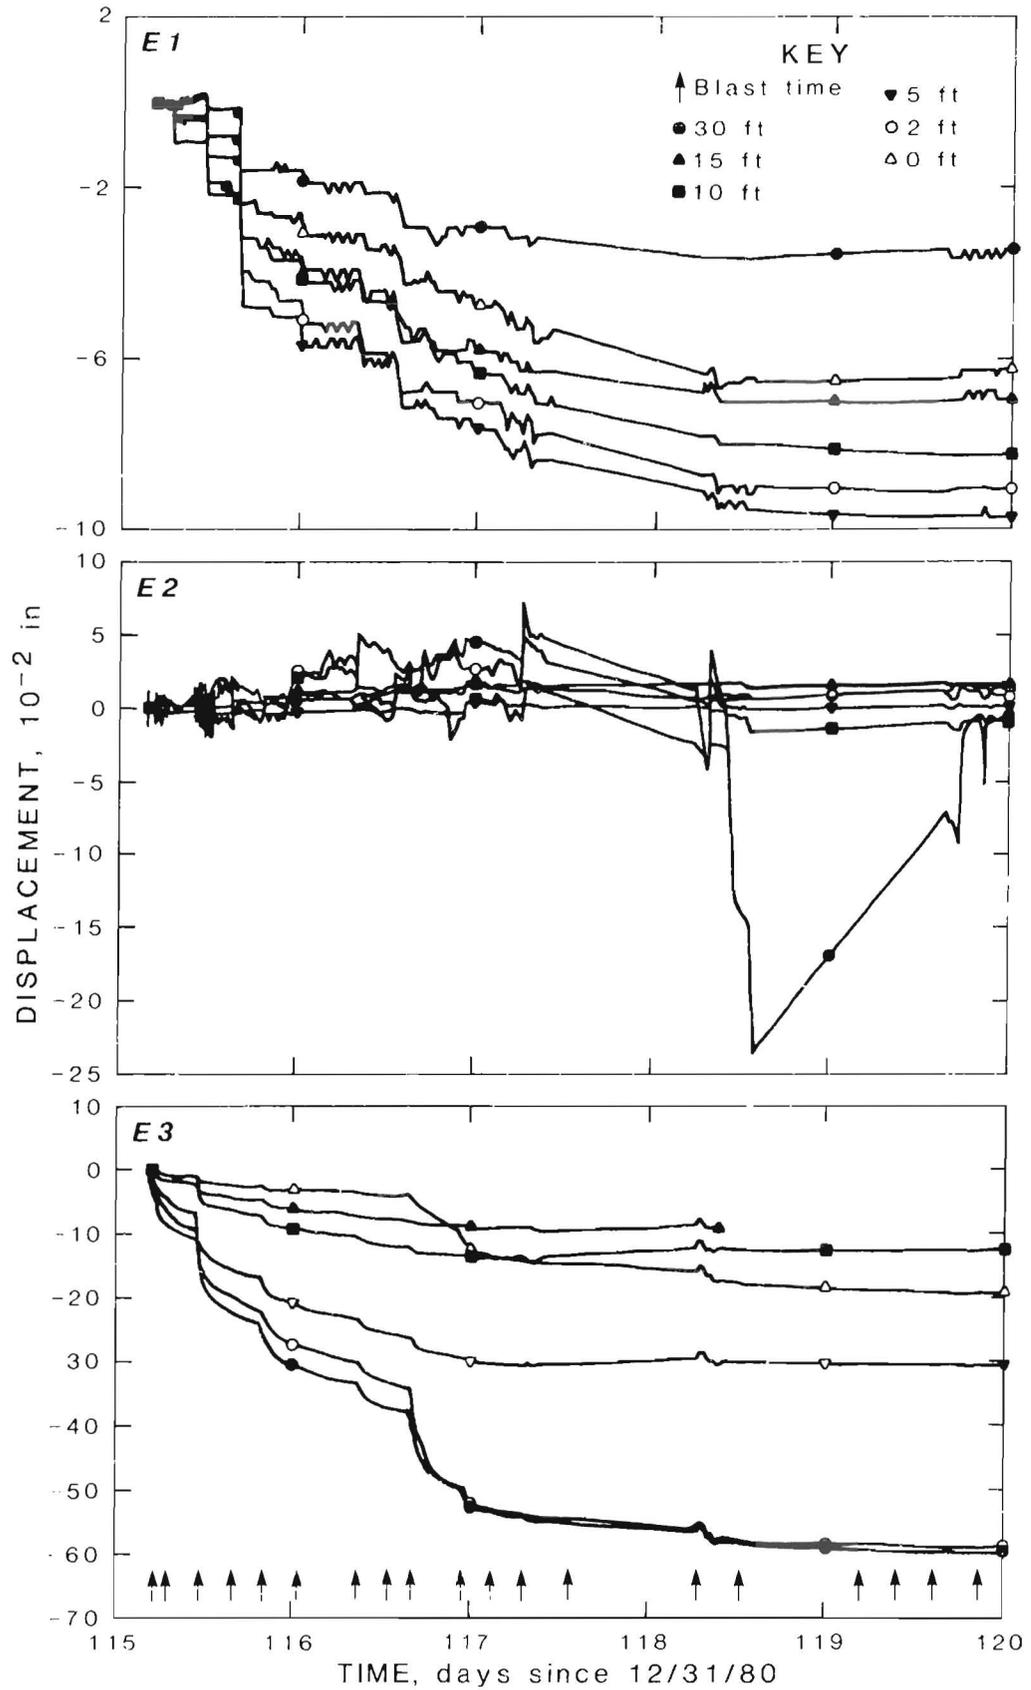
Figure C-1.-2,414-ft depth-5-day displacement at each MPBX location (E-1-E-3).

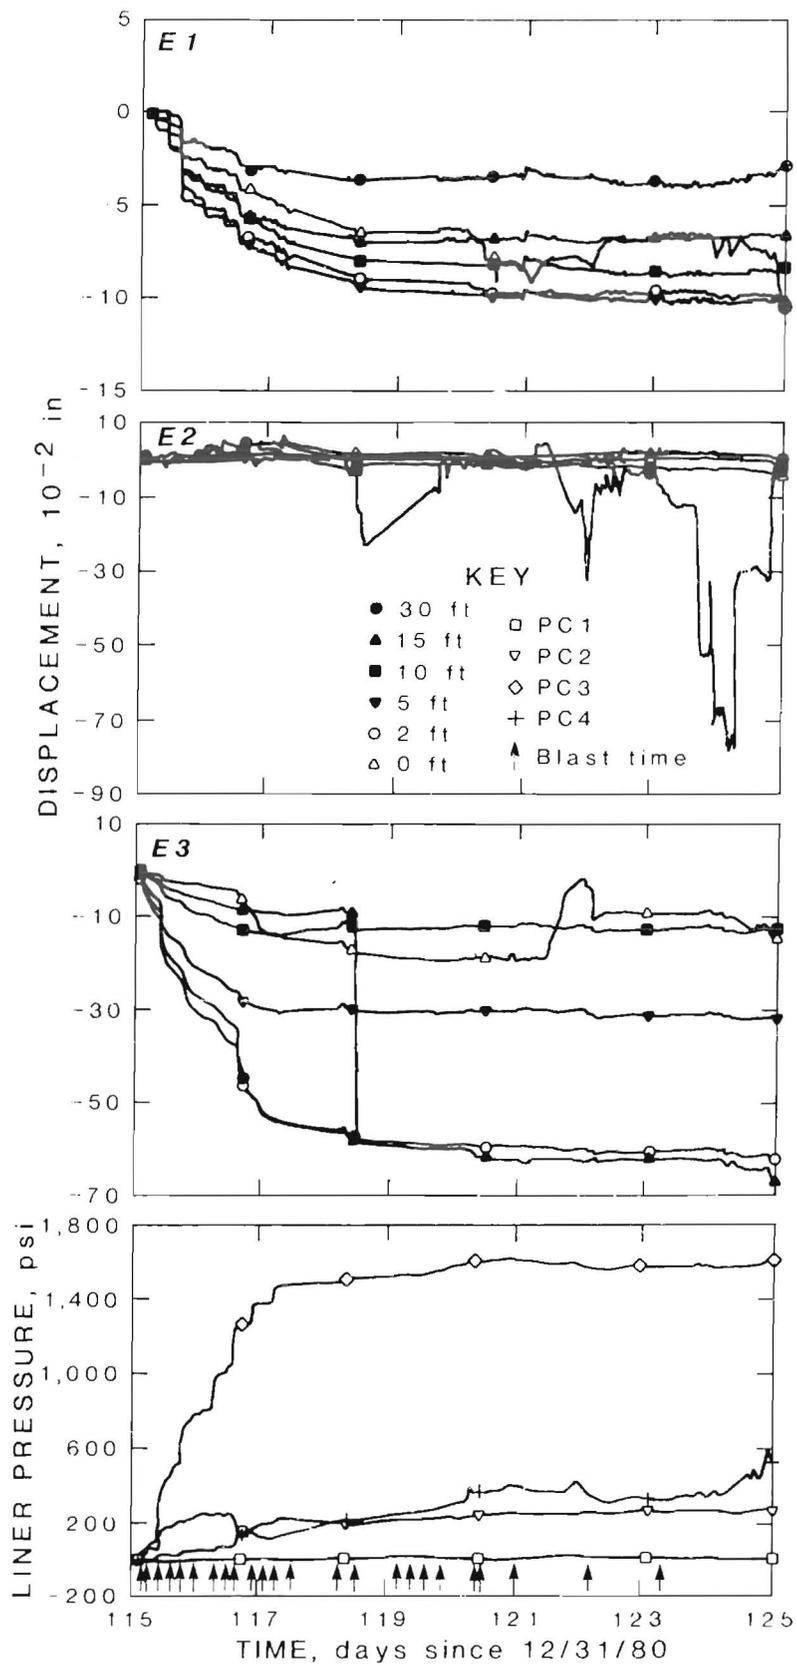
Figure C-2.—2,414-ft depth—10-day displacement and liner stress at each M<sub>P</sub>BX location (E-1—E-3).

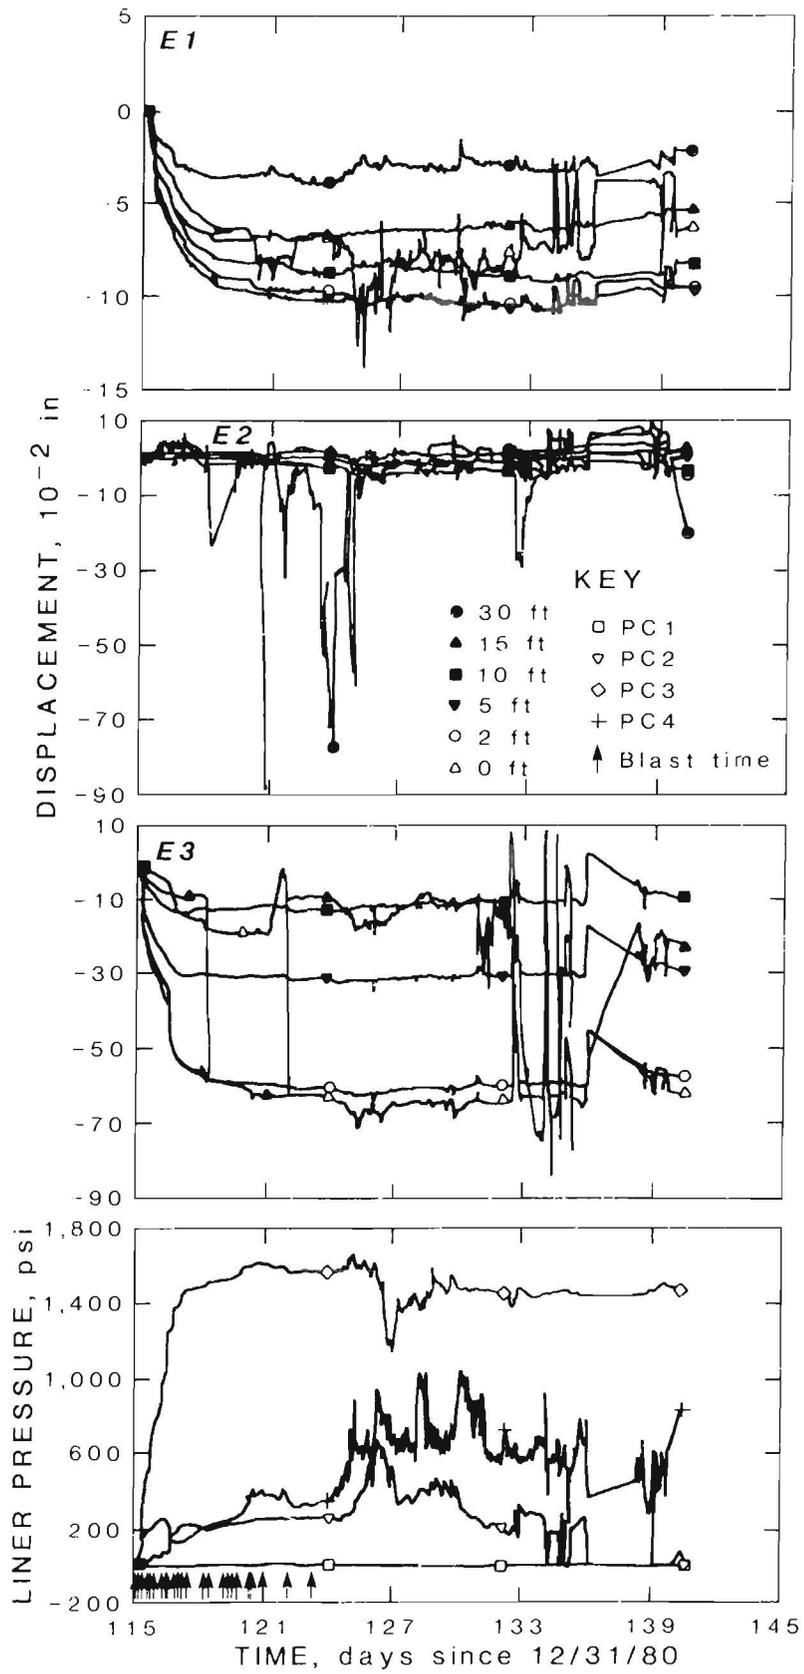
Figure C-3.—2,414-ft depth—30-day displacement and liner stress at each MBPX location (E-1—E-3).

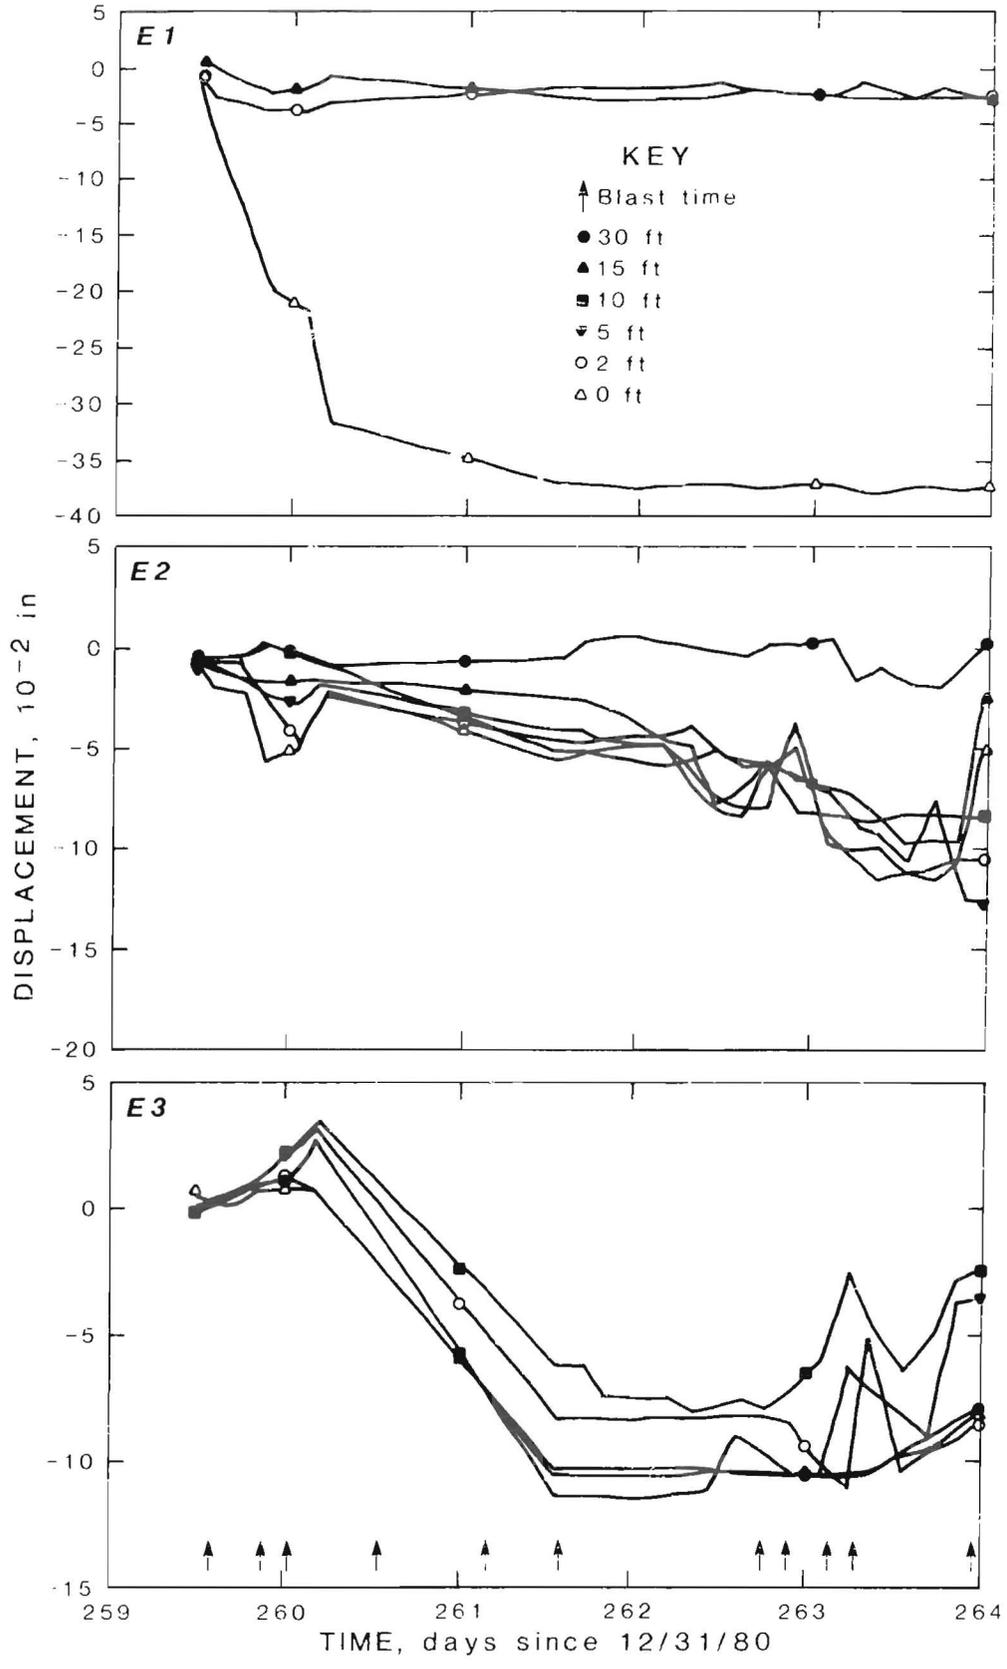
Figure C-4.-4,063-ft depth-5-day displacement at each MPBX location (E-1-E-3).

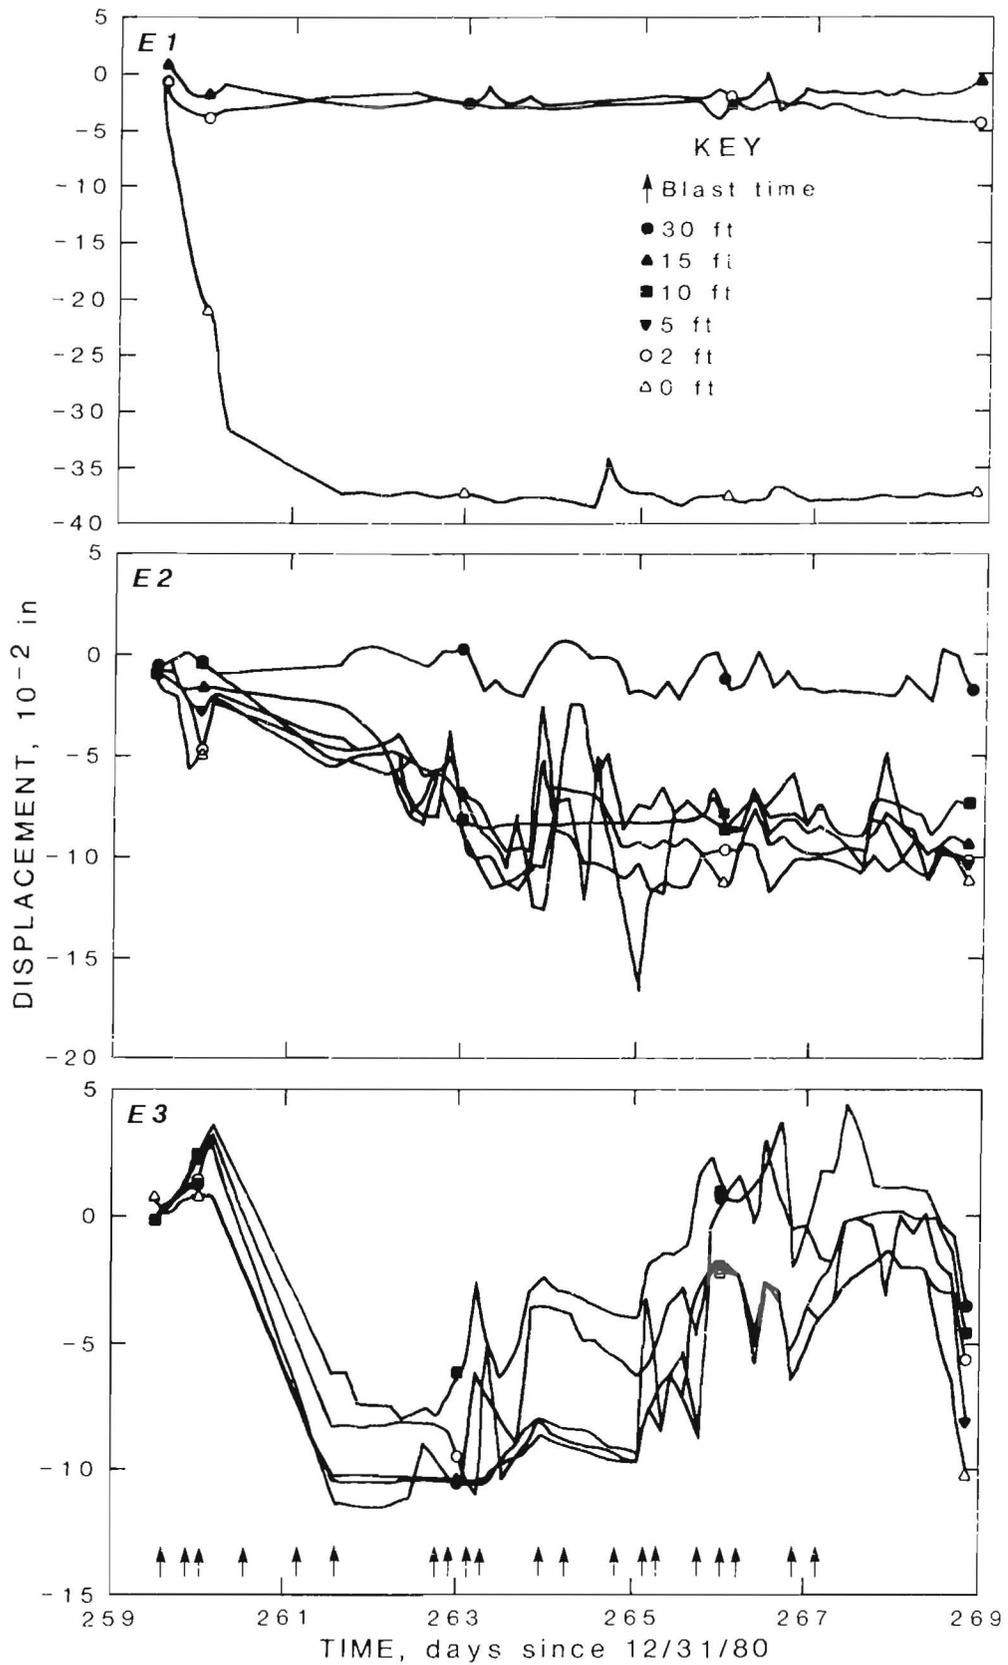
Figure C-5.—4,063-ft depth—10-day displacement at each MPBX location (E-1—E-3).

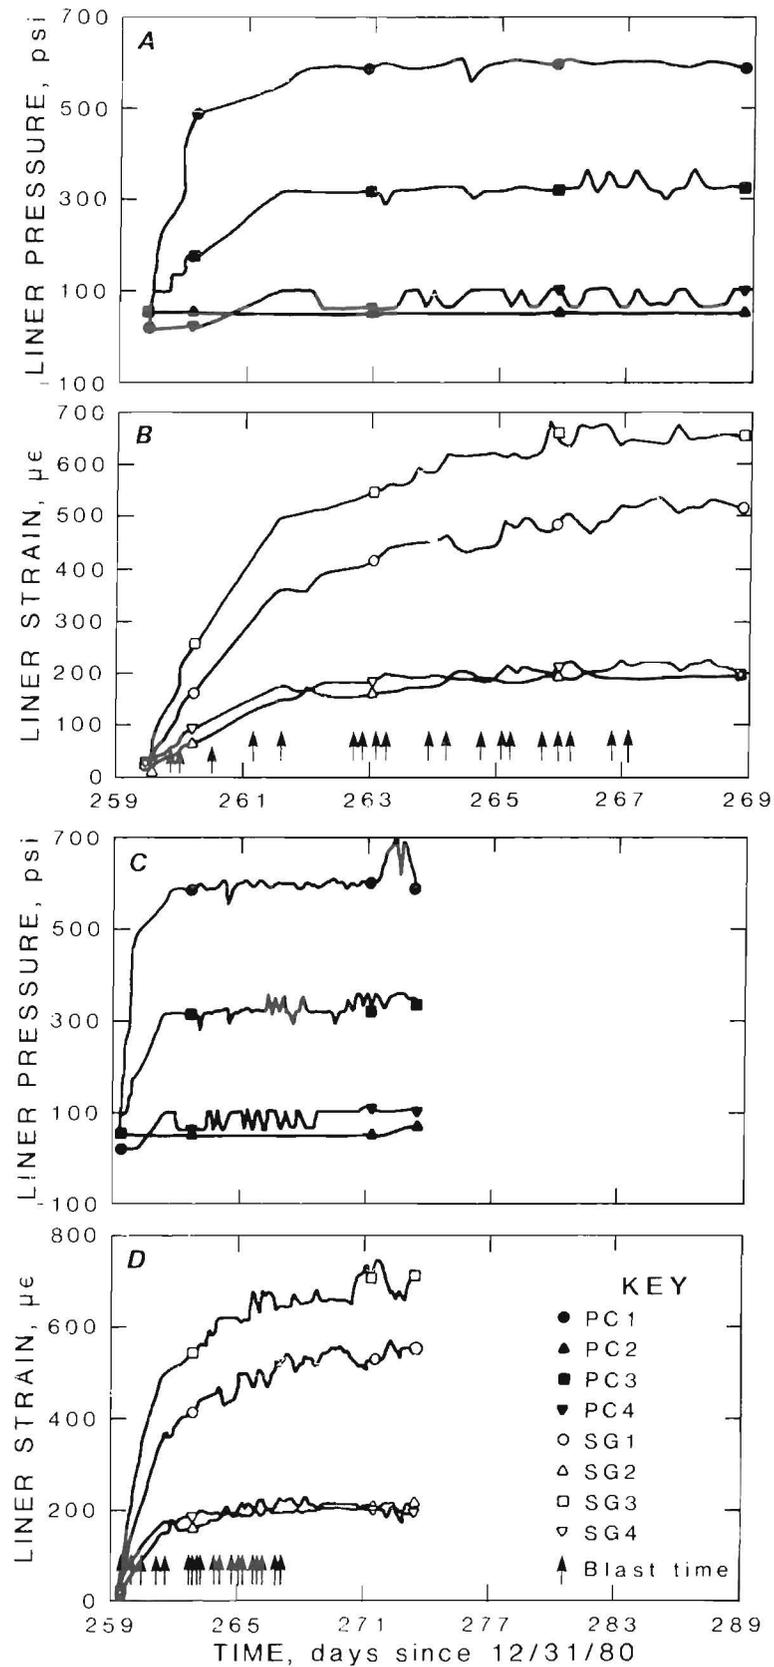
Figure C-6.—4,063-ft depth—10-day liner stress (A) and strain (B) and 30-day liner stress (C) and strain (D) at each MPBX location.

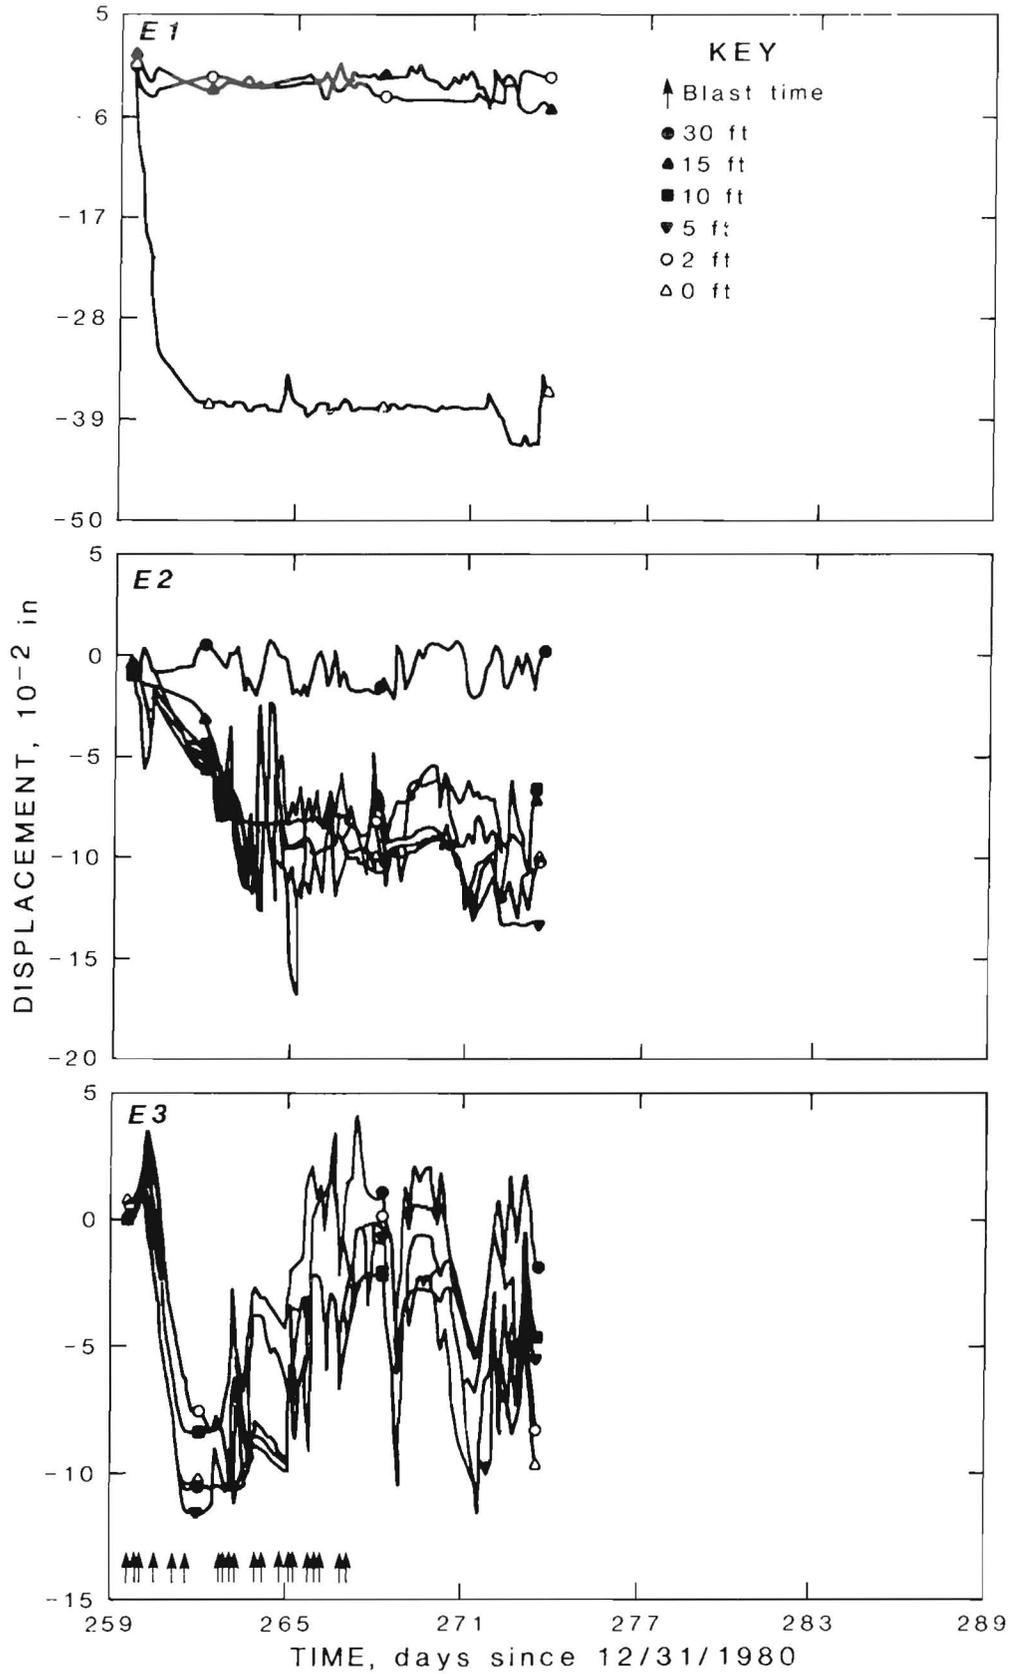
Figure C-7.-4,063-ft depth-30-day displacement at each MPBX location (E-1-E-3).

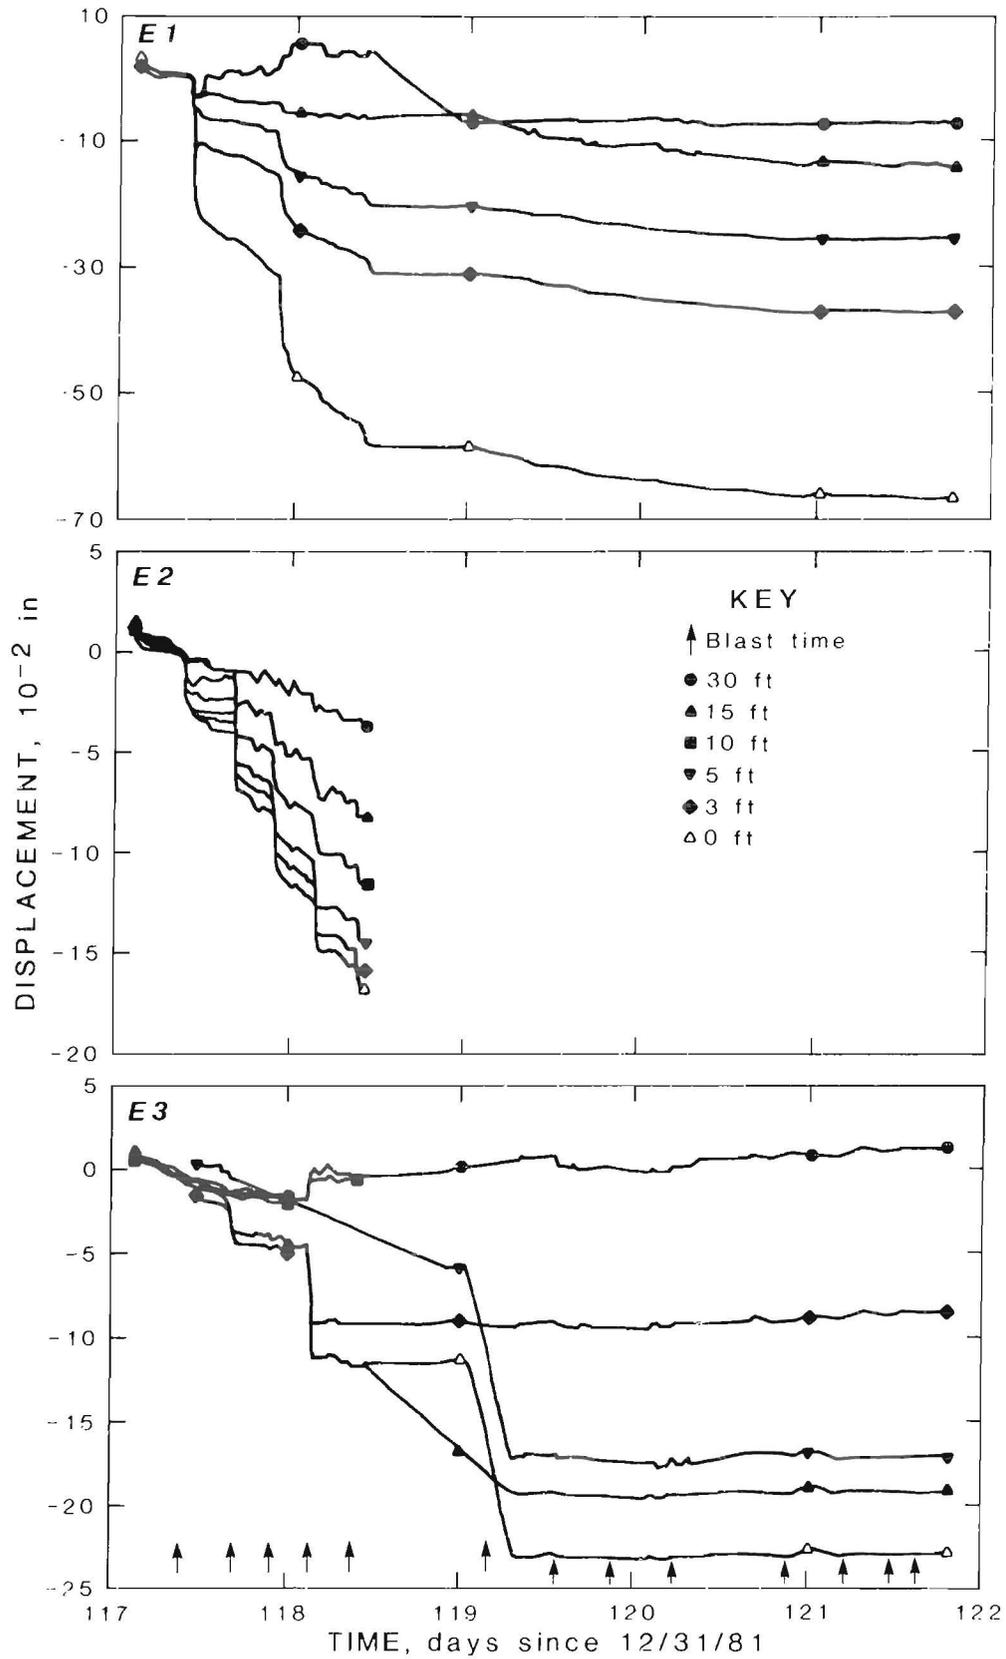
Figure C-8.—5,191-ft depth—5-day displacement at each MPBX location (E-1—E-3).

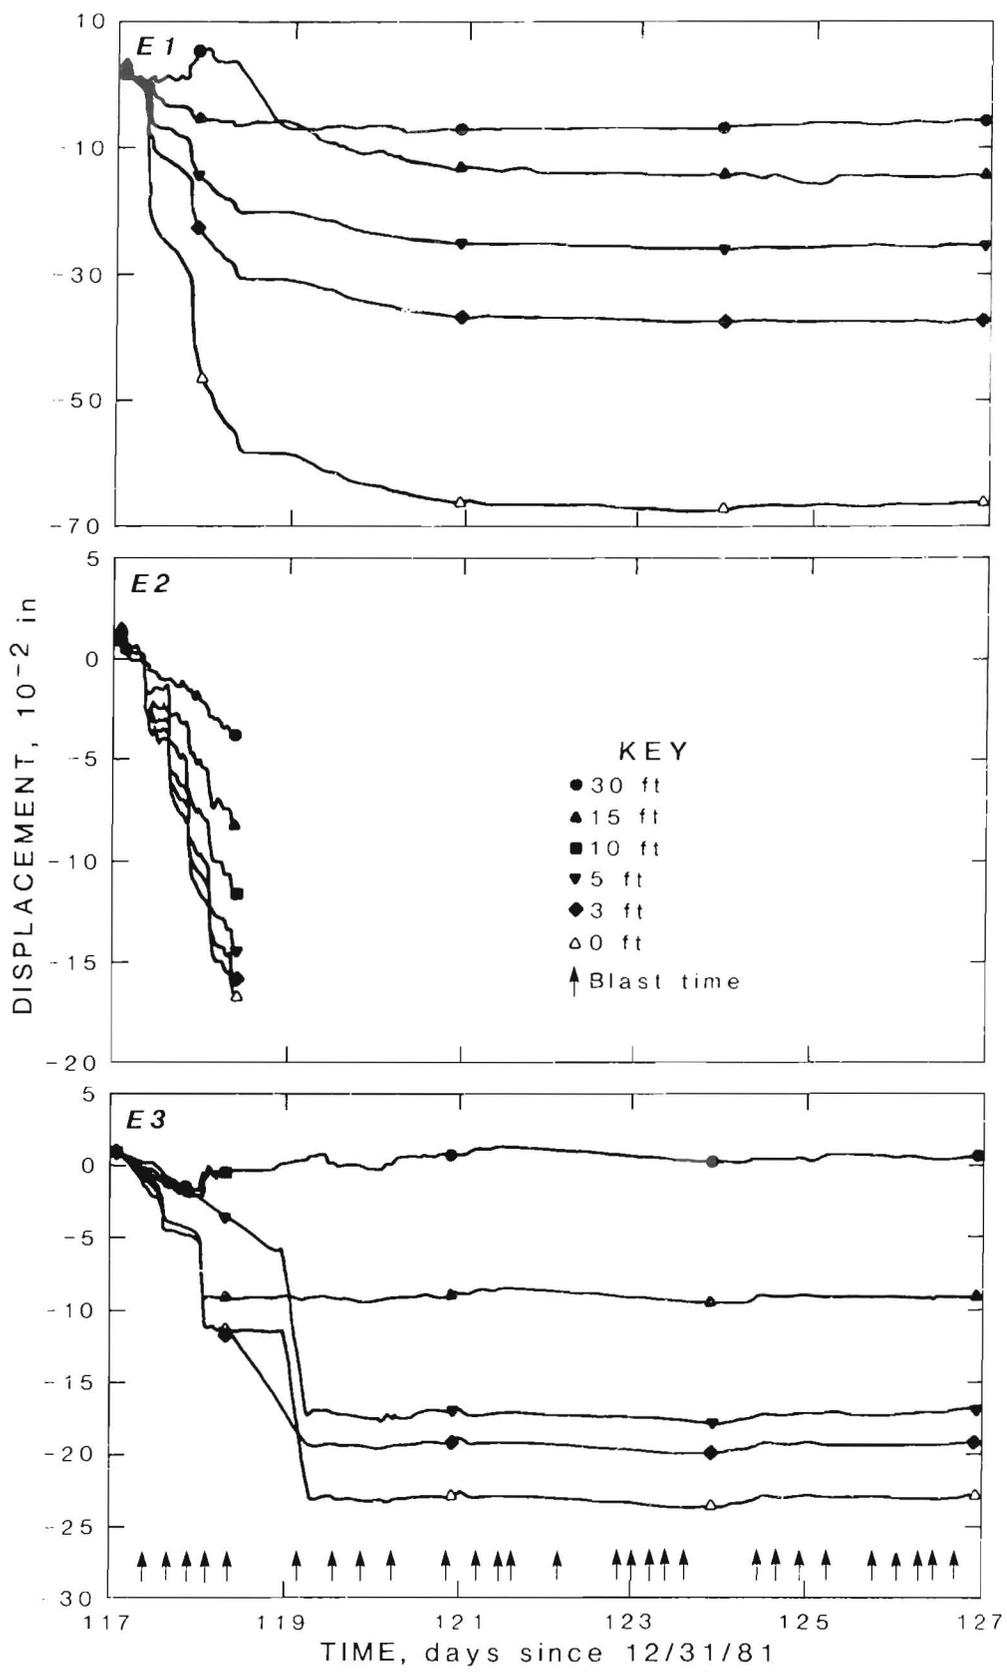
Figure C-9.-5,191-ft depth-10-day displacement at each MPBX location (E-1-E-3).

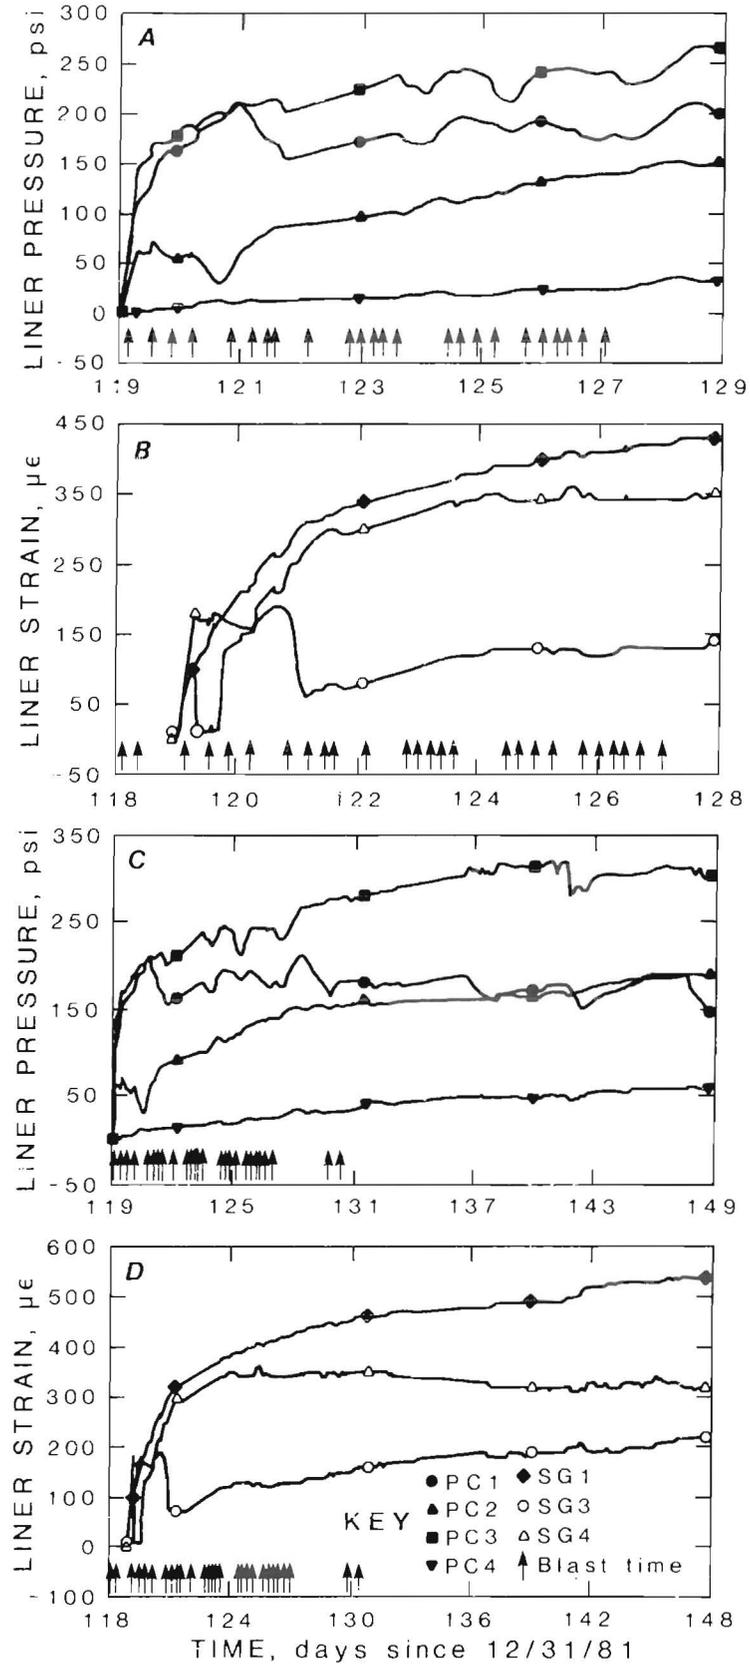
Figure C-10.—5,191-ft depth—10-day liner (A) stress and strain (B) and 30-day liner stress (C) and strain (D) at each MPBX location.

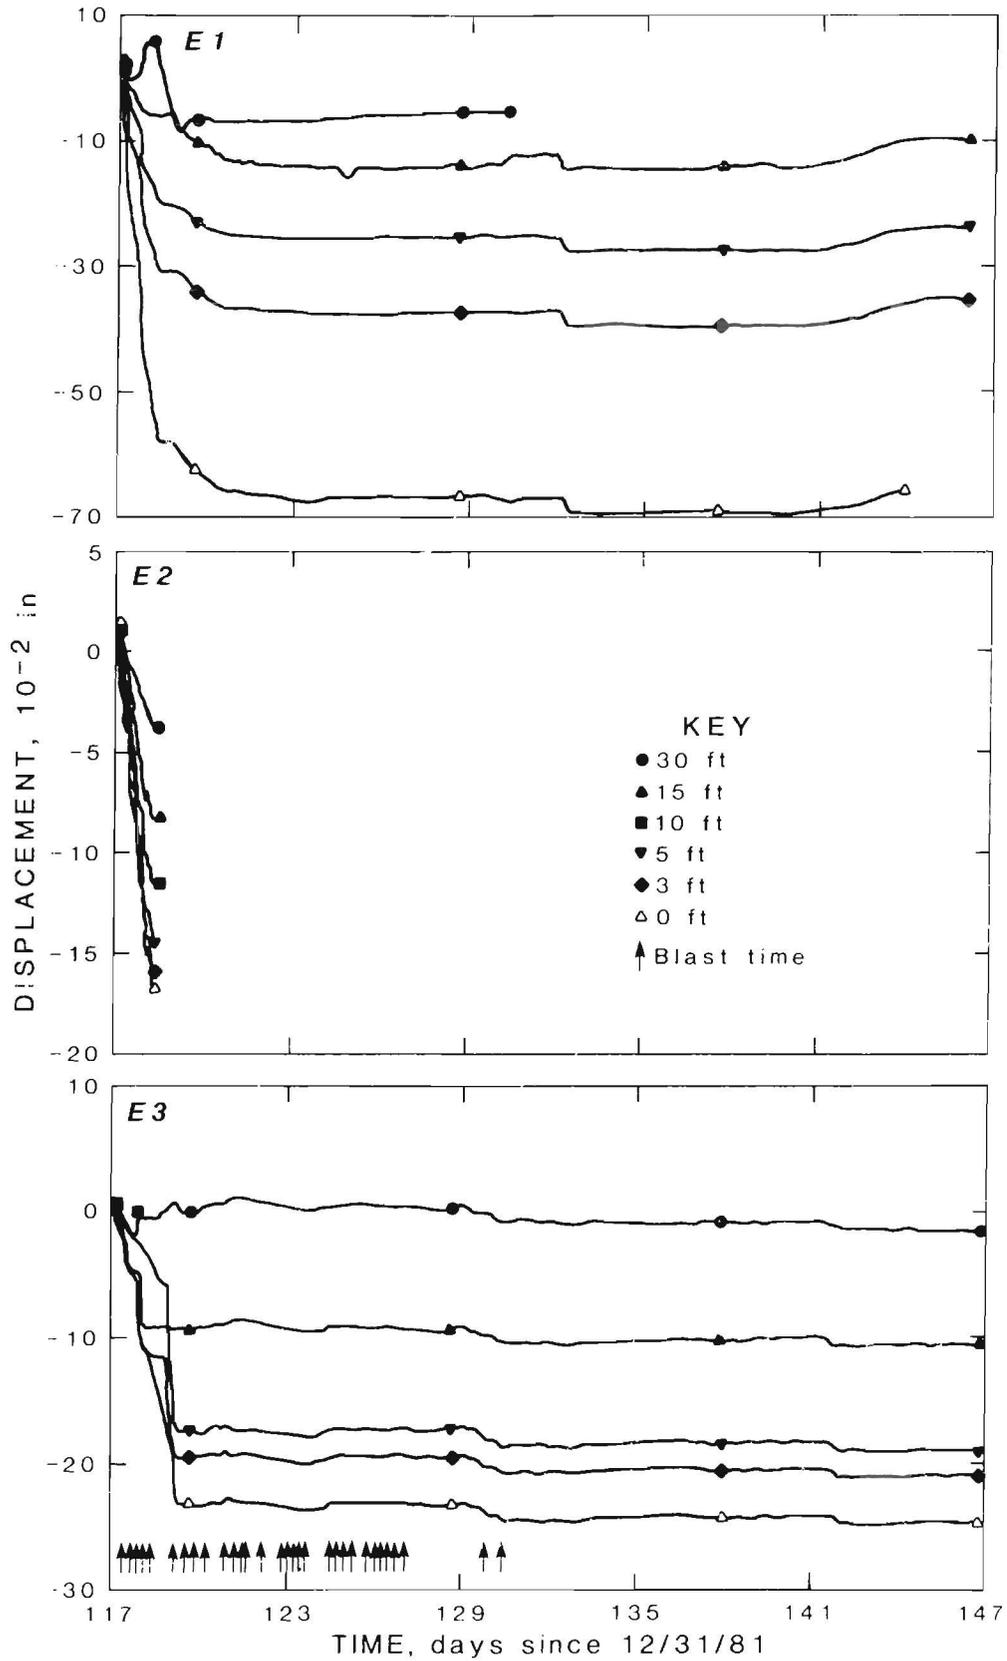
Figure C-11.—5,191-ft depth—30-day displacement at each MPBX location (E-1-E-3).

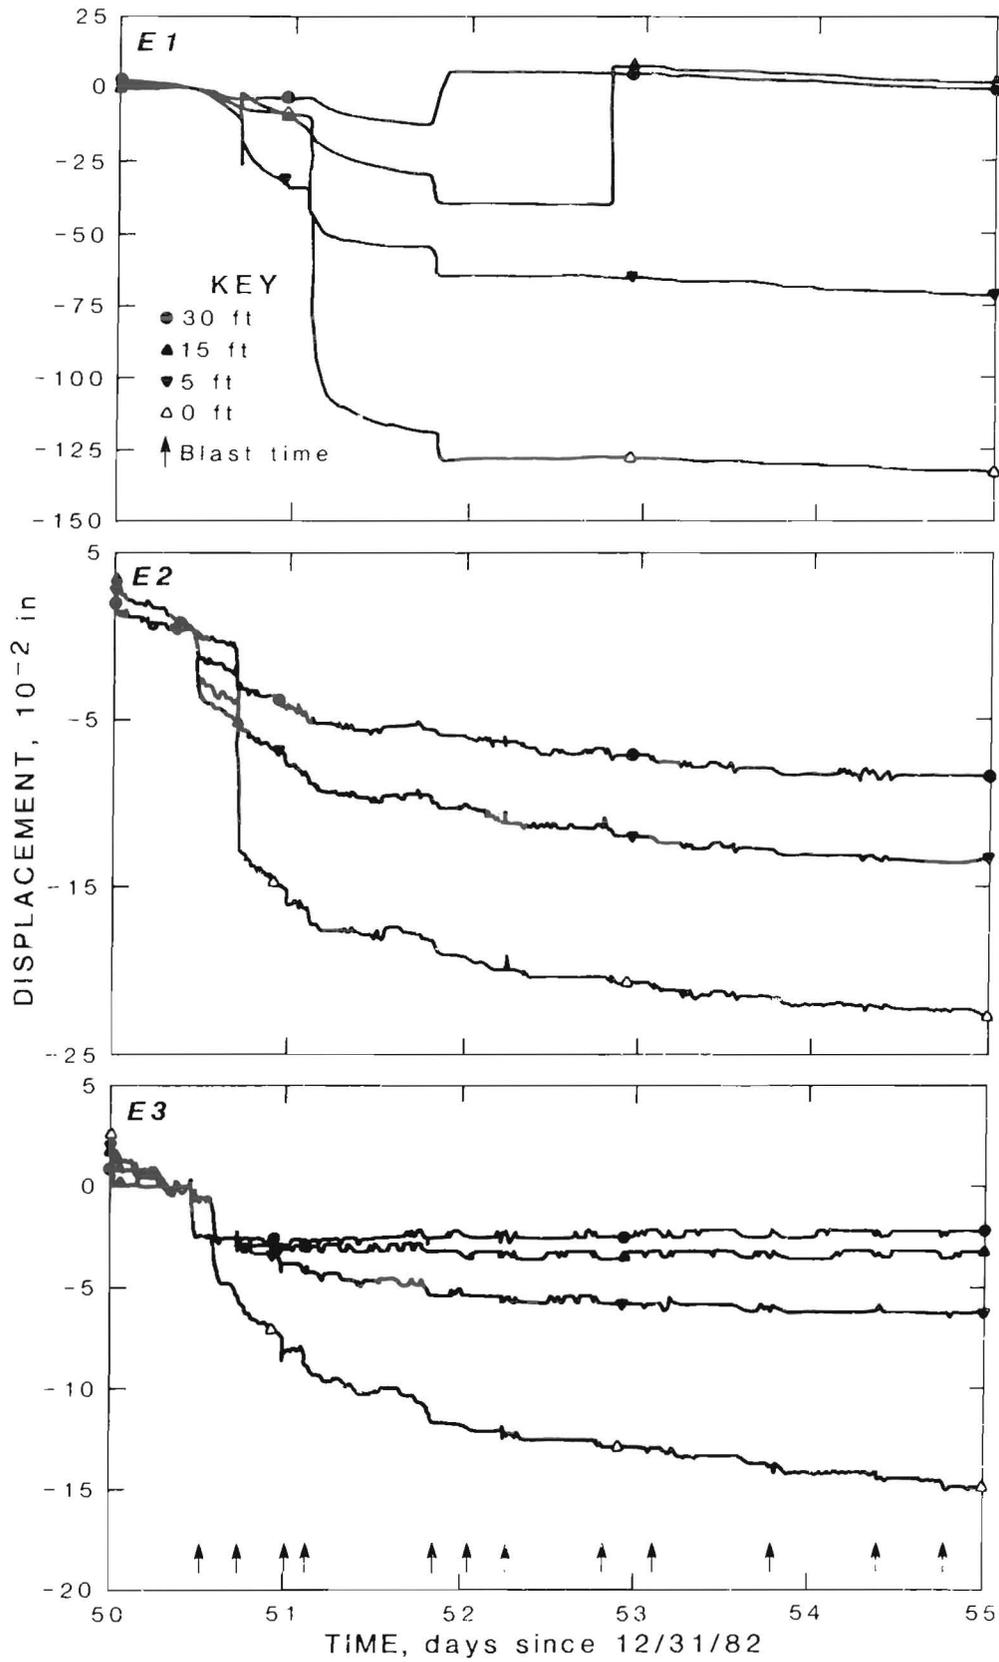
Figure C-12.—5,955-ft depth—5-day displacement at each MPBX location (E-1—E-3).

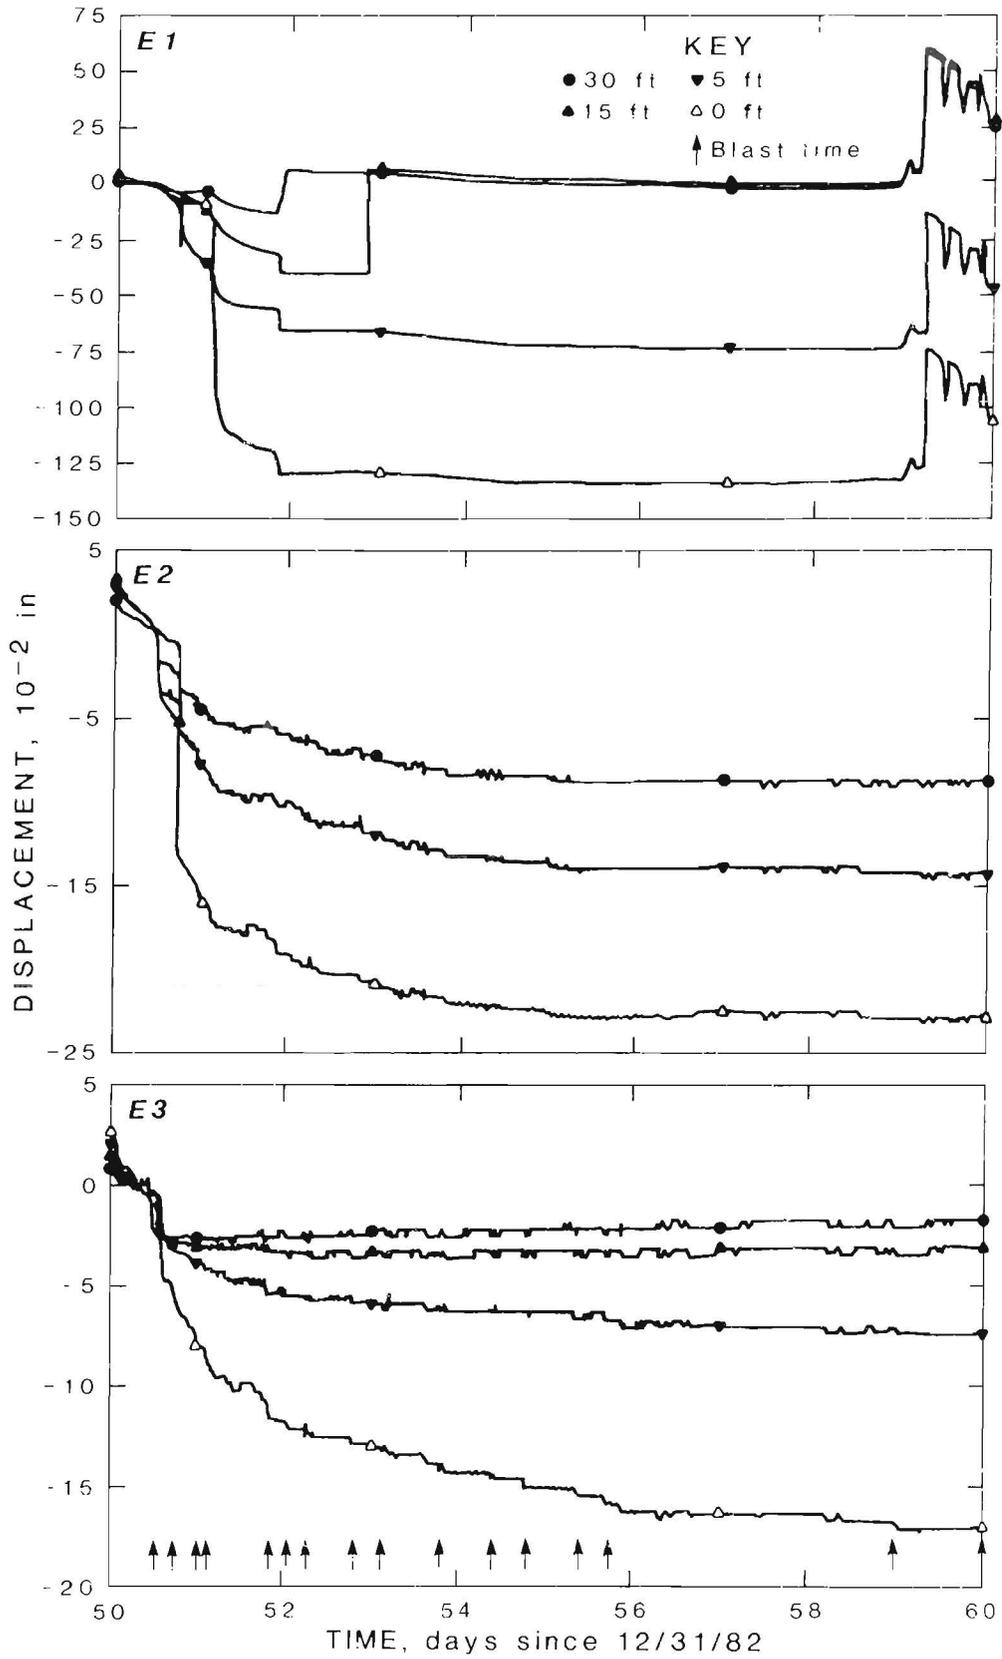
Figure C-13.--5,955-ft depth--10-day displacement at each MPBX location (E-1-E-3).

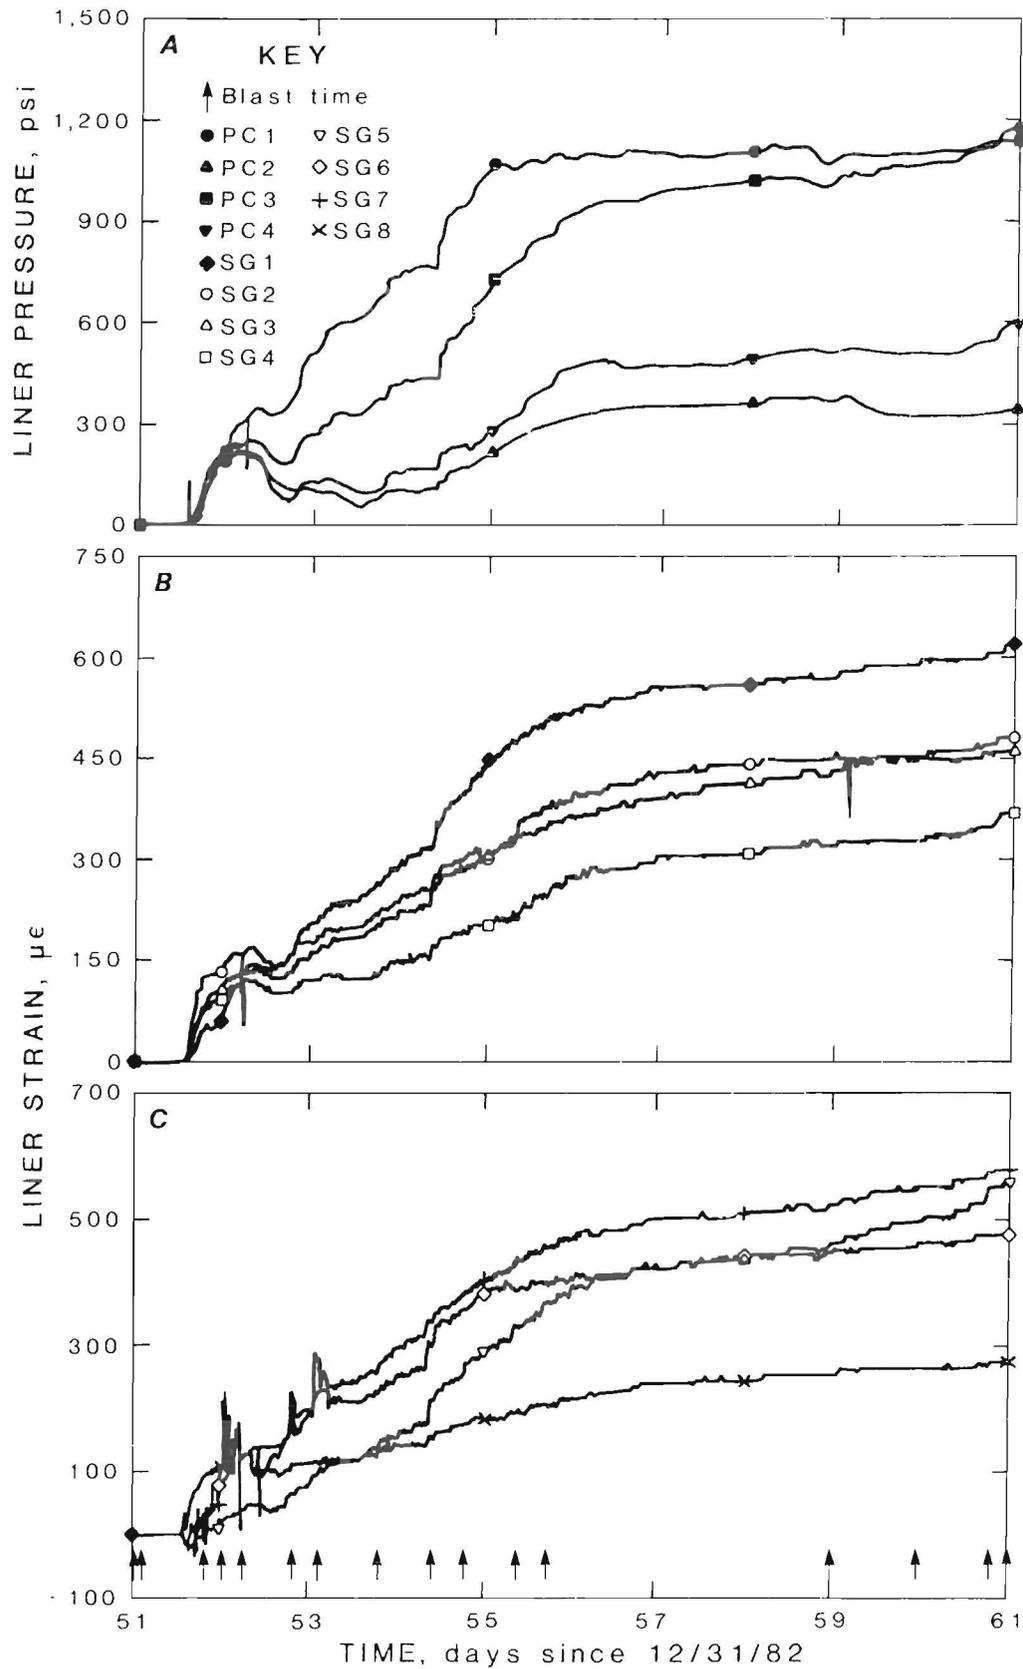
Figure C-14.—5,955-ft depth—10-day liner stress (A) and strain (B-C) at each MPBX location.
