**RI 9231**

# In Situ Measurements and Preliminary Design Analysis for Deep Mine Shafts in Highly Stressed Rock

By M. P. Board and M. J. Beus

BUREAU OF MINES

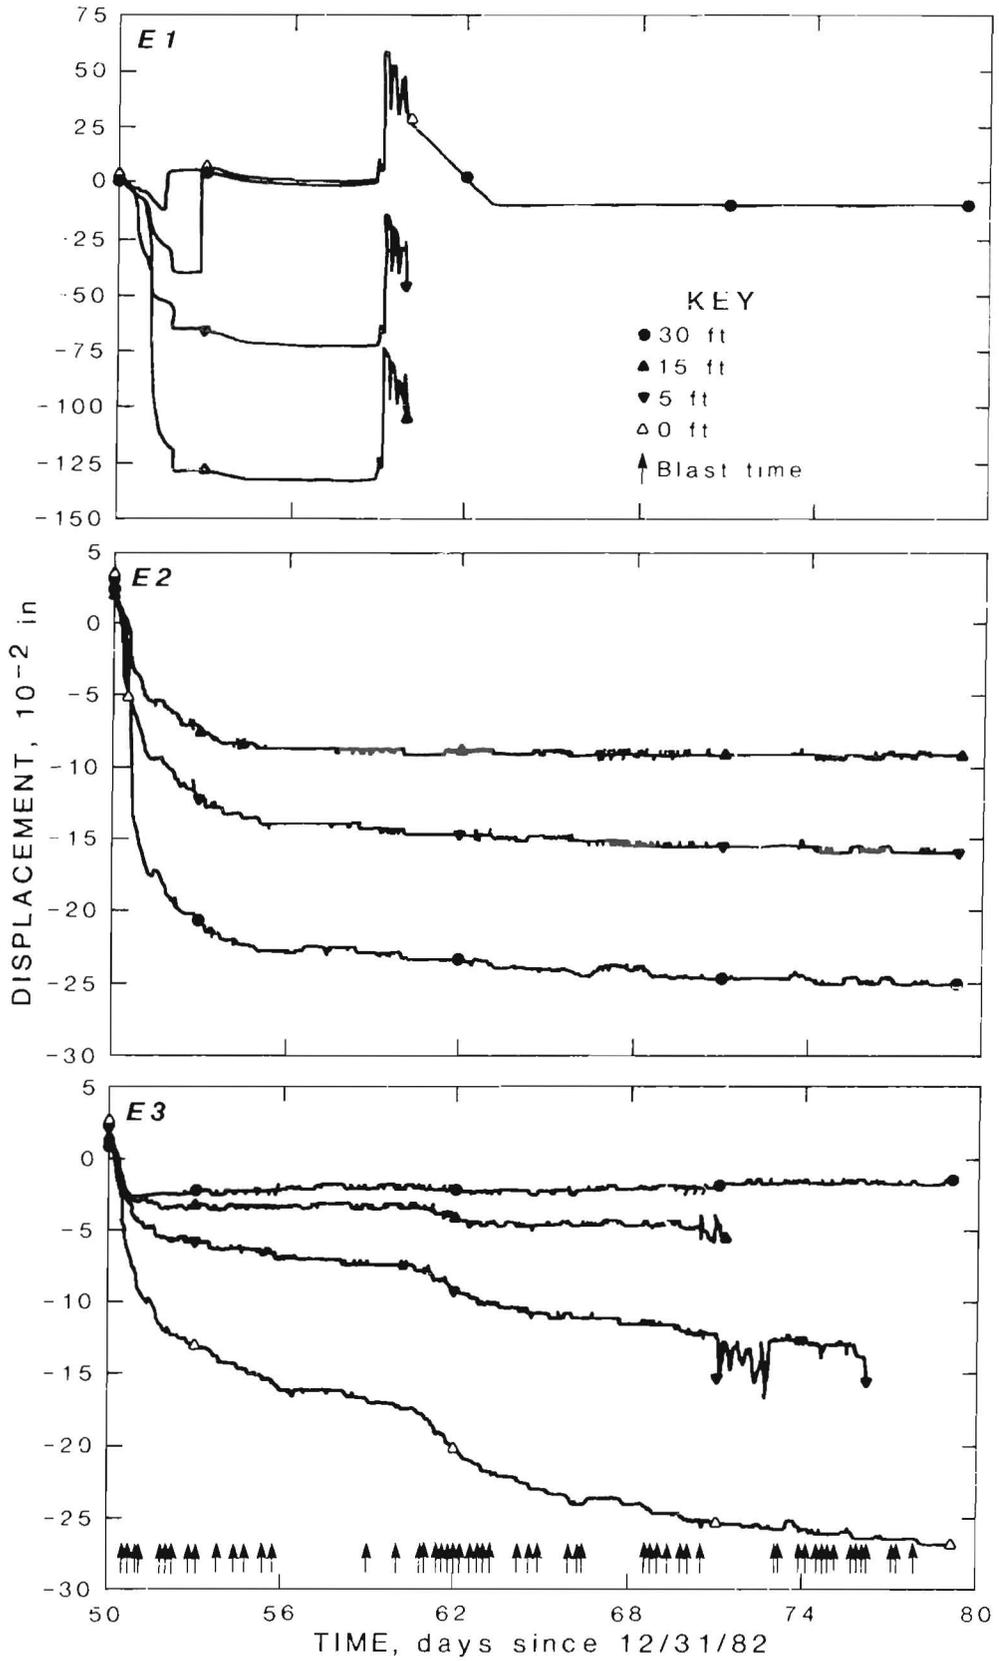
Figure C-15.—5,955-ft depth—30-day displacement at each MPBX location (E-1—E-3).

The installation at the 5,955-ft depth exhibited anomalous behavior, but was found to be due to secondary excavation of a loading pocket about 45 ft below the instruments (3). Displacement was reactivated as shaft excavation resumed, as seen in figure 9D, at about 11 days elapsed time. MPBX-E3, which was oriented roughly parallel (within 10°) of the longitudinal axis of the loading pocket, was most responsive. The additional increment of collar displacement due to loading pocket excavation and subsequent shaft sinking was almost 60 pct of the initial displacement levels at day 79. The displacement was also fairly deeprooted, as even the 15-ft anchor position showed additional movement (fig. C-15).

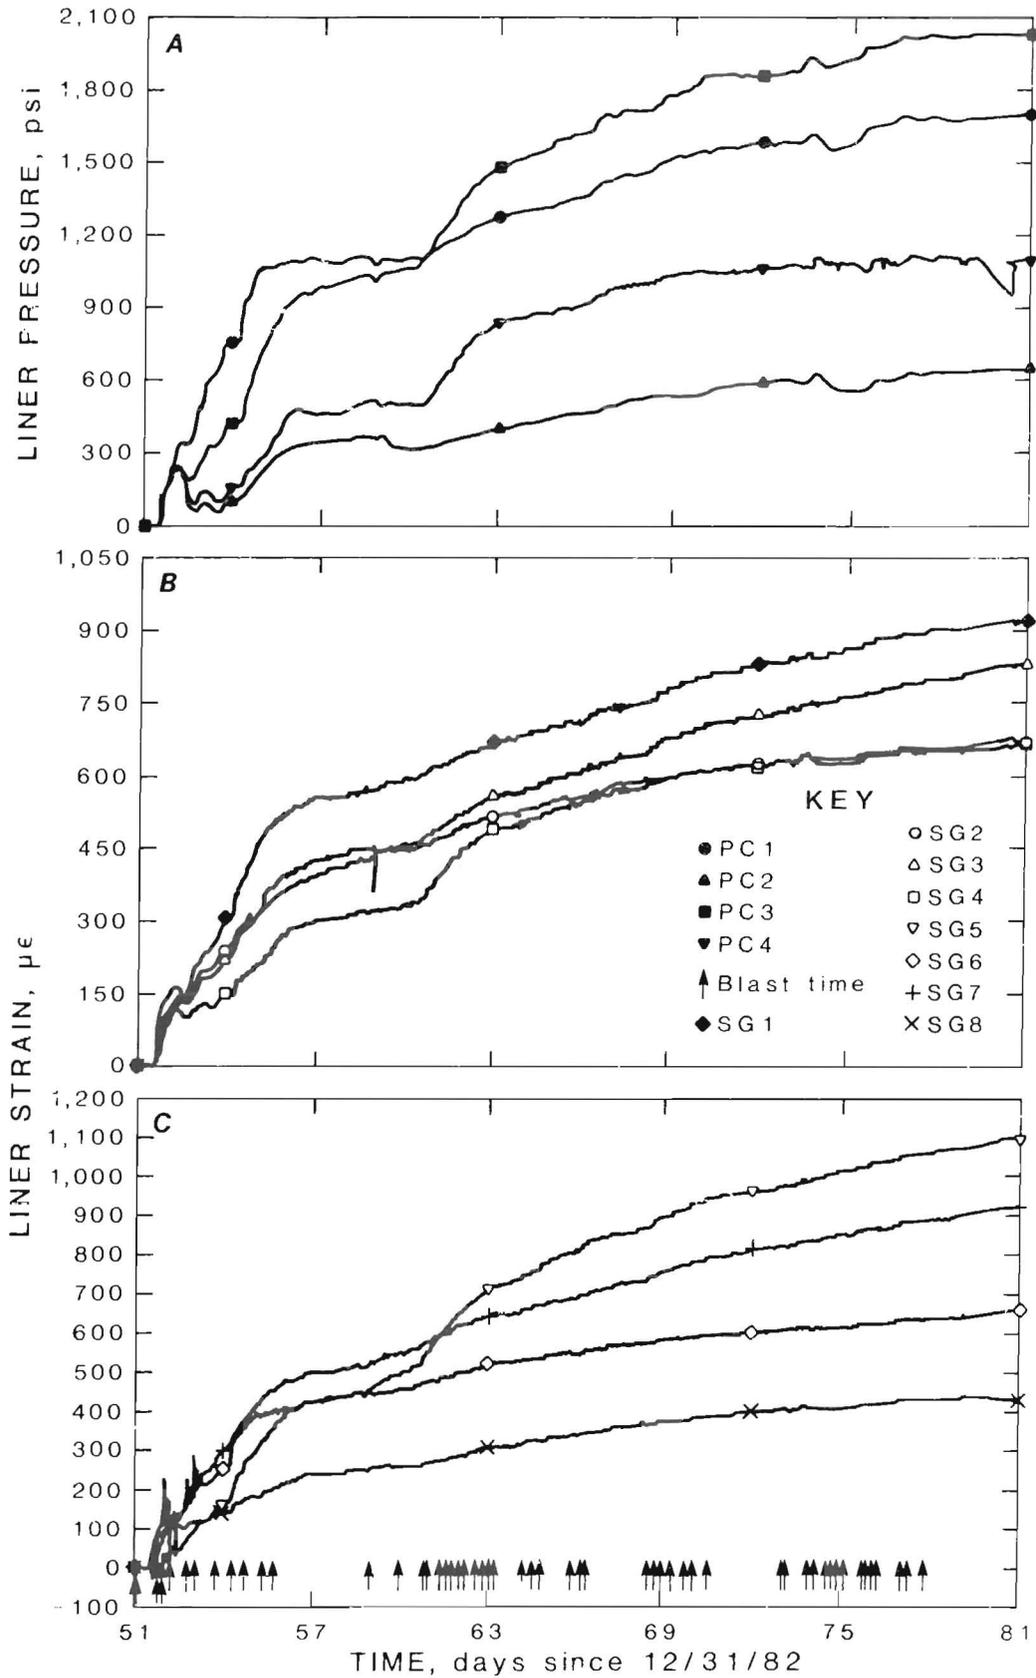
Figure C-16.—5,955-ft depth—30-day liner stress (A) and strain (B-C) at each MPBX location.

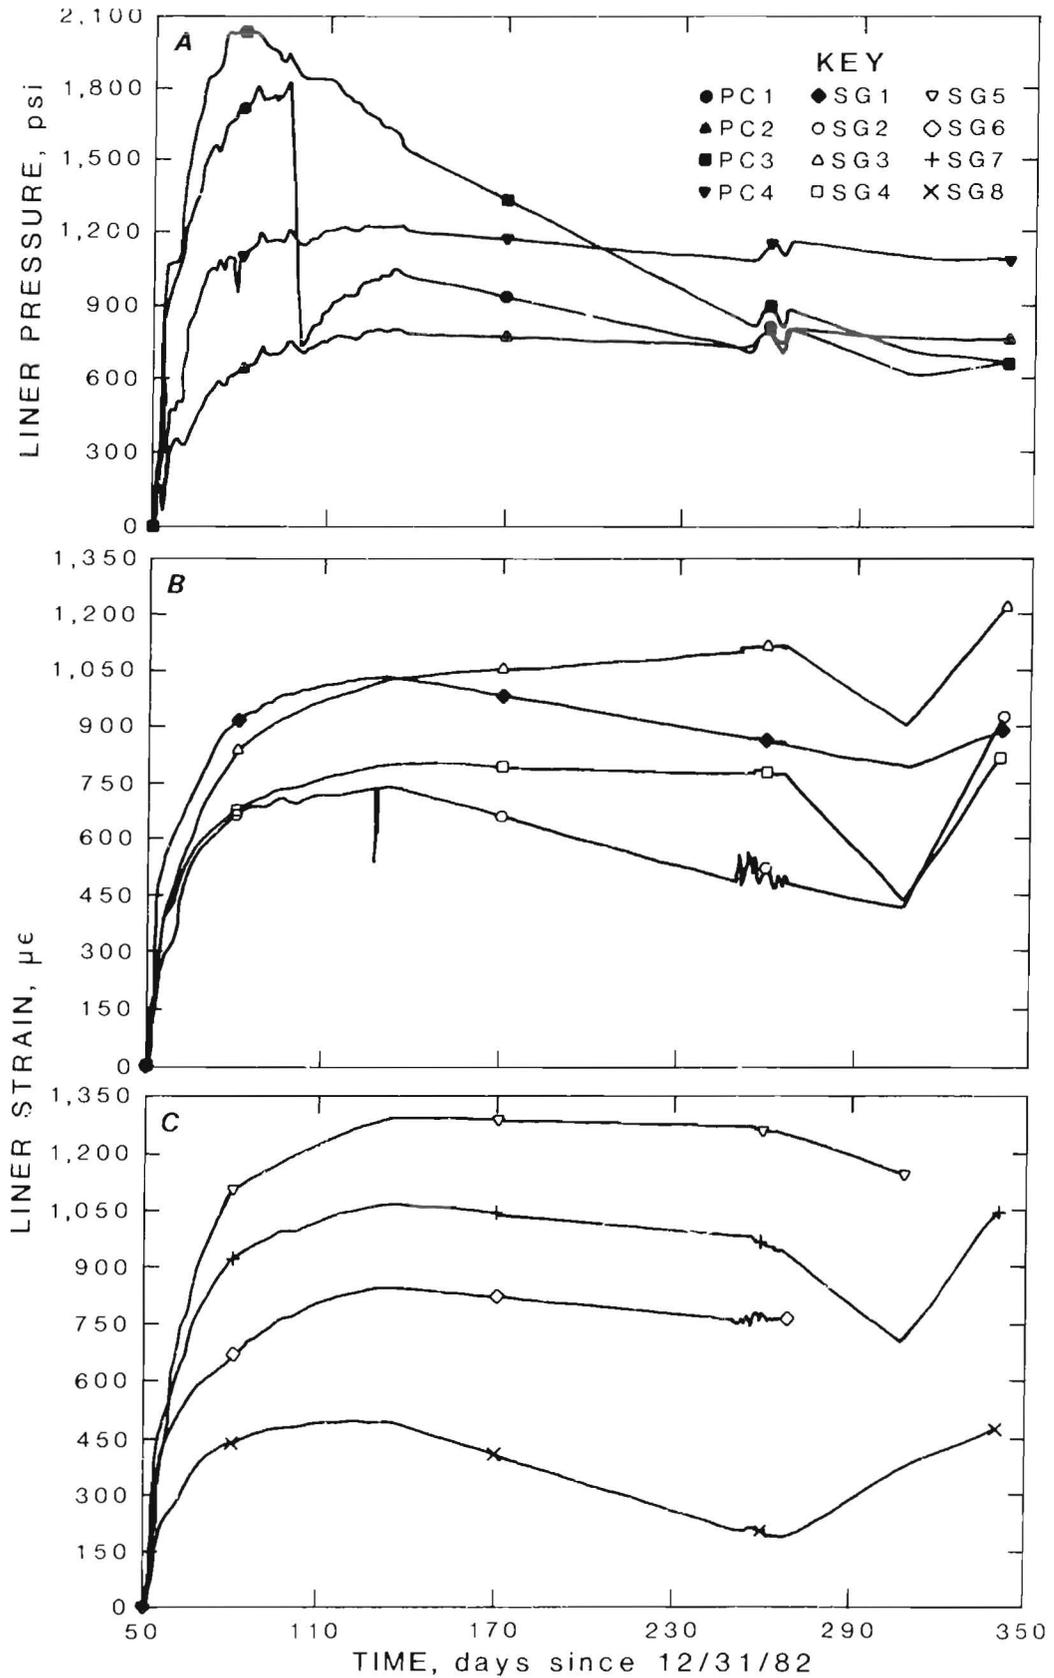
Figure C-17.—5,955-ft depth—300-day liner stress (A) and strain (B-C) at each MPBX location.
