Prof Saf. Author manuscript; available in PMC 2024 May 24.

Forklift Safety – Pilot Study Evaluation of Retrofit Lights

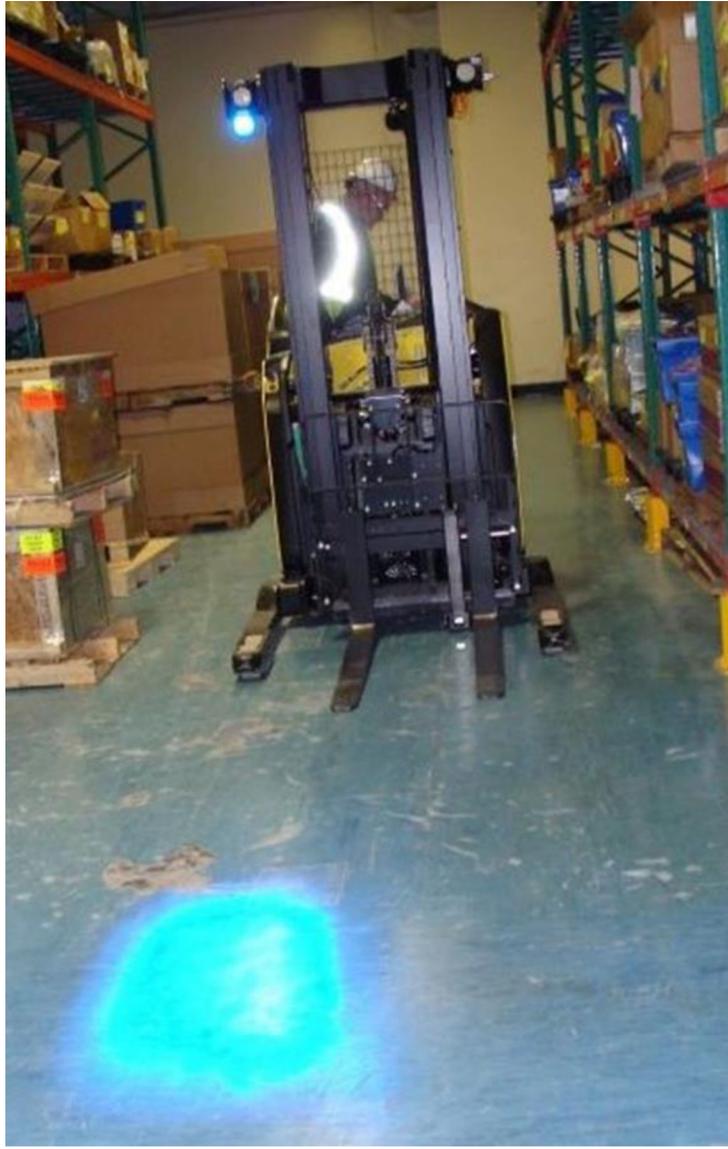
Figure 1.
Single forward-facing blue light installed.

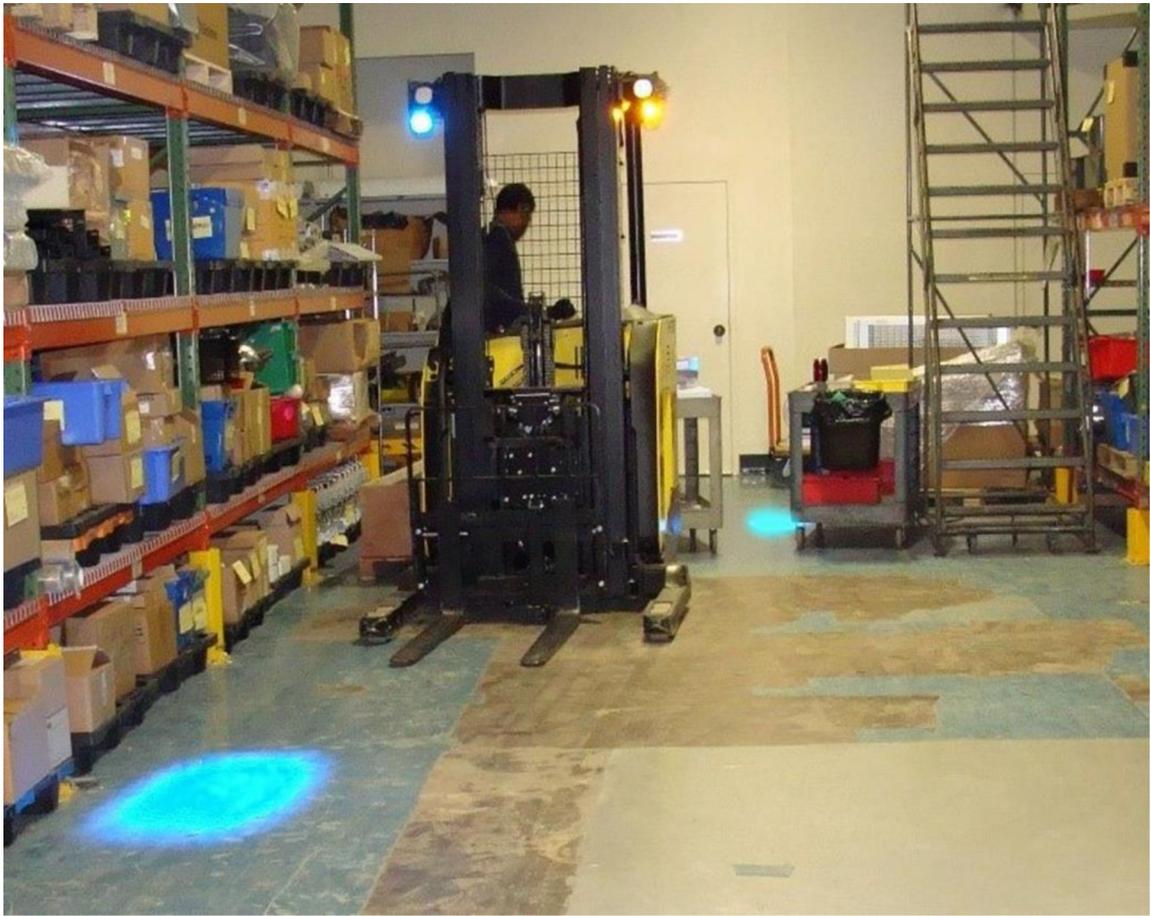
Figure 2.
Forward- and rear-facing blue lights installed.

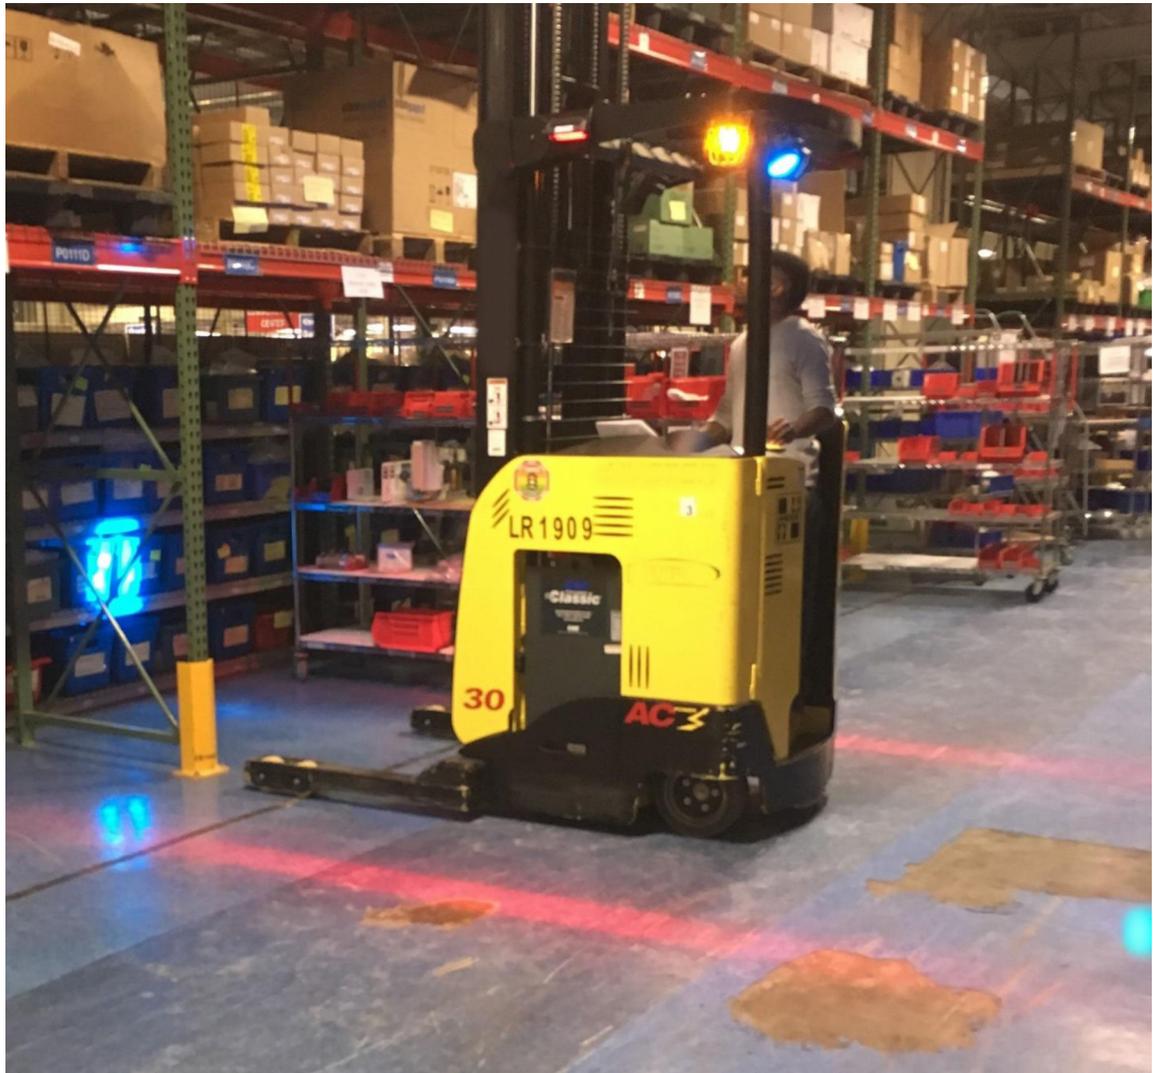
Figure 3. Red lights installed on each side, with the front blue light visible on the storage rack and the rear blue light visible on the floor (right edge of photo).

The blue lights were well-received by the employees who answered our questions, and they felt the lights provided extra warning to pedestrian workers and other vehicle operators. Regarding the issue of glare, the research team suggested to the forklift manufacturer’s technical sales representative the idea of automatically dimming the front blue light when the forklift is paused to remove or place a load on the racks. The response was it might work, but would require modifying the wiring by the manufacturer, and may be viewed as too costly. The location of the red lights was also a problem, but that has already been remedied by the forklift distributor by moving the location of the red lights toward the rear of the canopy, thus eliminating the glare.
