# Death in the line of duty...

**NIOSH**  
Fire Fighter Fatality Investigation  
and Prevention Program

February 28, 2013

## Volunteer Fire Fighter Dies After Being Ejected From Front Seat of Engine—Virginia

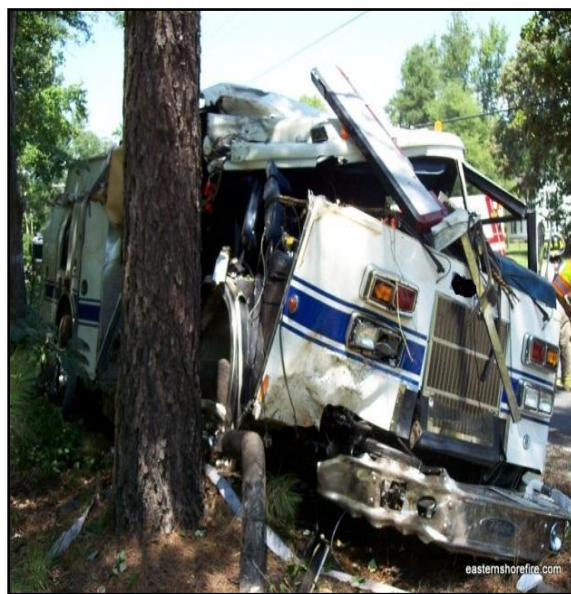
Crash site.

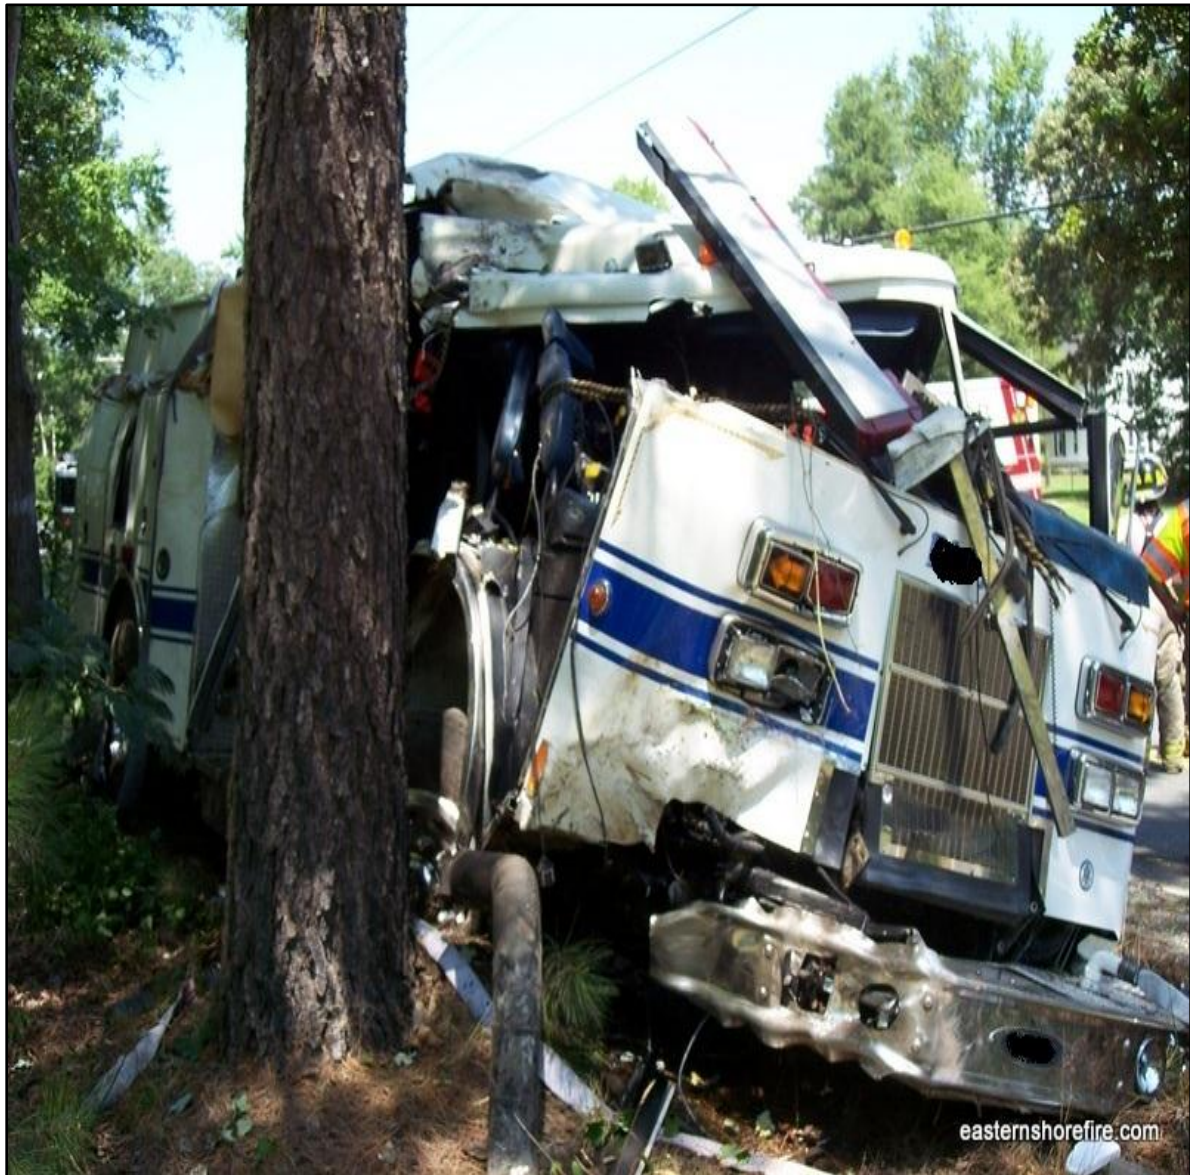
**Photo 1. Crash site.**  
*(Photo courtesy of easternshorefire.com.)*

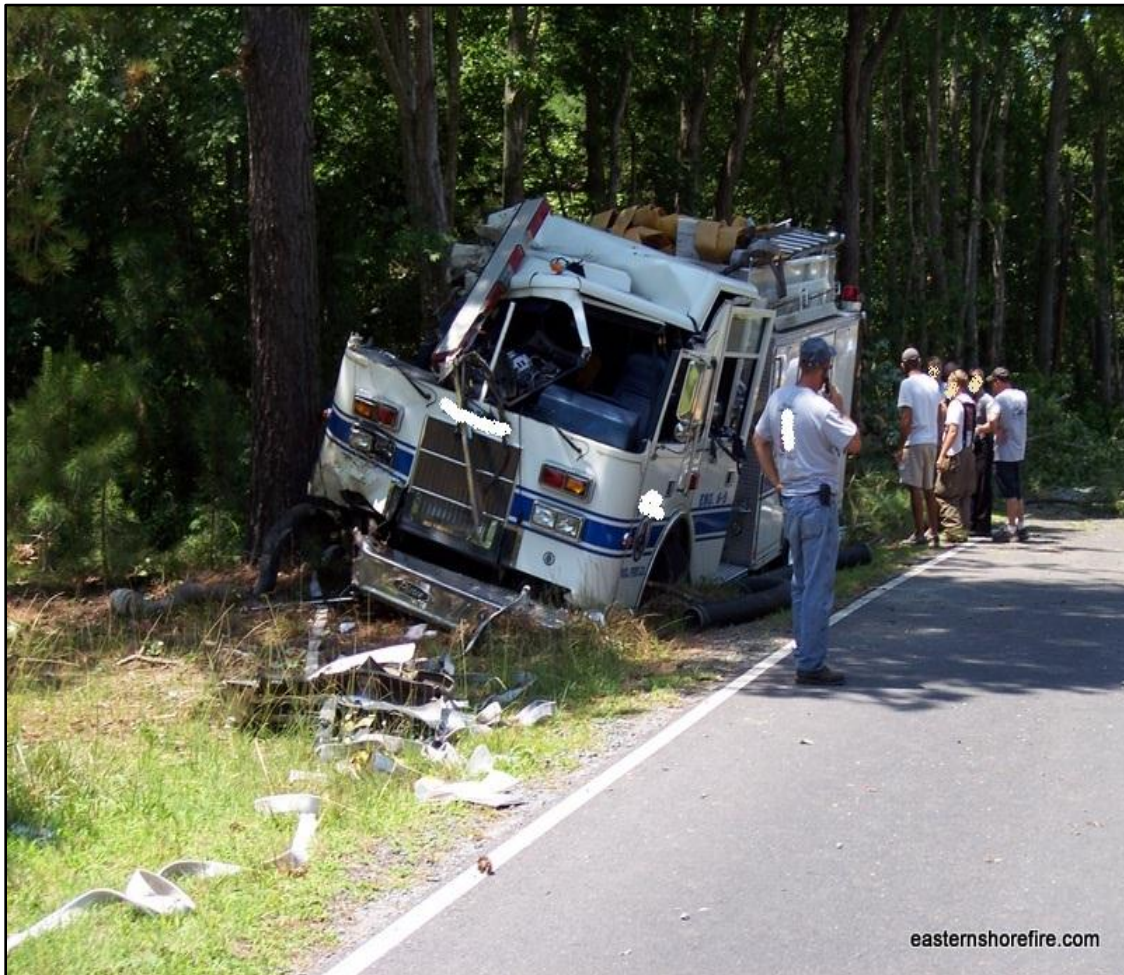
**Photo 2. Engine 6-5's final position just off the roadway in the wooded area.**  
*(Photo courtesy of easternshorefire.com.)*

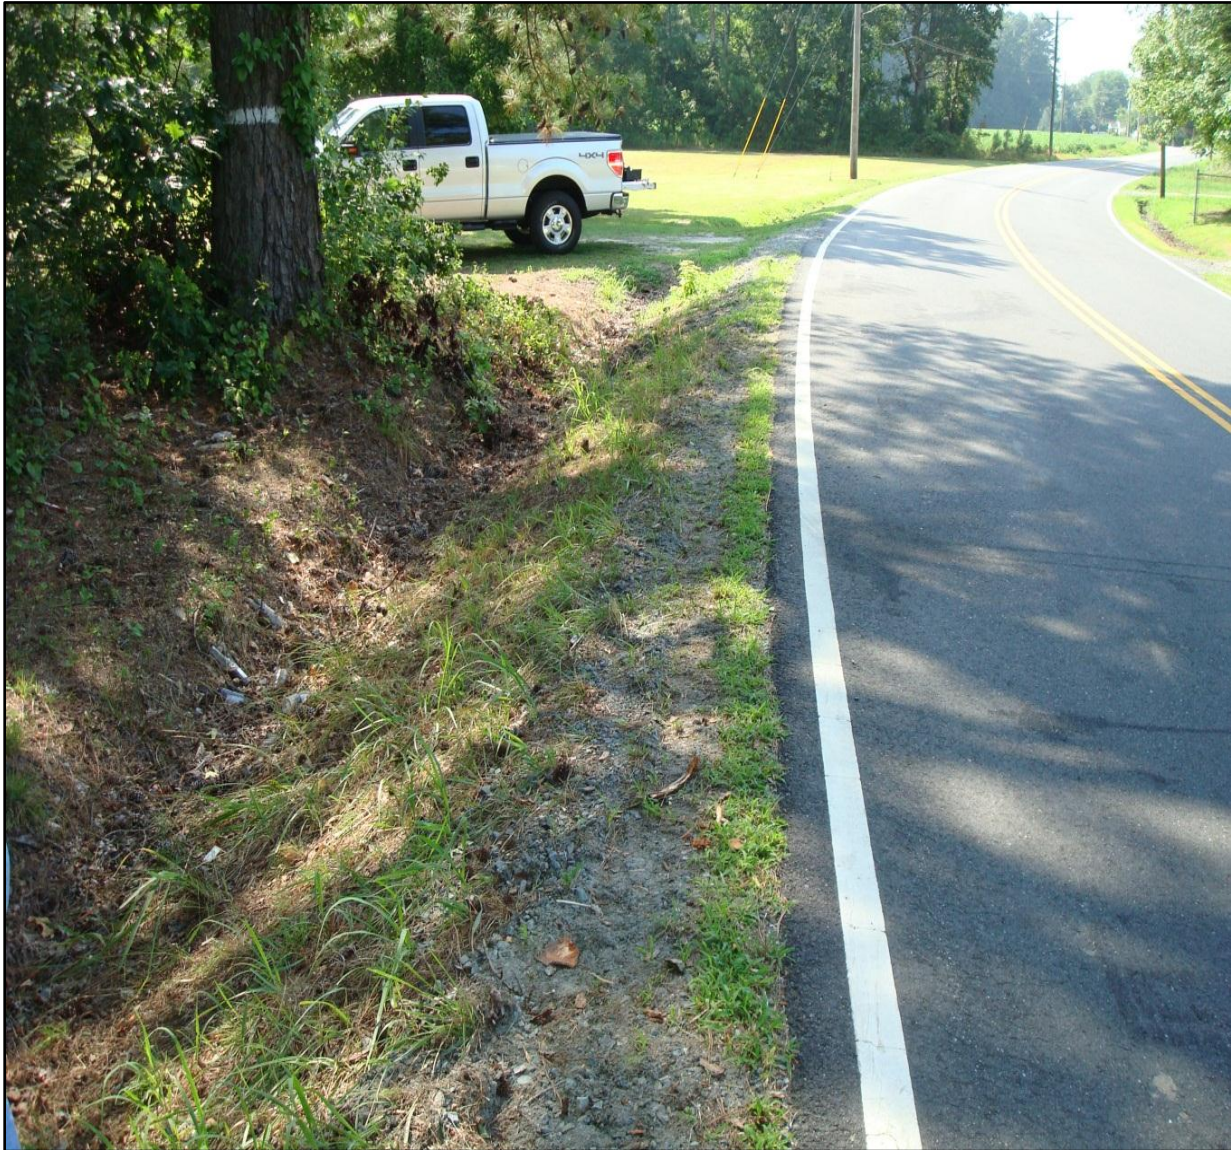
Engine 6-5 was traveling on a two-lane paved asphalt state highway with a posted speed limit of 45 mph. The incident occurred as the engine entered a slight left turn after exiting a right turn. While entering the turn, the right rear wheels of Engine 6-5 left the paved surface and the engine went into the ditch. There was a narrow soft shoulder and ditch at the point where Engine 6-5 left the roadway (see Photo 3). The roadway was narrow and had a minimal shoulder in the curve (see Photo 4). The roadways in the area were reported as dry by other emergency personnel and police. At the time of the

**Photo 3. Curve where Engine 6-5 left the roadway. The ditch is visible just to the side of the pavement.**  
*(Photo by NIOSH.)*

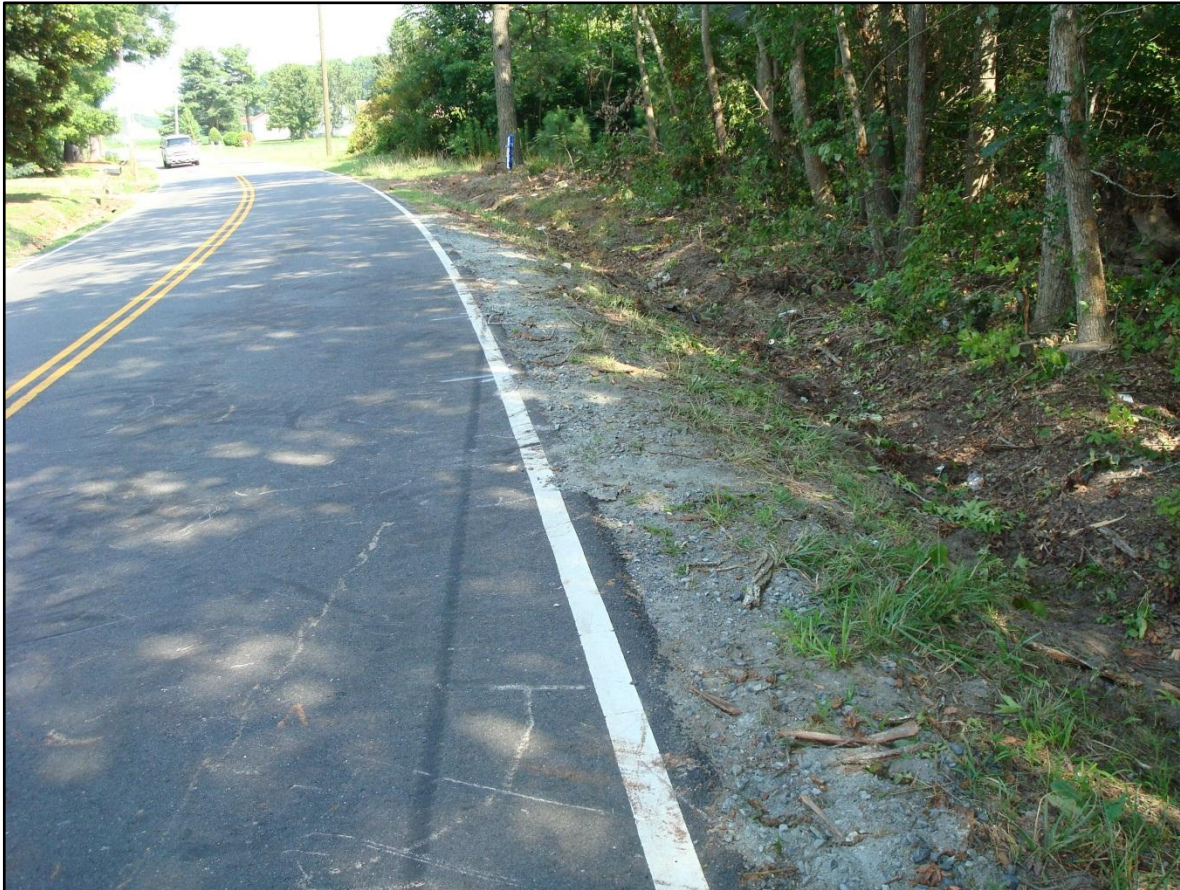
**Photo 4. Crash scene after Engine 6-5 was removed. Yaw mark from left side dual wheels. Right side dual wheels were already off the roadway.  
(Photo by NIOSH.)**

In this incident, the driver of Engine 6-5 stated during interviews that his speed was approximately 35–40 mph and the road conditions were dry. The driver also stated that the truck had seemed sluggish and he had mentioned that to the victim (they had no other conversation during the response). After coming around the first right-hand curve, he started to enter the second left-hand curve and he described the rear end as being “picked up and moved over to the right.” The truck’s right wheels dropped off the pavement and traveled in the ditch and struck a utility pole and several trees. Engine 6-5 did have anti-lock brakes, and yaw marks on the roadway showed the point where Engine 6-5 left the pavement and entered the ditch (see Photo 4).

The state police crash report estimates the speed of Engine 6-5 to have been 55 miles per hour and notes failure to maintain proper control by the driver as a factor. The posted speed limit for the highway was 45 miles per hour. The roadway was narrow and had a minimal shoulder in the curve (see Photo 4). The state police crash reconstruction personnel examined the truck and could find no issues with the truck regarding braking or steering. There were no indications that anything was mechanically wrong with the truck. The truck was sent to the manufacturer’s refurbishment plant in Wisconsin for evaluation and possible repair.

***Recommendation #1: Fire departments should ensure that fire department drivers/operators are trained in techniques for maintaining control of their vehicles at all times.***
