REPORT#: 15MI066

Farmer Starting Tractor From Ground Run Over by Tractor

Michigan Fatality Assessment and Control Evaluation (FACE) Program

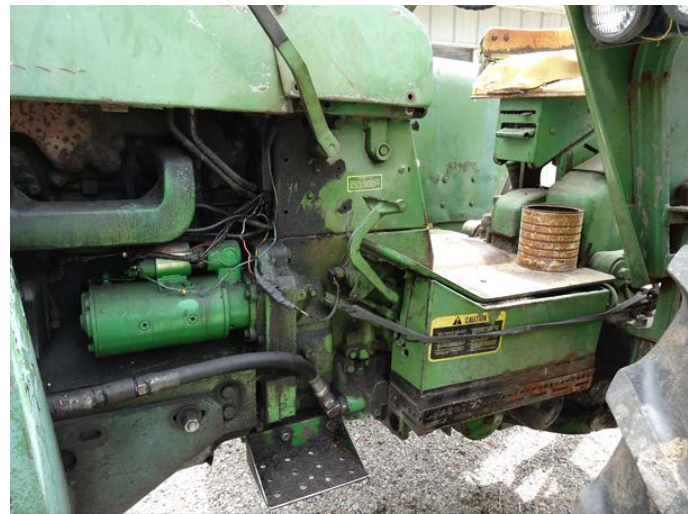
Photo 1. Driver side of tractor

The John Deere 3020 tractor had previously been driven into and parked in a pole barn. The tractor was usable, but in overall poor condition (tires, seat, controls, loose sheet metal, handles, etc.) (See Photos 1 and 2). The tractor starter wiring had been modified, including cutting the wire to the clutch safety switch, the cable that controlled shifting would not let the tractor be placed into neutral, and the emergency brakes were frozen.

The step used to access the operator platform was 26 inches above the ground and the operator platform was approximately 40 inches above the ground. The tractor tire was size 14.9-38 and 5 feet tall.

Recommendation #3: Owners/operators should inspect and maintain equipment to ensure it is in good operating condition.

Discussion: Like many farmers, the decedent used the tractor "because it still worked". The tractor, although operable, was not in good condition, and had many safety issues placing any individual operating the tractor at risk. Tractor owners should ensure that any individual, including themselves, conduct a preoperational check of the tractor to ensure that all safety controls are in place and all systems are in good operational condition. A pre-operational checklist, as a minimum, could include these items:
