NJ FACE INVESTIGATION REPORT

FACE 13-NJ-059

Batch Maker Dies after Toxic Exposure to Toluene Vapor

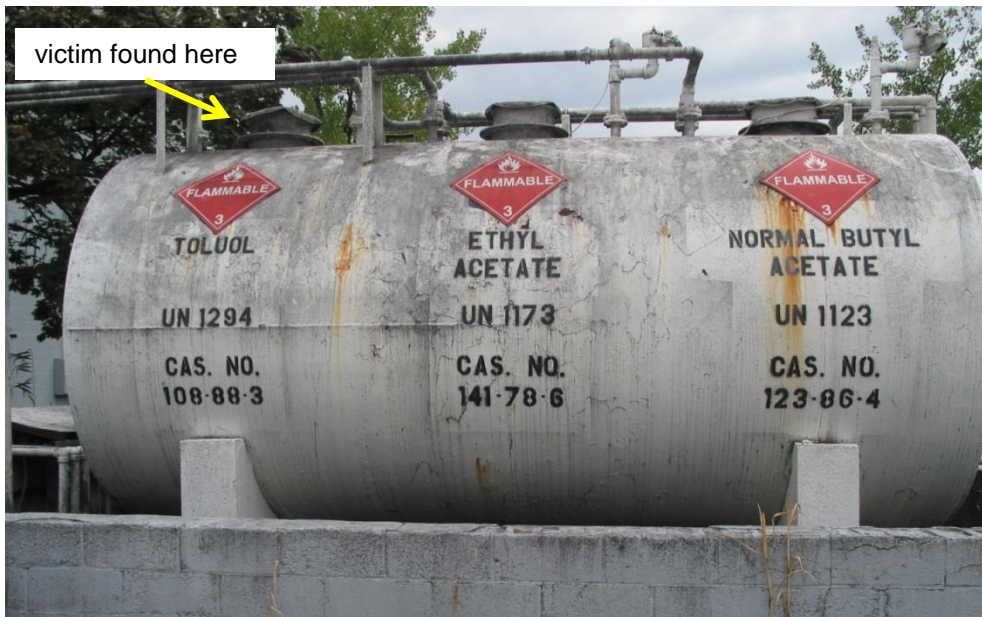
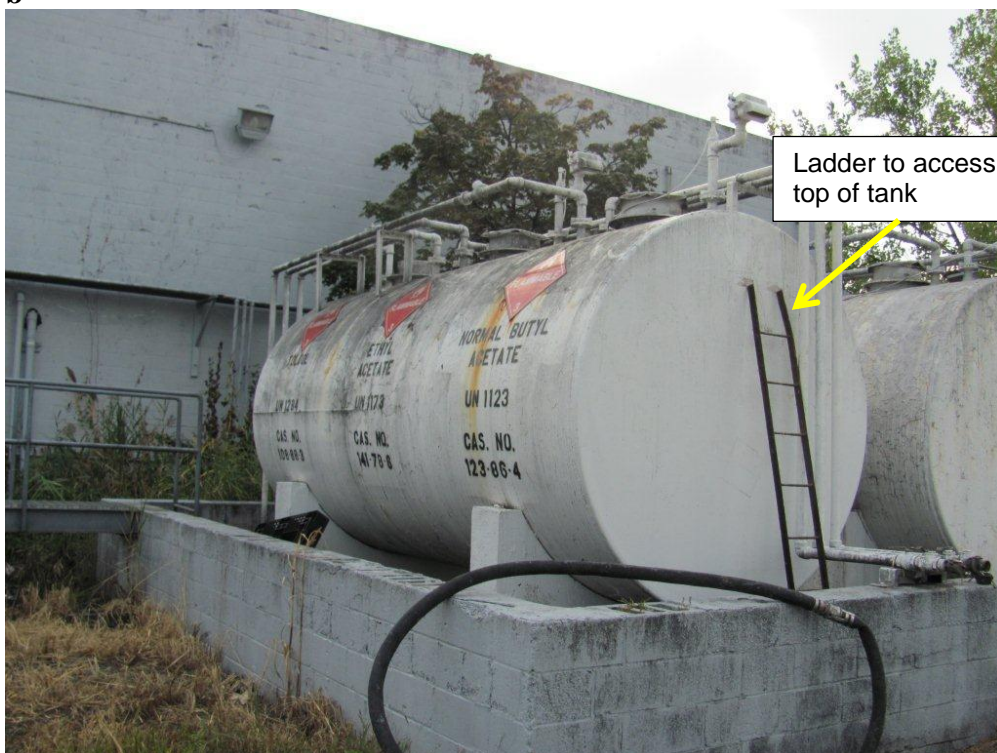
FIGURE 1: Incident site, above-ground storage tank with three 2,000-gallon sections (a. side view; b. front view).

The incident occurred on an extremely hot summer day (approximately 95° F at the time of the incident, wind speed up to about 12 mph), with no significant precipitation recorded. The incident site was located in the backyard of a manufacturing plant in northern NJ. The company manufactures varnishes, lacquers, enamels and other coatings. A total of 12 nonunion workers are employed on site. The incident occurred on the top of a 37-year-old, 6,000-gallon above-ground storage tank, separated into three 2,000 gallon sections used for storage of toluene, ethyl acetate, and butyl acetate (Figure 1). The cylindrical tank was 16 feet (192 inches) in length by eight feet (96 inches) in depth. The tank access was an 18-inch diameter access port, 12 inches in height (Figure 2). The total distance from the tip of the port to the bottom of the tank was nine feet (108 inches).

NJ FACE recommends developing a method of determining the volume of the liquid in the tank without entry. This can be accomplished in many ways, including retrofitting the tank with a small, sealed window for external view, fixing or replacing the volume gauges, or the creation of a permanent system that would indicate the remaining volume without the need for manual gauging. If an alternative method cannot be developed, the employer must comply with OSHA's confined space entry standard (CFR 29, 1910.146).

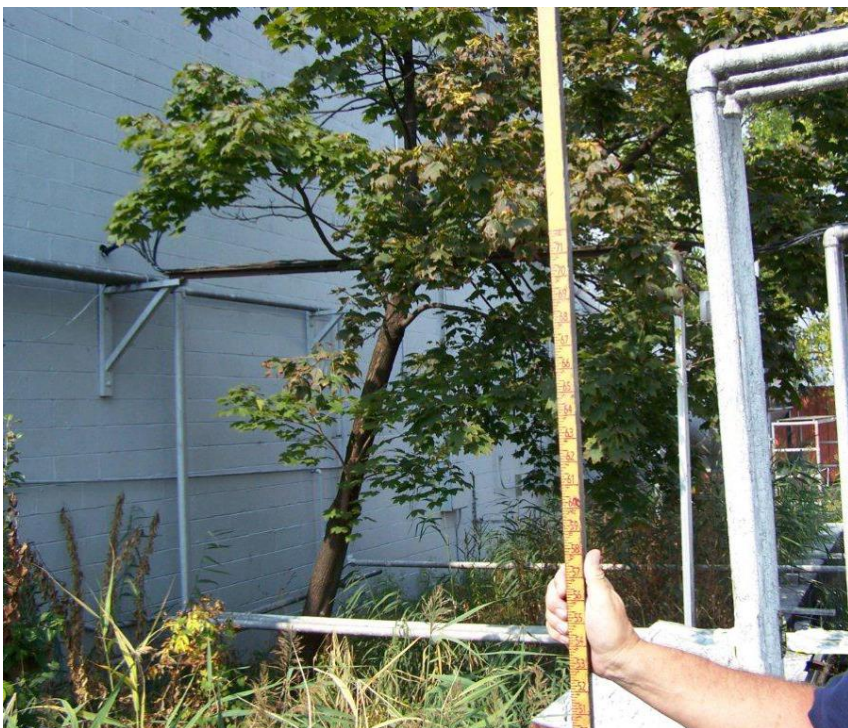
Figure 3. Eighty-four-inch-long wooden measuring stick used to manually gauge the volume of the remaining liquid in the tank.

Two batch makers were trained by the plant manager to measure the volume of liquid in each section by using an 84-inch-tall wooden measuring stick (Figure 3). Measurements were taken either daily or every other day in order to determine if additional solvent needed to be ordered. The tank-level gauges were not functioning, and volume measurements had been conducted manually for approximately the past 30 years.

Discussion: According to 1910.146(b), entry into a confined space is *considered to have occurred as soon as any part of the entrant's body breaks the plane of an opening into the space.*¹ As such, the job task of opening the hatch and inserting the stick into the tank is considered a confined space entry. The victim and the coworker would open the access port and lower the stick down to the bottom of the tank. Since the stick was eighty-four inches long, and the distance from the top of the hatch to the bottom of the tank was nine feet, the workers had to reach two feet into the tank in order to obtain an accurate volume measurement.
