MIFACE INVESTIGATION REPORT: #08MI171

SUBJECT: Laborer Died During Test Drive of Four-Wheel All Terrain Vehicle (ATV)

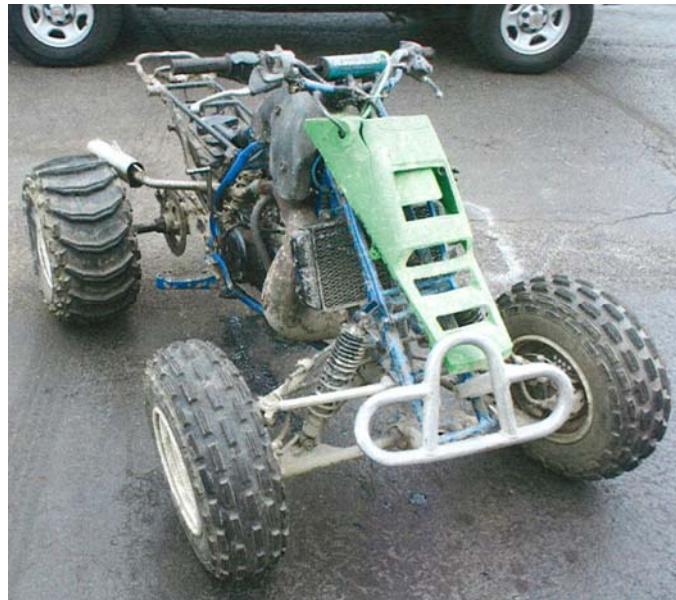
Figure 1. ATV involved in incident

The ATV involved in the incident was a Kawasaki Tecati Model XF 250. The seat was not present. The ATV had foot pegs upon which the rider's feet rest. The ATV did not have a heel guard. The ATV belonged to a friend of the decedent's employer. The ATV would go into gear but would not move. The friend tried to repair the ATV at his home, but was unsuccessful. Mentioning his problem to the decedent's employer, the shop owner told him to bring it to the shop and he would take a look at it. The friend brought the ATV into the shop and the owner diagnosed the problem. The ATV owner repaired the ATV and then left the ATV at the shop. A couple of days later, the ATV owner returned to the shop to place oil into the transmission.

- Employers should ensure all ATV components are present prior to a test drive.

The seat was missing from the ATV at the time of the incident. Negotiating a turn from a crouched position rather than a sitting position could make it more difficult for a rider, especially an inexperienced rider like the decedent. When an employee performs a test drive of an ORV, all essential parts, such as the seat, should be present.

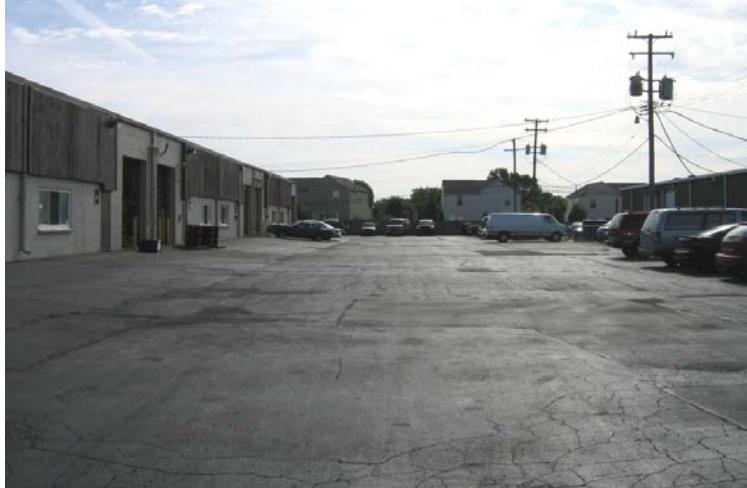
Figure 2. View of parking lot, looking west to east

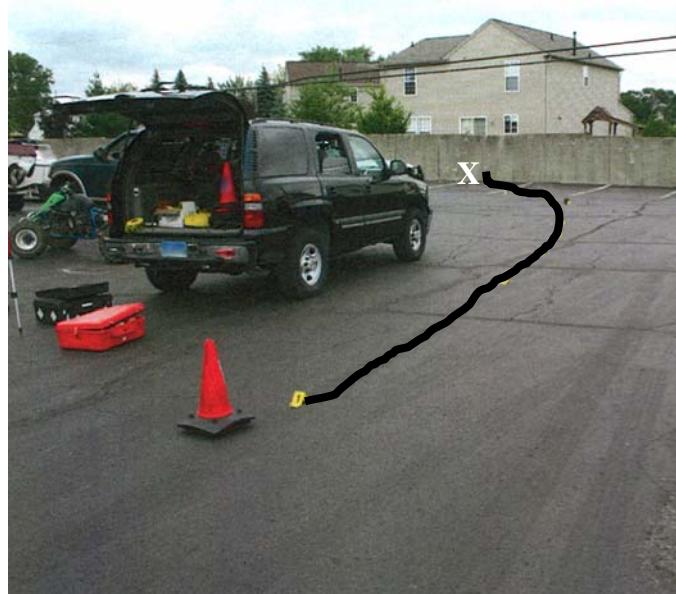
The decedent reached the west end of the parking lot and stalled the ATV. After restarting it, he rode the ATV eastbound. He was traveling an estimated 30 mph. As he was approaching the east end of the parking lot, he began to slow down (Figure 3). It appears he was making an attempt to turn the ATV to the left (north) to an approximately 59-foot wide parking area located at the east end of the building (Figure 4). To balance as he was making the turn, the decedent right foot came off of the foot peg and landed on the ground. His foot may have landed between the peg and the right rear tire. The ATV's right tire ran over his foot, dislodging his shoe. The decedent lost control of the ATV and it flipped onto its right side and rotated counterclockwise. Both the ATV and the decedent struck a concrete wall at the east end of the parking area (Figure 3, location of X near wall). The decedent landed on the right side of his body, sustaining head and rib injuries.

Figure 3. Path of ATV as decedent slowed and attempted to turn north into parking area to the east of the building

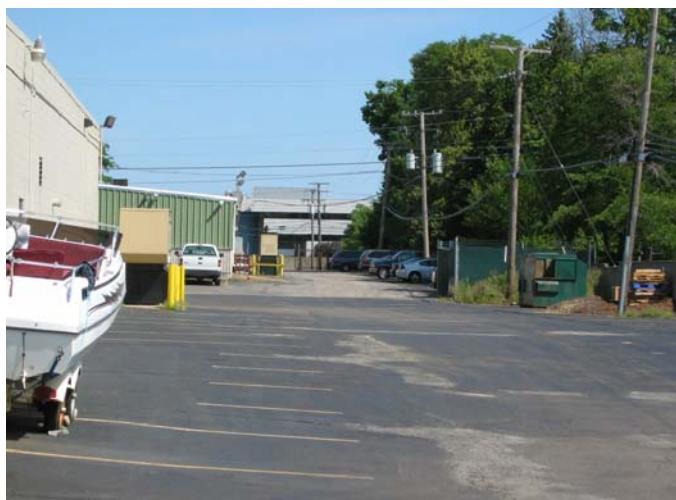
Figure 4. Parking area into which the decedent was attempting to turn
