Foreign-born Semi Driver Dies After Driving Over Embankment

Incident Number: 09KY071

Release Date: **August 3, 2010**

Subject: **Foreign-born Semi Driver Dies After
Driving Over Embankment**

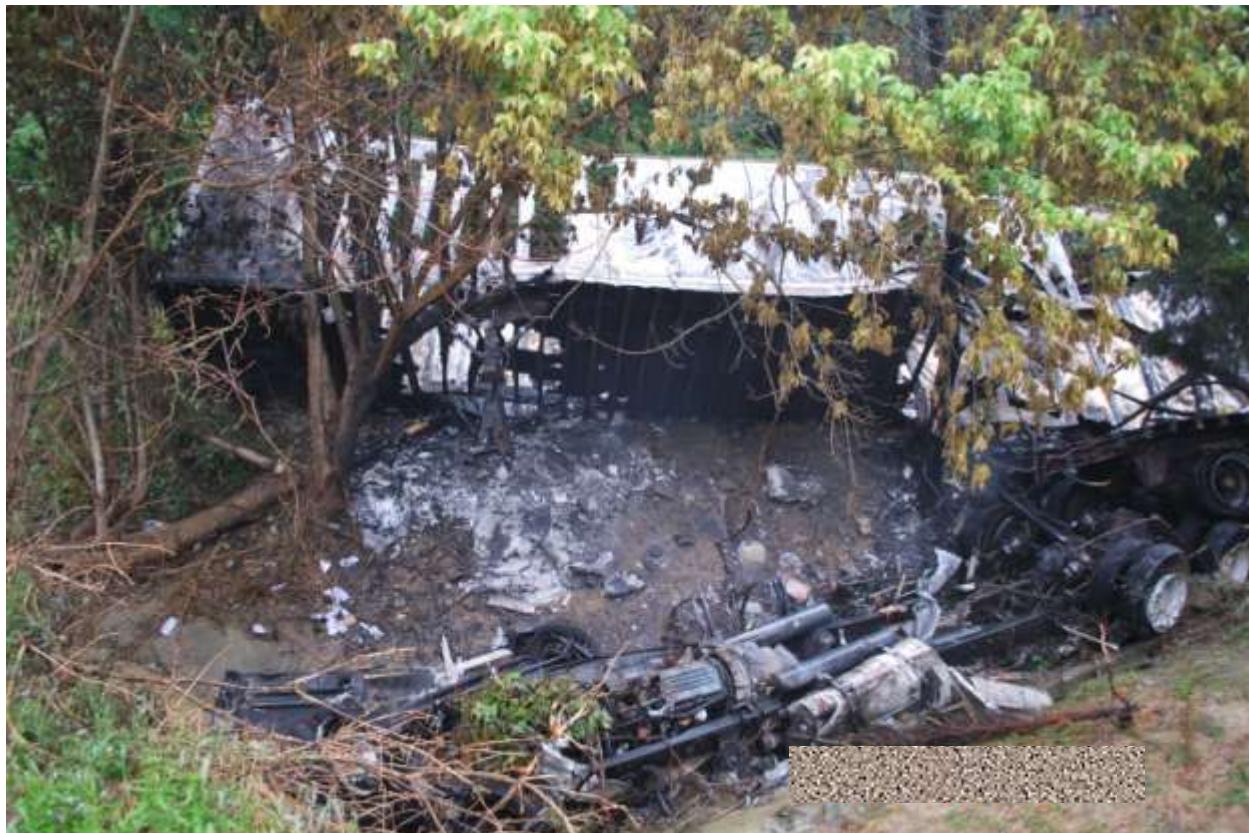
Photograph of the semi tractor-trailer involved in this incident. Photograph courtesy of local official.

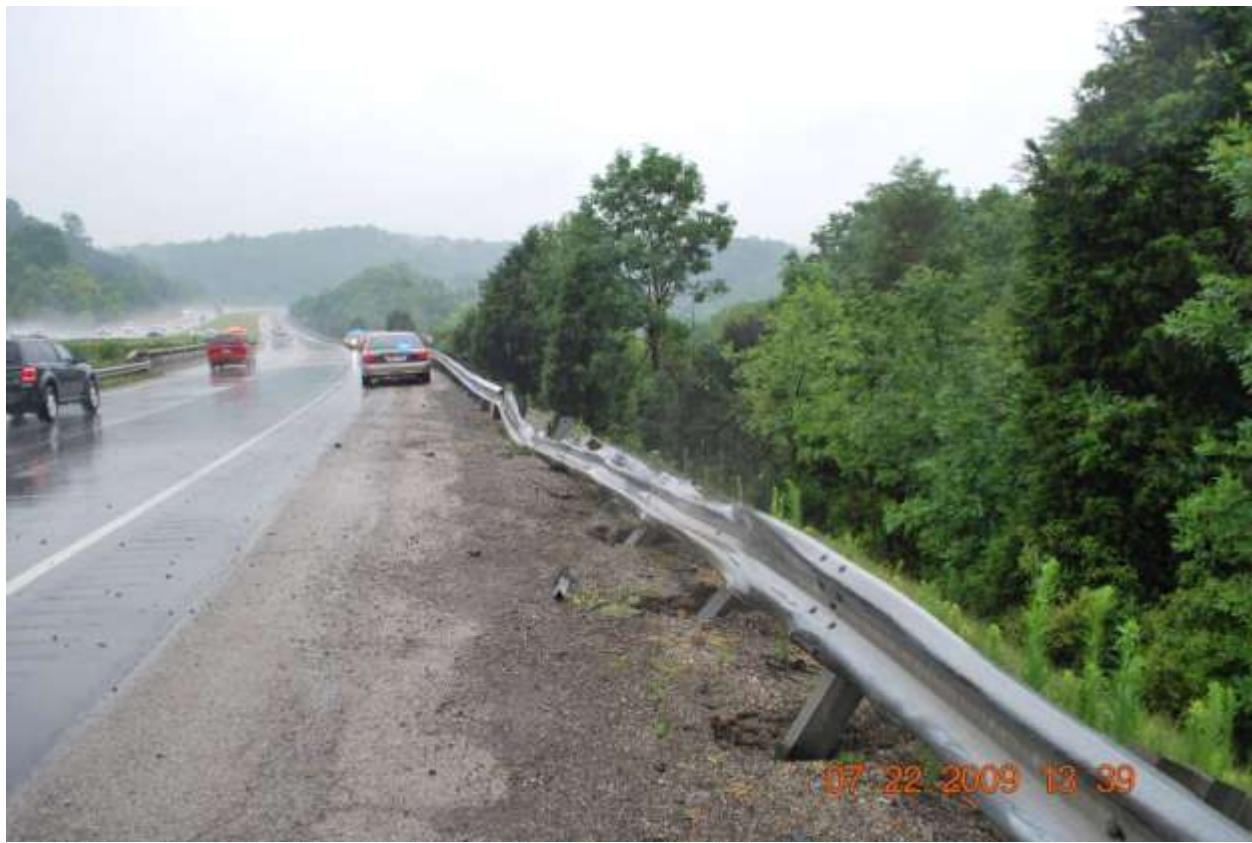
At approximately 11:30 AM, the truck driver had been enroute for approximately 50 miles and was headed southwest on a rural, four-lane interstate. It was raining, the asphalt pavement was wet, and the speed limit was 70 miles per hour. The local terrain was hilly, and the tractor-trailer was headed downhill into a curve when the driver drove off the pavement on the right side over the emergency lane, over a guardrail, then traveled 185 feet through dense trees and into a ravine. With the fuel tanks damaged, the tractor overturned and the trailer disengaged from the fifth-wheel. A fire ensued; the tractor flipped over, ejecting the driver and the tractor came to rest on its top. The trailer settled in an upright position partially across the overturned tractor.

Location where semi tractor-trailer driver drove off of interstate into ravine. Photograph courtesy of local official.

Recommendation No. 5: A comprehensive motor vehicle safety assessment of Kentucky’s interstate system needs to be performed in the area where the collision took place.

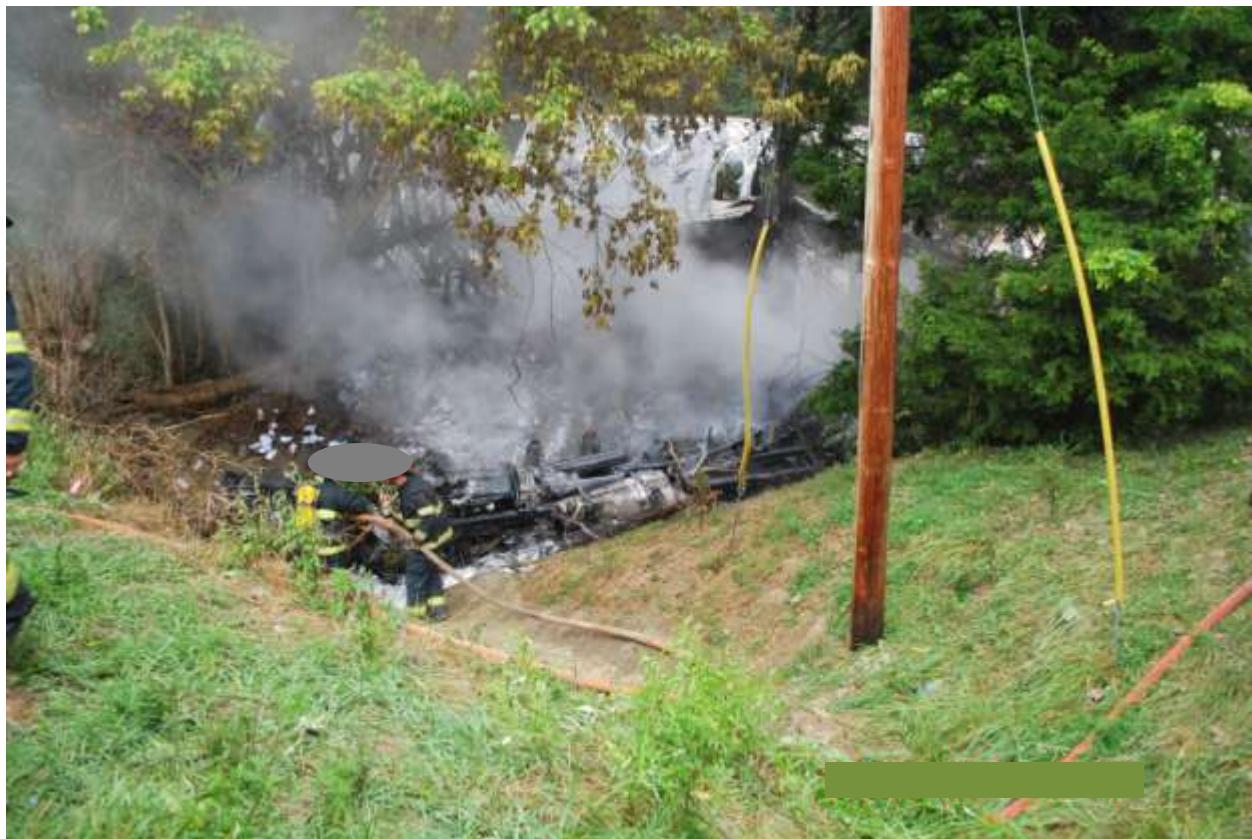
Path of semi tractor-trailer from the interstate. Photograph courtesy of local official.
