## **Massachusetts FACE • Occupational Fatality Report**

### **Truck Driver Suffocates when Engulfed while Clearing Jammed Woodchips being Unloaded from an Open Top Trailer with a Movable Floor Unloading System – Massachusetts**

**Investigation: # 08-MA-001-01**  
**Release Date: April 9, 2009**

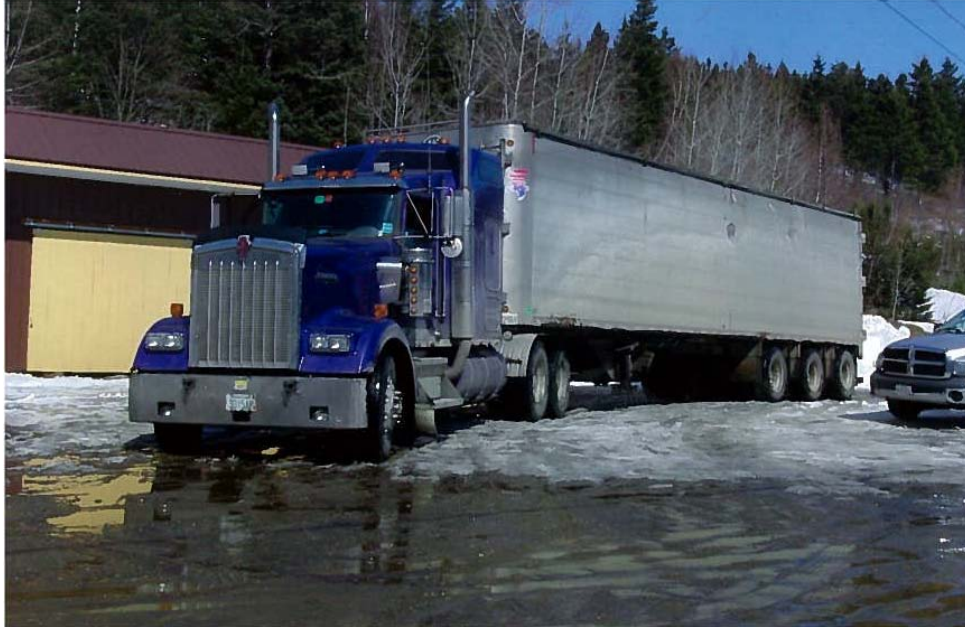
The victim was driving an 18-wheel tractor trailer truck equipped with a sleeper bunk on the day of the incident. The trailer was manufactured in 2002 and the trailer's dimensions are eight feet six inches high; seven feet nine inches wide and 45 feet long (Figure 1). The trailer has an open top for loading the trailer and one cross stability bar. This cross stability bar runs the width of the trailer and is centrally located at the top of the trailer. A fixed ladder is attached to the exterior of the trailer at the front driver's side for access to the top of the trailer. Another fixed ladder is located inside the trailer directly opposite of the exterior fixed ladder. This fixed interior ladder is used for entering and exiting the trailer. The rear of the trailer is equipped with a gate.

**Figure 1 – Truck and trailer involved in the incident.**

**Recommendation #1: Employers should minimize product jamming by ensuring that trailers equipped with both cross stability bars and movable floor unloading systems are not loaded up to or above the cross stability bar.**

**Discussion:** In this case, it was reported that when using the movable floor unloading system to offload woodchips, these woodchips would routinely jam at the cross stability bar, which is centrally located at the top of the trailer. Employers transporting products, such as woodchips, that have the potential to jam using trailers that are manufactured with cross stability bars and equipped with movable floor unloading systems can reduce jamming during unloading by ensuring that these trailers are not loaded up to or above the cross stability bar.

An option to minimize product jamming while unloading is for employers to use movable floor unloading systems only in trailers designed without cross stability bars. Trailers designed without these bars, although they weigh more, would allow woodchips and other loaded products to flow continuously from the front to the rear of the trailer when being offloaded. However, cross stability bars should **never** be removed from a trailer without first consulting the trailer's manufacturer or an engineer.

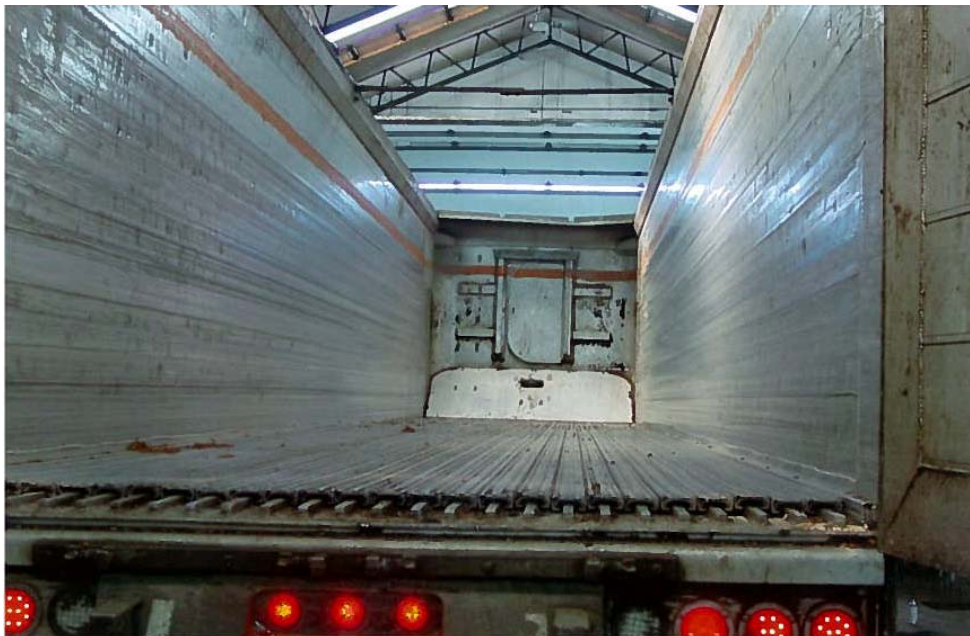
The trailer is equipped with a movable floor unloading system (Figure 2) that was manufactured in 2002 and purchased by the company at the same time the trailer was purchased. The movable floor system is designed to replace the flooring furnished by the trailer manufacturer. The

movable floor unloading system is a hydraulic-based system with three cylinders, which allows various sections of the floor to move at different times. The flooring of the movable floor system is made of narrow aluminum slats that run approximately the length of the trailer. Underneath the aluminum floor slats are cross pieces that run the width of the trailer. Every third cross piece is attached to one of the three cylinders and every third aluminum floor slat is attached to the same cross piece. There are a total of 26 floor slats.

To unload the trailer, the movable floor system is switched on and the first of the three cylinders is engaged. The cross pieces associated with this cylinder move towards the front of the trailer, the section closest to the truck's cab. Given that every third aluminum floor slat is attached to these cross pieces, every third floor slat also moves towards the front of the trailer. This does not cause the load inside the trailer to move. This sequence continues for the second and the third cylinders until all of the floor slats are in the same position, at their most forward point. Then all three cylinders engage at the same time in the reverse direction moving all cross pieces and all of the floor slats at once towards the rear of the trailer. This motion causes the entire floor of the trailer and the product on the trailer's floor to move towards the rear of the trailer. This process is then continuously repeated and eventually the entire product inside the trailer is offloaded.

**Figure 2 – Trailer's movable floor unloading system.**

**Recommendation #2: Employers should ensure that trailers with movable floor unloading systems are either equipped with automatic sweeping tarps or that manual sweeping does not begin until after the entire trailer has been offloaded.**

**Discussion:** Although it appears that the victim was not accessing the trailer to start sweeping, it was reported that it was common practice for employees to start sweeping the trailer's floor before unloading was complete. Employees would enter the trailer while the movable floor unloading system was operating and unloading product. A safe and quick way to sweep the floor of a trailer equipped with a movable floor unloading system is to have an automatic sweeping tarp installed as part of the unloading system. Automatic sweeping tarps are designed to sweep a trailer's floor, reducing the number of times employees have to enter the trailer. If trailers are not equipped with automatic sweeping tarps and need to be swept manually, employers should ensure that employees do not enter the trailer until the trailer is completely offloaded and the movable floor unloading system is turned off.

**Recommendation #6: Manufacturers of movable floor unloading systems should consider providing safety decal(s) that address the hazards of engulfment, clearing jams, and overloading trailers.**

**Discussion:** In this case, the manufacturer provided safety decals that warn employees of potential hazards associated with using the movable floor unloading system. Manufacturers of movable floor unloading systems should consider providing additional safety decal(s) focusing on the following hazards:

1. Engulfment – Engulfment hazard that exists inside trailers loaded with loose material
2. Jammed product - Never enter trailers when clearing jammed product
3. Overloading - Never overload trailers
