Male Semi-Truck Driver Killed In Rollover Crash On County Road

Incident Number: 05KY008

Kentucky Fatality Assessment and Control Evaluation (FACE) Program

Release Date: **February 15, 2008**

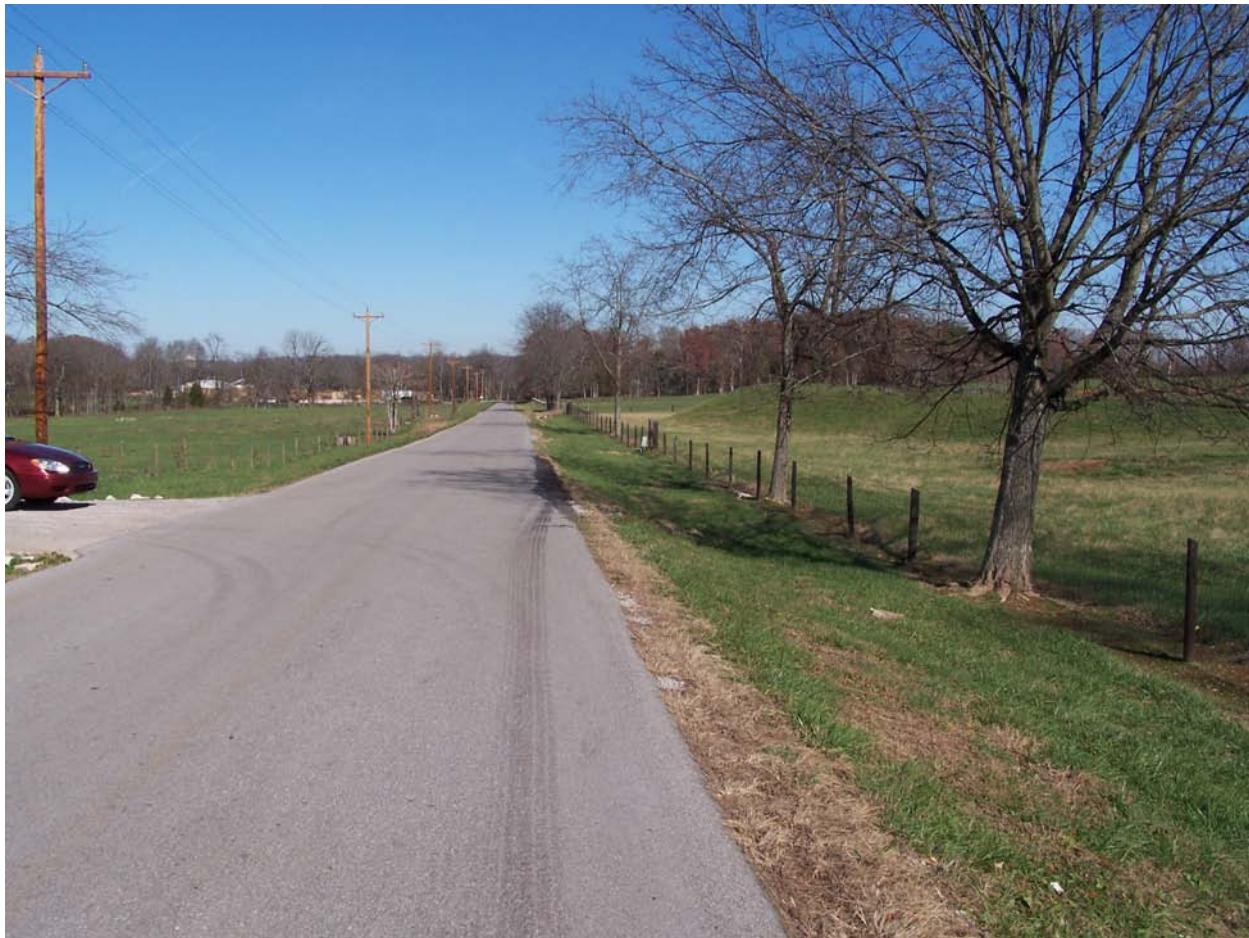
Photograph of county road where a semi-tractor trailer left the pavement and turned over. Grade is steeper than it appears in this photo.

After traveling for approximately one mile, the tires on the right side of the trailer dropped off the pavement. The roadway was straight and did not have paved shoulders on either side. Instead, the ground dropped off at a steep slope and according to the police report, was saturated with water. There was evidence that the driver attempted to correct the trailer and return it to the pavement but could not due to the saturated ground and the weight of the lumber. The tractor trailer struck a tree then overturned onto a fence. There were no witnesses to the crash.

Recommendation No. 5: County roadways in Kentucky should be designed and constructed with an adequate shoulder area, or have guardrails that will deter commercial vehicle drivers from leaving the roadway.

The roadway involved in this incident was an old railroad bed turned into a county road which had been gravel until the county upgraded the surface to asphalt. It was 18 feet wide. Sections of the roadway's edge met with level ground. However, there was a steep embankment by the edge of the roadway where this incident occurred. This made it difficult for the driver to correct the semi-tractor trailer when the right tires slipped off the pavement. A guardrail or a few feet of shoulder may have helped the driver recover the errant vehicle.

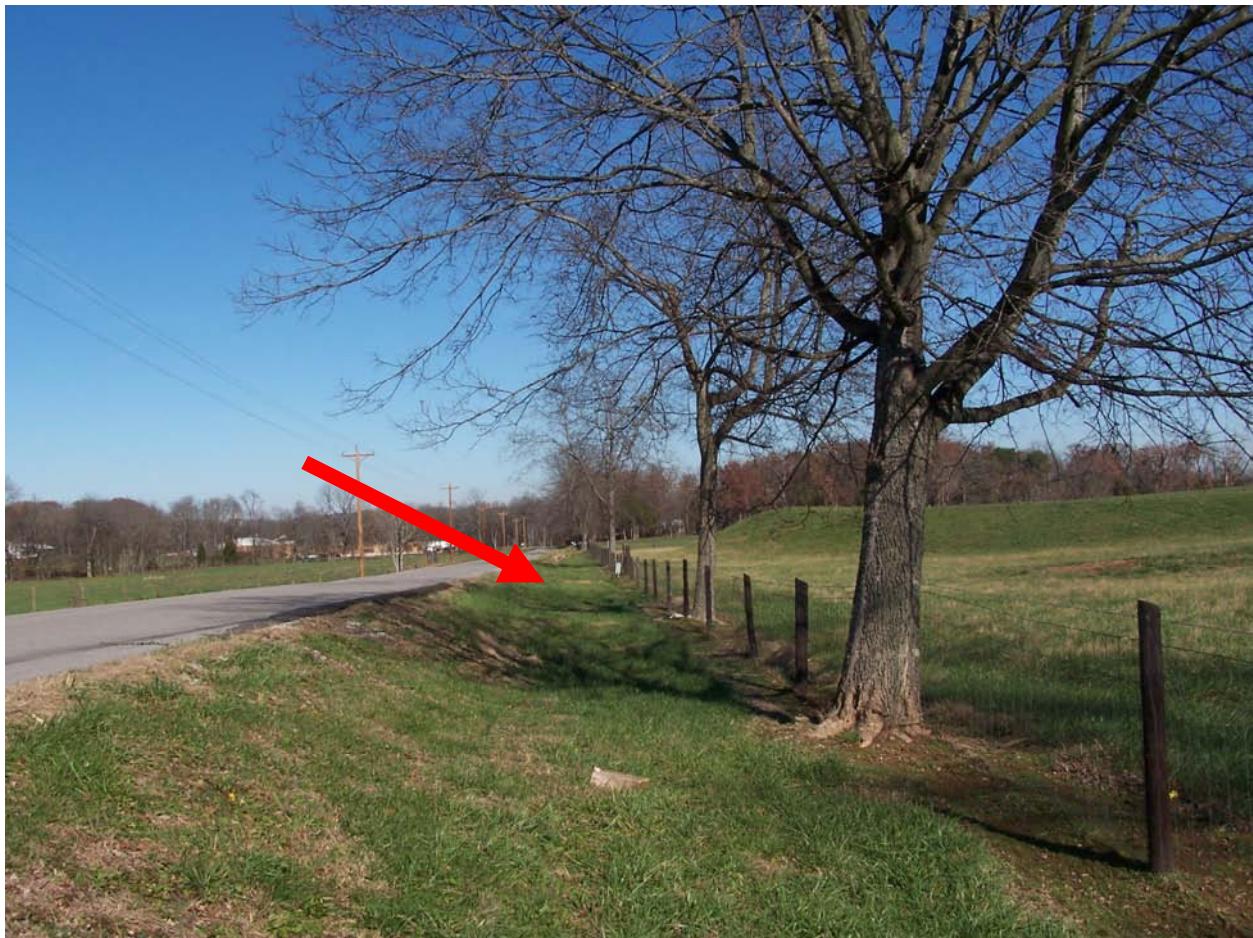
Red arrow shows the approximate location where the semi-tractor trailer went off the roadway and overturned.
