# **INVESTIGATION REPORT**

**FACE 06-NJ-063-01**

## **Worker Pinned Between Forklift and Boom Truck in Industrial Yard**

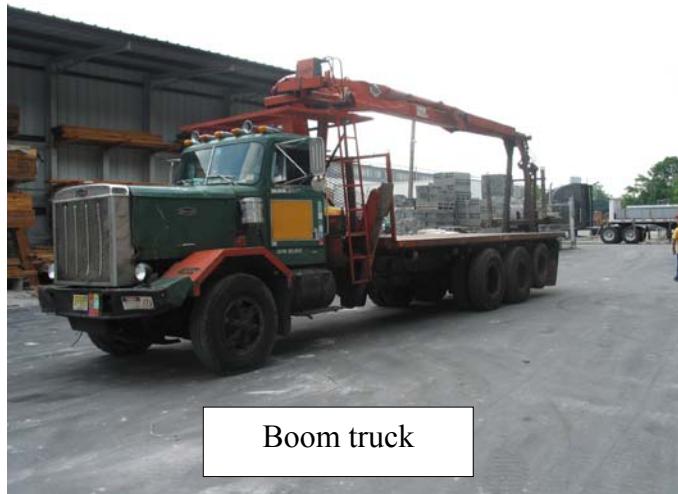
The incident site was a paved asphalt industrial yard with a 7 foot, 11 inch, central concrete pad, under which was the storage tank of diesel fuel used to supply the trucks. The concrete pad was elevated approximately one inch above the surrounding asphalt pavement. The yard had a slight grade. Supplies such as sheet rock were stored under covered open-front sheds located on both sides of the yard.

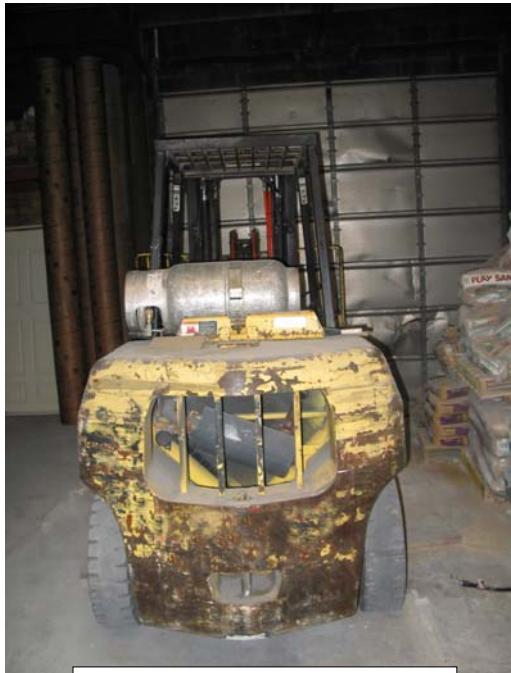
Forklift involved in the incident (rear view)

Two operators reported a history of failure of the emergency brake on the involved forklift. Service was performed four times in the previous year and the brakes were serviced twice. The forklift was examined by representatives from the forklift supplier and insurance company. FACE staff could not obtain a report on this examination. Therefore, no recommendations can be made addressing the presence or absence of mechanical defects.
