Fatality Investigation Report

OR 2006-03-1

Novice drywall installer dies in 7-foot fall from scaffold

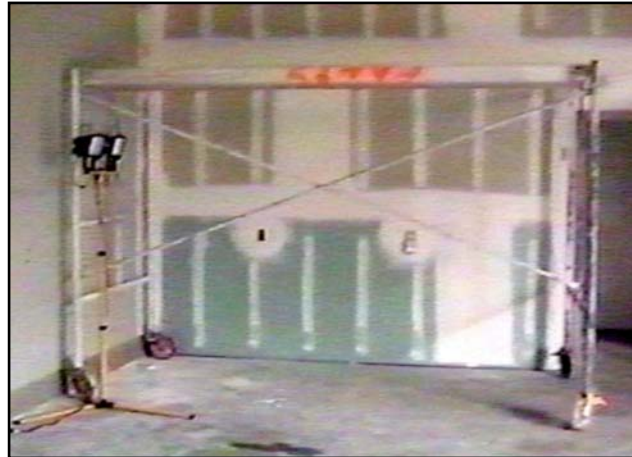
The scaffold used by the drywall installer and his lead man in this incident had only a single plank on the deck.

- **Workers on mobile scaffolding should double-check the structural stability of the scaffold and ensure that wheels are locked before mounting the work platform.**
- **A competent person must supervise the erection and use of scaffolds.**
- **Employers must ensure that construction workers are trained to identify, understand, and control fall hazards.**
- **Employers should consider using guardrails on scaffolds wherever practicable.**

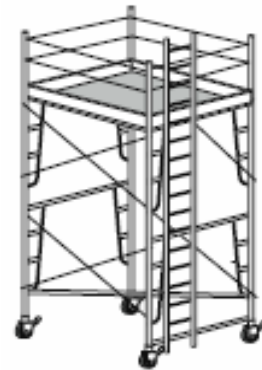
Example of a mobile scaffold with guardrail and mounting ladder (Source: OR-OSHA, 2005, *Scaffolds: Temporary elevated work platforms*).

Guardrails and toe guards on scaffolds are only required at heights 10 feet or more above the ground. This incident demonstrates that falls from less than 10 feet can still cause serious, even fatal injuries. Employers may want to consider the use of guardrails at lower heights to reduce risk for workers.
