**SUBJECT:** A machine operator's helper died when caught in a slitting machine.

**SUMMARY**  
**California FACE Report #06CA002**

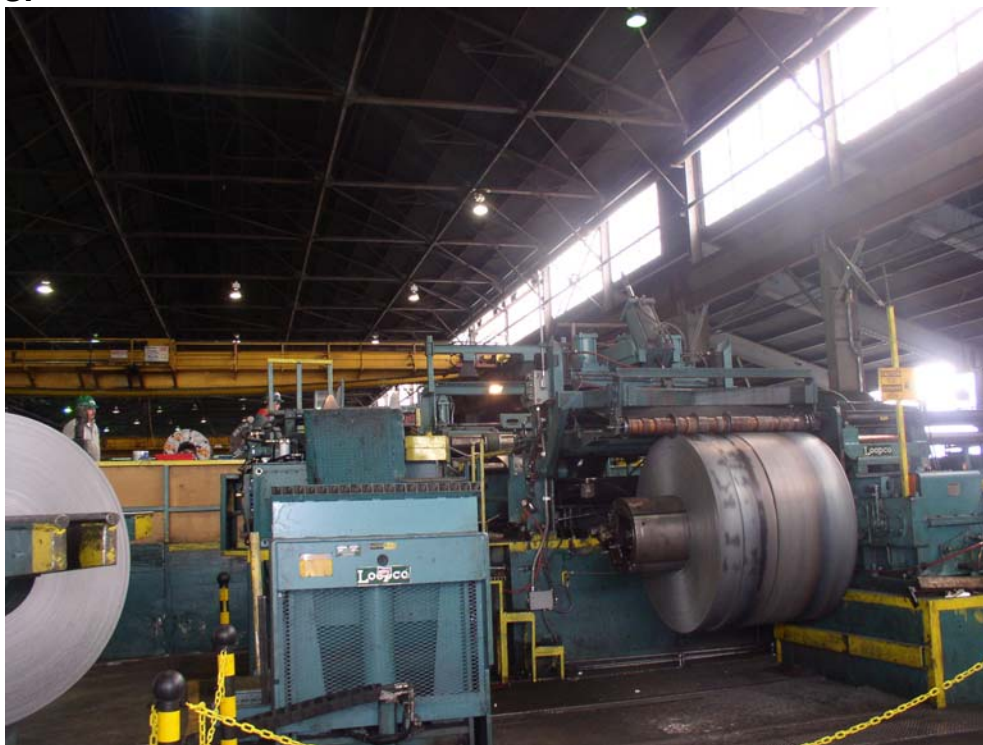
The site of the incident was a factory that manufactured carbon steel tubing. The machine involved in the incident was called a slitter. The machine was used to cut sheets of different gauges of steel into different widths depending on the customer's order. On the day of the incident the victim and another temporary employee were

Exhibit 1. A picture of the slitting machine involved in the incident.

**Recommendation #1: Ensure employee safety by installing guards around the moving parts and pinch points of machinery to protect employees from accidental contact.**

Discussion: In this particular case, the victim was performing a task described as one of his normal duties. Heavy machinery with rapidly moving parts can present serious risks of worker entanglement. The risk associated with operating such machinery is mitigated by physical guarding, safety interlocks and sensors, and/or the use of specially adapted long-handled tools. Manufacturers of heavy machinery can ensure newly made equipment has adequate guarding, and employers should consider retrofitting older equipment.

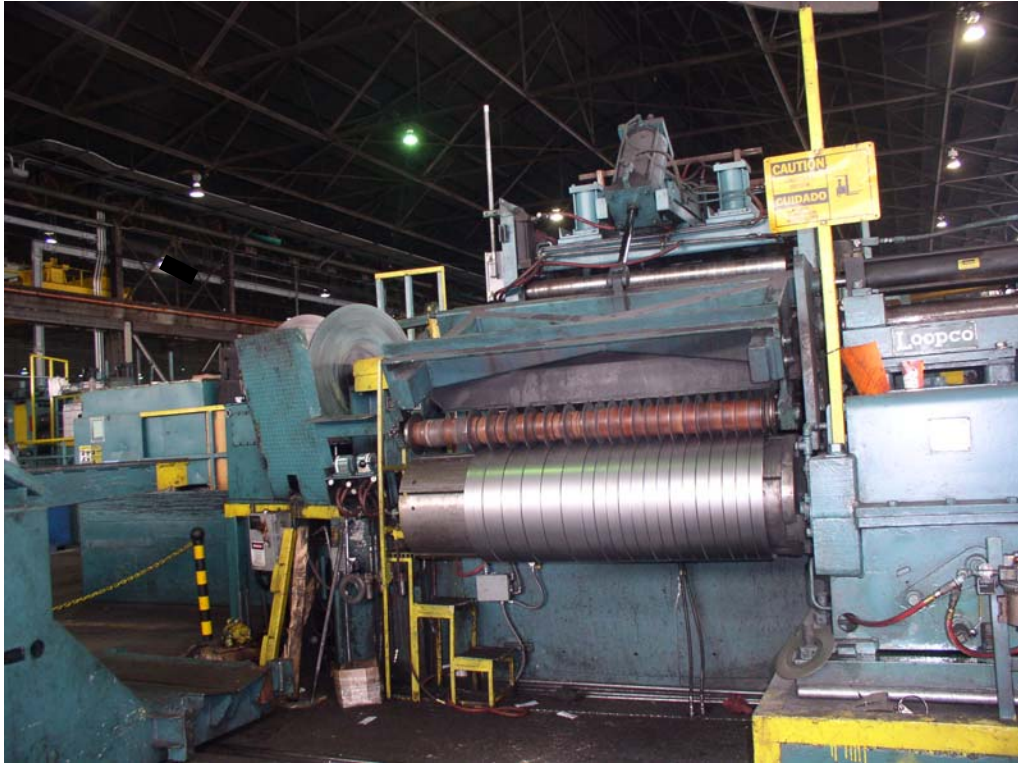
The paramedics arrived and found the victim approximately three feet off the floor entangled between the cut #16-gauge steel sheets wrapped around the rewind cylinder of the slitting machine. The paramedics found no pulse and pronounced the victim dead.

Exhibit 2. A picture of the rewind cylinder with the cut steel being wound onto the cylinder.

Discussion: The client company in this incident had performed job-specific hazard assessments sometime in the past and had identified the open rewind cylinder as a potential entanglement risk. Their IIPP had written work practices to help avoid entanglement; however, no guarding or safety interlock system had been built for the rewind cylinder. Although the machine in this incident was constructed at a time when guarding was not required, current regulations and state-of-the-art machinery designs require guarding or safety interlocks. By periodically re-performing job hazard assessments, both the acceptability of risks from certain hazards and any new solutions to hazard abatement can be reviewed.

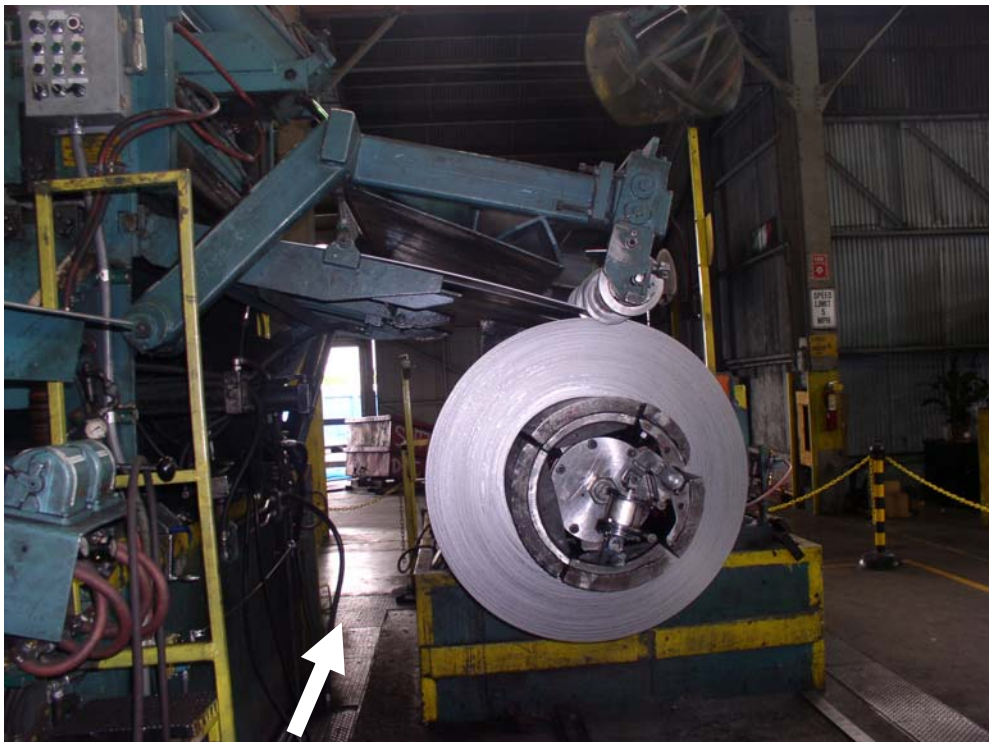
At approximately 12:30 p.m., the victim and the other temporary employee were assisting the machine operator guide a new sheet of carbon steel into the slitting machine. After the slitting machine cut the steel sheet into strips, the victim guided the finished product onto the machine's rewind cylinder. The victim placed the cut steel strips in the groove in the rewind cylinder and then jogged the cylinder forward just enough to complete a full wrap around the cylinder. The victim then checked the alignment of each strip and used a steel bar to tap misaligned strips into place. The operator stated that after the victim connected the cut steel to the rewind cylinder and aligned all the strips, he was clear of the machine and he gave him the signal to go ahead and start the machine. The operator turned his attention away from where the victim was standing and started the machine. The operator stated that suddenly the machine shook and then jammed. He said he immediately pressed the emergency stop button and went to investigate the problem. He found the victim caught between the cut steel and the rewind cylinder. He immediately called for help.

Exhibit 3. A picture of the rewind cylinder from the side showing where the victim was standing (white arrow) prior to getting entangled in the steel.

**Recommendation #2: Ensure employees do not operate machinery without proper guarding or equivalent safety protection.**

Discussion: The slitter is a swift moving machine that takes different gauges of steel stock and cuts them into varying sizes of strips. These types of machines should be

equipped with some type of barrier or safety system to prevent worker entanglement. Occasionally, a breakdown in these safety systems can occur or the systems are bypassed, and the machine is able to run without the safeguards. Employers should have programs that ensure that employees do not operate such machinery if those safety measures are not present. Employers can enhance worker compliance with safe work practices through programs of task specific training, supervision, recognition, and progressive disciplinary measures.
