## MIFACE Investigation #05MI078

### Subject: Forklift Operator Dies When Head Caught in Lowering Mast

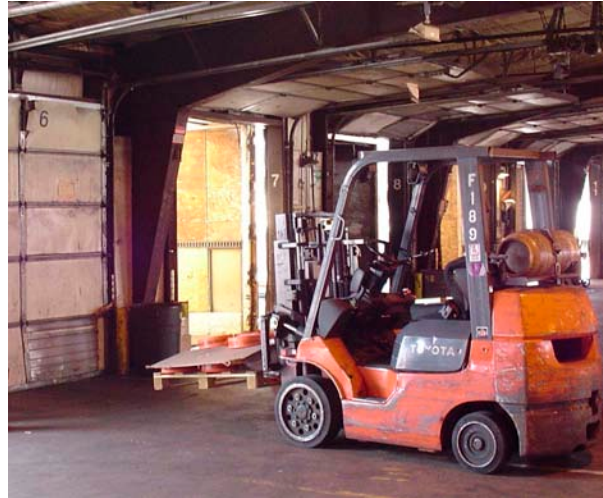
Figure 1. Forklift driven by decedent on dock

On the day of the incident, the decedent was operating was a Toyota Model #7FGCU25 forklift. According to the MIOSHA file, the forklift was in good operating condition, however the control labels had been worn off and the brake pedal was missing the rubber cover. The employer stated that pre-shift inspections were to be conducted, but, according to documents in the MIOSHA file, the firm's forklift mechanic stated pre-shift inspections were rarely performed or inspection documentation turned in. The last inspection for this forklift that was returned to the forklift mechanic was turned in over four weeks prior to the incident.

- Employers should instruct forklift operators never to stand inside the cage of the forklift nor place any part of their body through the mast while it is in operation.

Workers should not attempt to perform tasks outside the protective cage of a forklift unless the forklift is completely and properly shut down. Employers should instruct forklift operators that prior to dismounting the forklift, the forklift forks should be lowered to the ground, the forklift engine turned off, the parking brake set, and the controls neutralized. Employees should never attempt to adjust or otherwise access loads until the forklift is properly shut down. Loads should then be adjusted from outside the protective operator's cage. This would eliminate reaching through the front of the protective cage, inadvertent contact with machine controls resulting in the machine or machine components striking or pinning a worker, and would also eliminate the hazard of a worker on foot being struck by the machine.
