SUBJECT: A farmer was killed while bypass-starting his tractor.

SUMMARY

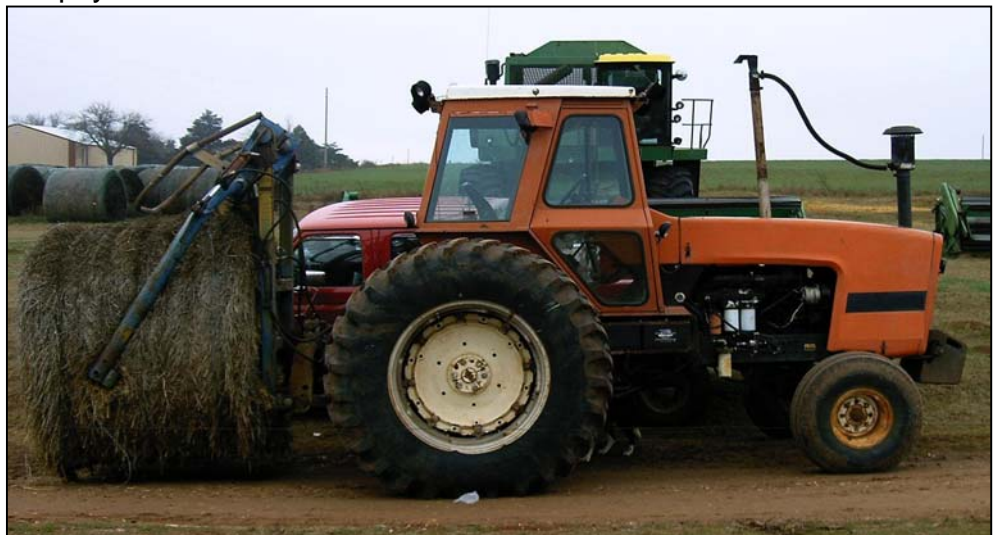
Figure 1. Tractor involved in the incident

Victim: The victim was a self-employed owner/operator of a cattle and crop farm. He had worked all of his adult life on the same farm where he was born and raised. The victim was operating a 23-year-old tractor that he had purchased new (Figure 1). The victim was familiar with jump-start procedures and had performed an ignition bypass-start many times before. According to his wife, the decedent had been ill for the past few days and seemed to be feeling very cold and weak on the day of the incident.

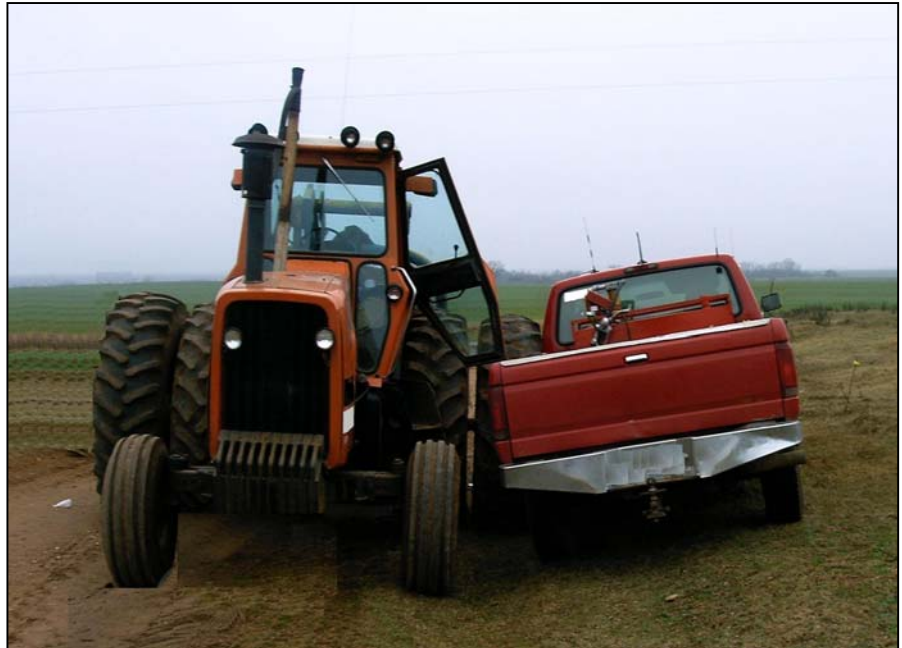
Figure 2. Positions of truck and tractor after the incident occurred

on the unguarded starter to complete a circuit and start the tractor. When the engine started, the tractor was in gear and the brake was not set, which caused the tractor to move forward and strike the victim, throwing him back against the side of the truck. The decedent fell to the ground where he was run over by the dual rear tractor tires. The tractor came to rest and died when the rear wheel hit the truck (Figure 2). The victim's wife was sitting in the truck the entire time and witnessed the incident.
