# Fatality Investigation Report

OR 2004-07-1

## Nursery laborer killed in skid-steer loader

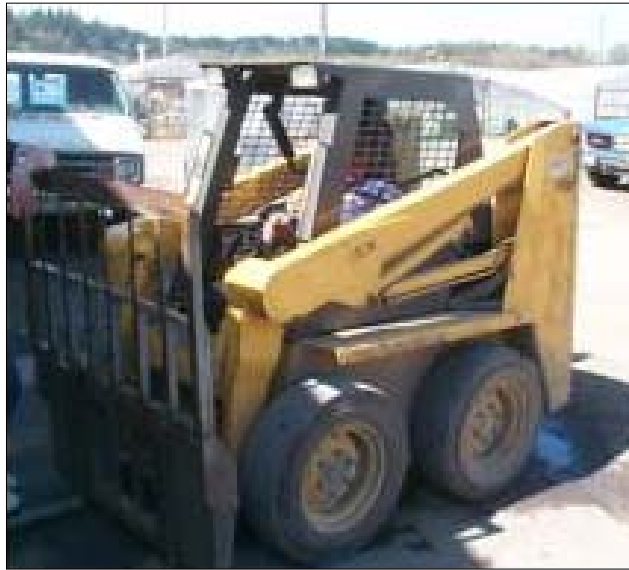
One of three similar skid steers operated at the worksite.

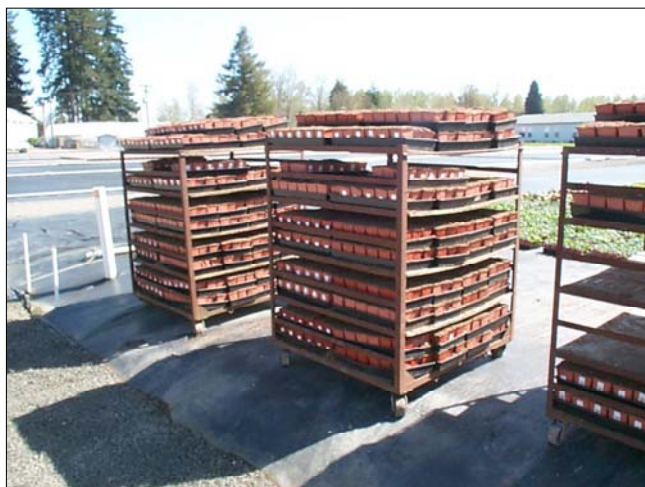
Metal carts containing plants, which the victim was picking up with the skid steer and moving into greenhouses.
