# Fatality Investigation Report

OR 2003-6-1

## Logger killed by falling sheave when yarder tower collapses

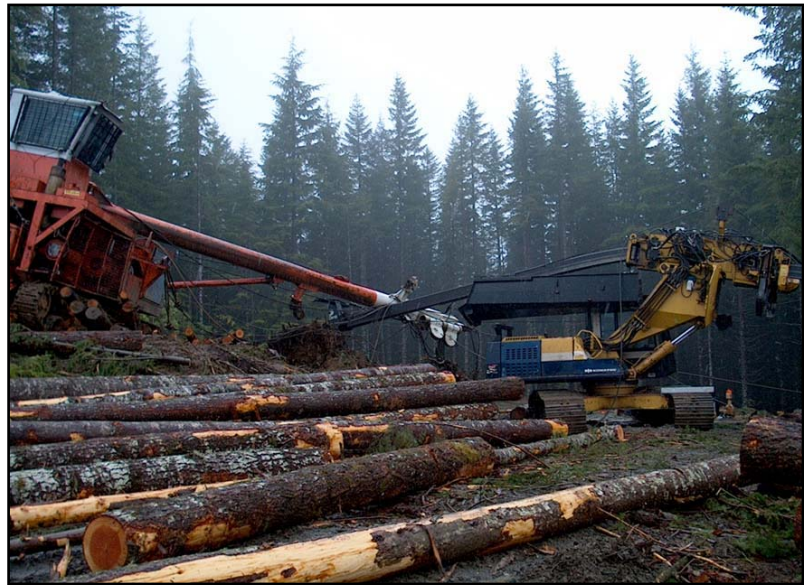
When guyline support failed, the yarder tower fell onto a nearby delimber (right).

The tower fell forward in the direction of the turn, striking the boom of the delimeter, operating in front of and below the yarder. A [sheave](#) located midway along the boom, attached by a solid steel pin (about 1 3/8-inch diameter), sheared off and was forced downward, though still attached to the cable running through it. The sheave struck the chaser on the head and punched through his hard hat.

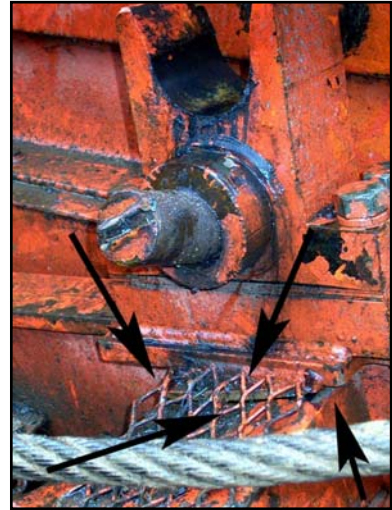
Tower hinge and box beam (arrows) broke, allowing tower to come down.

Tower stability in a skyline yarding operation involves several primary factors: skyline [deflection](#), skyline braking, and the size of turns and anchorages. It is unclear if the tower failure in this incident was the immediate result of the tower setup, or in the guyline setup. An engineering failure analysis would be necessary to isolate the initial cause of the incident.

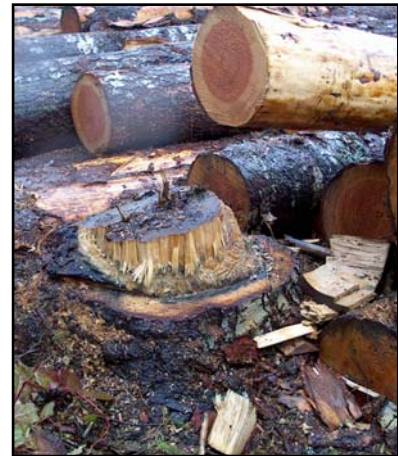
Anchor stump #1. The cable pulled over the top of the stump. Note proximity of log deck to stump (see Recommendation #1).

Sufficient stump height for guyline anchors must be available around a landing site. In this incident, one guyline was evidently attached to the bowl of the stump, with not much room above the notch, which may have contributed to the guyline pinching off the top of the stump and coming loose.

When planning units, it is also important to give the logger sufficient space around the landing to deck the logs waiting to be shipped. Make sure the decking areas do not interfere with the guylines in any way. A guyline can possibly shake loose when bumped.

**Recommendation #1. Plan the landing site for yarding requirements beforehand. Make sure nearby anchor stumps are left at an appropriate height to secure guylines, and the guylines will not interfere with decking the logs at the landing.**

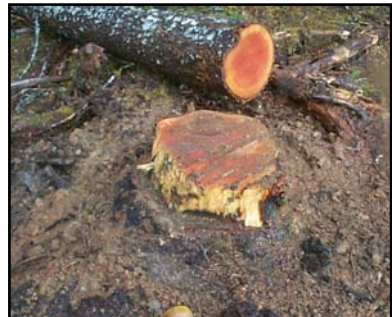
Anchor stump #2. Fresh dirt indicates the stump pulled out of the ground and released its guyline.

The two anchor stumps that failed were both 20-22 inch [dbh](#) Douglas fir, 35-40 years old. The third and fourth anchors were guyed off to notched stumps and [double-tied](#) back to green trees. The employer reported checking the anchors daily, during the course of several turns, for signs of failure. One logging expert consulted in this investigation believed the notch cut into the first stump was in the root swell and not in the holding wood, and this may have contributed to the tower failure.

**Recommendation #3. Check security of the guyline anchors daily, before and during operation.**

Stumps used as anchors should be observed daily for signs of failure: pulling out of the ground, slabbing off, becoming loosely attached, wire rope eating too deeply into the notch, and so on. Check anchors (stumps) while the operation is in progress. Do not attempt to continue logging operations if an anchor stump/tree shows signs of failure.
