Part-time Farmer Dies Following a Tractor Rollover in West Virginia

Case: 02WV024-01

Release Date: December 19, 2002

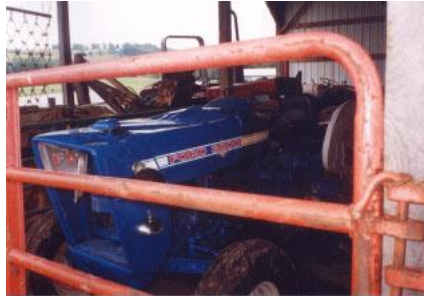
Figure 1. 1965 Ford 3000.

On July 23, 2002, a 74-year-old male part-time farmer (victim) died of injuries sustained when the tractor he was driving rolled over while mowing. The victim was using a 1965 Ford 3000 wide front-end configured tractor (see [Figure 1](#)). The tractor was equipped with a side mount sickle-bar cutting attachment. With his left rear wheel on the downhill side, he was traversing a slope exceeding a 50% grade (27 degrees) (see [Figure 2](#)). Speed of travel was unknown but his right wheels ran over a woodchuck mound which increased the grade to approximately 60% (31 degrees) (see [Figure 3](#)). This shift placed the tractor's C.G. outside of the tractor's stability baseline, causing it to roll downhill to the left and land on the victim. The tractor did not have a ROPS or a seat belt. The victim's son-in-law came out to the field to check on the victim and found him lying on the ground shortly after being struck-by the tractor. He called EMS which arrived within minutes and transported the victim to a medical center where he died approximately 3 hours later.

Recommendation #1: Equip all tractors with rollover protective structures and a seat belt.

[Owners of older model tractors should contact their County Extension Agent, equipment dealer or equipment manufacturer to determine if retrofit ROPS and operator restraint systems are available for their equipment. Such systems should be installed by the manufacturer or an authorized dealer].

Discussion: Preventing death and serious injury to tractor operators during rollovers requires the use of ROPS and a seat belt. These structures, either a roll-bar frame or an enclosed roll-protective cab, are designed to withstand the dynamic forces during a rollover. In addition, seat belt use is necessary to ensure that the operator remains within the "zone of protection" provided by the ROPS. OSHA regulations require that all tractors built after October 25, 1976, and used by employees of a farm which employs 11 or more must be equipped with ROPS and a seat belt.¹ In West Virginia, many tractors are in use on family farms with fewer than 11 employees and therefore do not fall under OSHA regulations. Given the uneven terrain and environmental conditions in West Virginia, all farmers should voluntarily have their older tractors retrofit with a properly designed ROPS and seat belt system. A ROPS retrofit kit is available for the tractor involved in this incident (1965 Ford 3000). If the tractor had been equipped with a ROPS and seat belt had been used, this fatality might have been prevented.

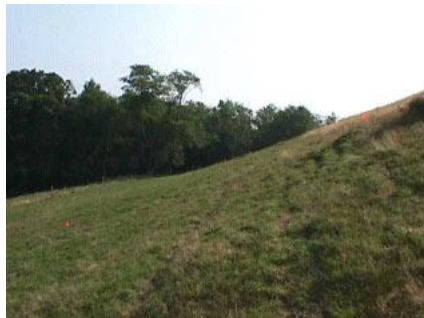
Figure 2. The 50% (27 degree) slope the tractor was traversing. From this perspective, the tractor was traveling away from you.

The black arrow represents the tractor's position before the roll.

Recommendation #2: Consider permanently omitting steep areas from mowing.

Discussion: Discussion: Steepness of slope and the traversing of hillsides are variables associated with tractor rollovers in West Virginia. Rate of speed, operation being performed, smoothness of terrain, tractor model, wheel configuration, attachments, and the operator's actions also play a role. Therefore, assigning a specific numeric figure as a "do not exceed" degrees of slope is difficult. However, a slope exceeding a 50% grade, as was the case in this incident, leaves little room for operator error and uneven terrain and should be avoided. In fact farmers who have slopes in this range should carefully consider whether mowing them is crucial to the farm's operation. Those slopes which are not critical to the operation and productivity of the farm should be allowed to naturally return to brush and eventually woods. Where mowing is necessary, other safer means such as walk behind mowers should be used. Another possibility may be the integration of vegetation eating livestock such as goats.

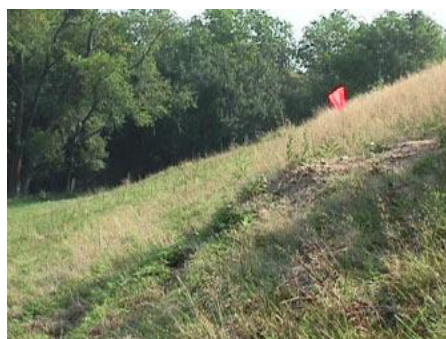
Figure 3. The orange flag marks the dirt mound which was created by a woodchuck.

The tractor's right front and right rear wheels ran over this mound causing the tractor to roll left down the slope.
