Youth Killed While Driving Golf Cart at Country Club - Massachusetts

Investigation: # 00-MA-50-01

Release Date: December 20, 2001

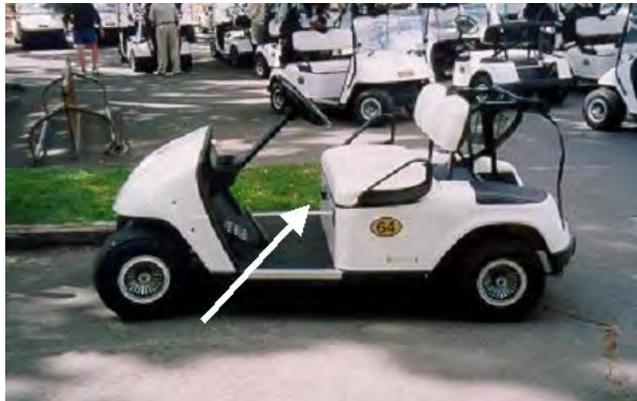
The golf cart involved in the incident was one of approximately 75 golf carts the country club owned. The golf carts were four wheeled, two passenger, 36-volt battery operated, rear wheel drive vehicles. They could move in both forward and reverse directions and were equipped with backup alarms. A direction control lever used to switch the golf cart from the forward to reverse directions was located on the lower section of the seat by the operator's

lower right leg ([Figure 1](#)). This location made the control lever difficult to see and access. Each golf cart was equipped with a parking brake/hill brake, which, when engaged, locked the brake pedal in a downward position. To release the brake, the operator had to apply enough pressure to the gas pedal to “pop” the brake off. Although the majority of the golf carts at the club had canopies, the golf cart the victim was using was not equipped with a canopy. The canopies’ main function was not structural but to shade the operators from the sun.

**Figure 1 – Same model golf cart involved in the incident (side view).
Arrow points to the direction control lever.**

Recommendation #4: Manufacturers of golf carts should consider moving the direction control lever to the dashboard so that it is clearly visible and accessible to the operator.

Discussion: Golf carts manufacturers should consider moving the forward and reverse direction control lever to a location that the operator can easily access and clearly see the direction in which the lever is engaged prior to and while operating.

In this case, the control lever was located on the bottom half of the seat by the operator's lower leg, which made it difficult for the operator to see which direction the golf cart was engaged in. An inexperienced employee and/or an inexperienced driver, such as a young worker, might not realize which direction the golf cart was left in or mistakenly engage the golf cart in the wrong direction without realizing it. Moving the direction lever to the dashboard area would allow the operator to have an unobstructed view of the direction lever and reduce the chances of the operator engaging the golf cart in the wrong direction.

Retrofitting existing golf carts should also be considered. For example, an indicator light might be placed on the dash to inform the operator about the direction the golf cart is engaged in.

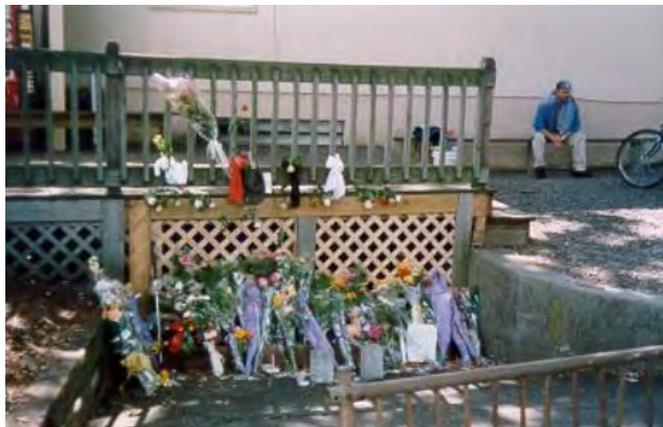
Because the incident was not witnessed, what exactly happened could not be determined. Investigating agencies identified two possible scenarios. Either the golf cart was parked and the victim was starting from a stopped position to go collect balls (scenario #1), or the victim was returning from collecting balls, and the golf cart was in motion just prior to the incident (scenario #2). In both scenarios, the golf cart involved in the incident had been the only one available for the victim to use and was or had been parked on the section of a paved pathway that was no longer in use. The pathway declined towards the building that housed the golf bag room and pro shop. A wooden deck had been built over the pathway and attached to building’s side approximately 10 years prior to the incident ([Figure 2](#)).

In either scenario, the 16-year-old victim was allowed to operate golf carts at work. On the day of the incident, the golf cart the victim was operating crashed into the side of the wooden deck attached to the building that housed the golf bag room and pro shop. After sliding approximately three feet underneath the wooden deck, the golf cart struck the

section of the deck where the floorboards are fastened to the joists severing the steering wheel from the steering column. The victim was pinned between the golf cart and the deck's floorboards, crushing his chest.

Figure 2 – Section of the deck the golf cart struck
