Farmer Is Run Over By A Tractor While Starting It When Not In the Operator's Seat

Case No.: 98IA073 Report Date: September 1999

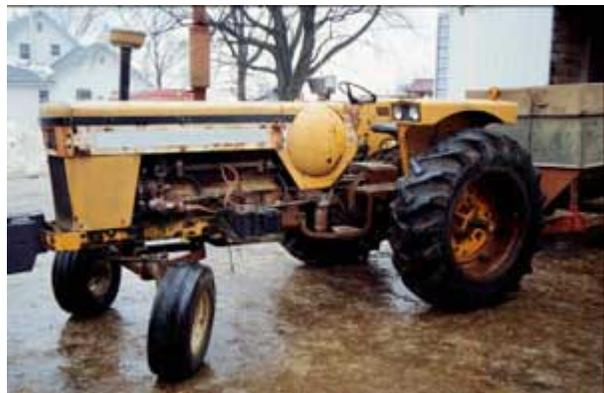
During the fall of 1998 a 60-year-old Iowa farmer was killed when he started his tractor. The propane-powered tractor was parked in a machine shed, which had a dirt floor. The farmer was working alone and evidently assumed the tractor transmission was in neutral, then started the engine while standing on the ground to the left of the tractor or while standing on the side step of the tractor. The ignition switch was easily reachable from the ground on the left side. The tractor started and lurched forward, smashing equipment in front of it and partially crashing through the tin wall of the shed. There were no witnesses to the event, but it appears that the farmer was standing on the ground, holding in the clutch with his left hand, starting the tractor with his other hand, then letting out the clutch assuming the transmission was in neutral. The tractor moved ahead about 3 m (10 ft), stalled, and stopped when it hit a corner post of the machine shed. The farmer was found trapped partially under the left rear wheel of the tractor, dead at the scene. The tractor engine was cold, with the ignition key in the on position. The tractor originally had a safety switch built-in to the transmission, but it had been bypassed by the previous owner of the tractor. This enabled starting the tractor in gear when the clutch was pressed down.

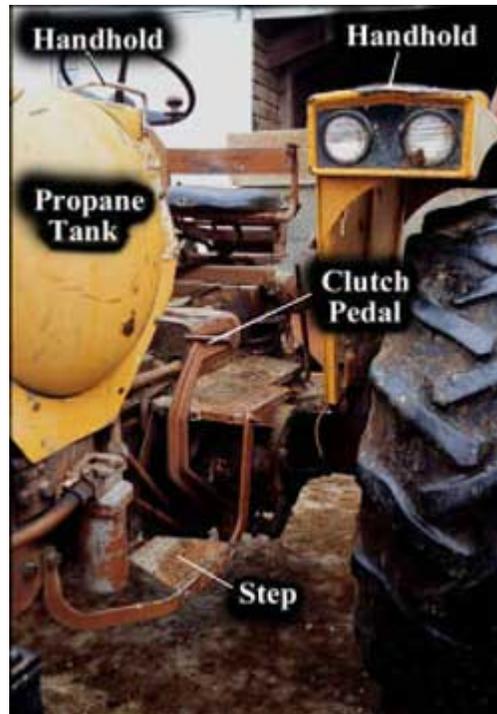
From photographs it was determined that the tractor moved about 3 m (10 ft) forward before hitting the corner post of the shed. The farmer was found trapped under the front edge of the left rear tractor tire. He was not completely run over, but pinned in front of the tire. Photographs

indicated the left rear tire was spinning for a moment in the dirt after it crashed into the shed wall. Rescue personnel found bird droppings on the seat of the tractor, suggesting the victim had not been sitting down on the operator seat that morning. He may have been standing on the ground or on the side step when he started the machine.

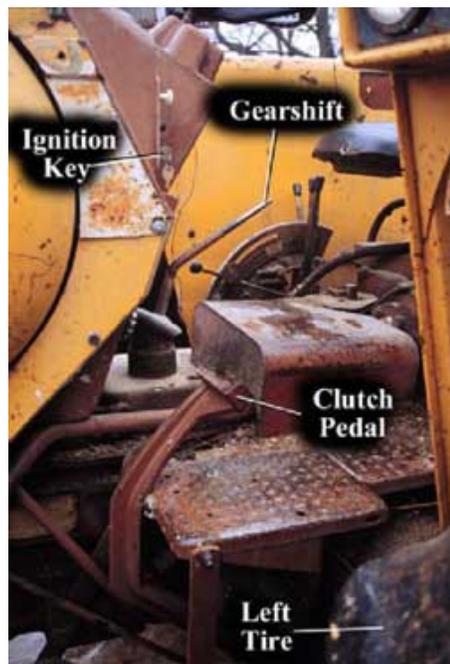
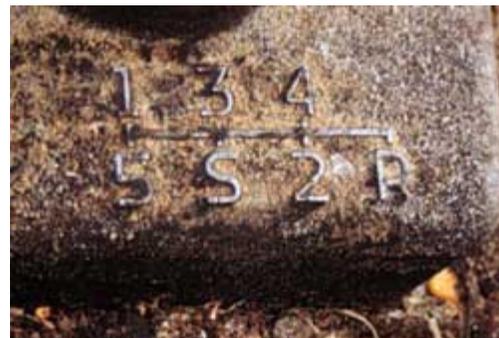
This tractor originally had a factory-installed electrical safety switch connected to the gear shift lever. This required the operator to put the gearshift in S, which stands for Start (neutral), before the ignition switch would turn the motor. This safety switch had been bypassed prior to the purchase of the machine to this farm. Without the safety switch present, the engine could be started with the transmission in any gear, provided the clutch was pushed in. These safety switches have been bypassed in some machines to gain perceived convenience in certain work situations. It makes the operation of the tractor identical to most trucks and cars with manual transmissions. An example of a working situation would be if the tractor stalled or was stopped on an incline while in gear. Then the transmission could be used as a parking brake, similar to most automobiles with manual transmissions. However, when the operator wanted to start the tractor again, the transmission would have to be put in Start (neutral). This could be difficult since the transmission has built-in hopping guards on the gears to prevent them from bouncing out of gear when in operation. Being on an incline provides sufficient gear pressure within the transmission that it is difficult to move the gearshift out of gear into neutral, without physically moving the tractor to relieve that pressure. This predicament is easily eliminated by bypassing the safety switch. Then the tractor can be started while in gear, provided the clutch is pushed in. When bypassing this safety equipment, the safety of the machine is greatly compromised.

The tractor was not known to start easily, and it is unlikely it started immediately after turning the key. A more likely chain of events was that the victim was holding in the clutch with one hand when he turned the key to start the tractor, and let the clutch out assuming the transmission was in Start (neutral). The Start position on the transmission and the 2nd gear mark were adjacent to one another (see [photo](#)), and it would be difficult to distinguish which position the transmission was in while standing to the left of the tractor. The other similar tractor on the farm

Recommendation #1: Farmers and tractor operators should not bypass factory-installed safety devices.

Discussion: The previous tractor owner had bypassed the safety mechanism, which required that the gearshift is in S (Start) position during starting. This may be convenient for some work situations and makes the tractor operate as automobiles and trucks with manual transmission, which can be started in gear without great danger of runover. However, in a tractor, bypass starting or starting while not seated causes a great hazard. While starting from the ground, the operator is standing in front of the rear wheels and if the tractor is in gear there is no time to get out of the way if the tractor starts and lurches forward. There was another similar tractor on this farm, in which the safety device was operational. The farmer may have by mistake assumed that this tractor had the safety switch and took the risk of starting while not seated. The tractor was bought with the factory-installed safety device disabled. New owners may be reluctant to make changes that would require additional time and expense. Therefore sellers should ensure that machines have functioning safety devices.
