**FROM: Iowa FACE Program**

**Date of Report: April 6, 1999**

**SUBJECT: Arc welder dies in explosion while using an old barrel as a worktable.**

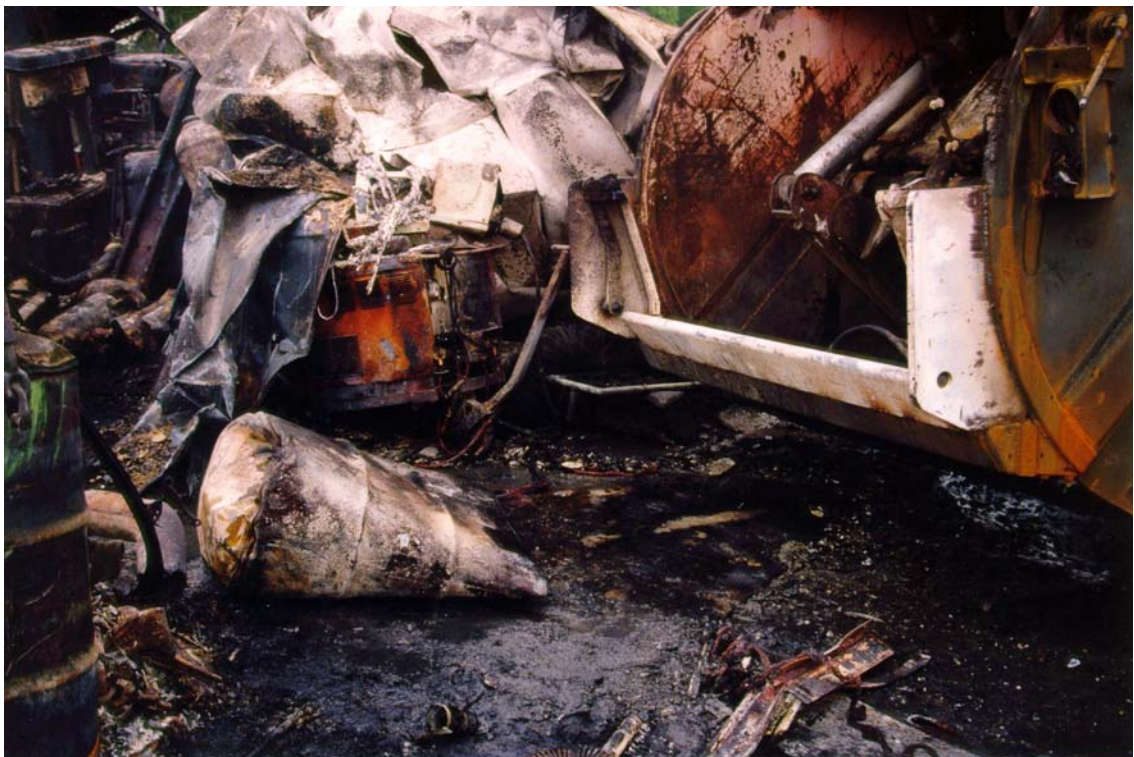
A 38-year-old male arc welder died as a result of an explosion at a construction company. The victim was working at a rural shop location to repair a large garbage truck, which was brought to the shop for repairs that morning. Several items were to be added to the rear of the truck and on the main box. The victim was working near a farm building, a 2-story large wood frame structure, which was used as a workshop and for storage of material used in connection with the construction business.

The victim was arc welding some brackets on the back of the truck. He was apparently welding with a wire welder and used a metal 55-gal barrel as a worktable while welding. Apparently the heat or sparks from the welding ignited residual vapors and/or material in the barrel, causing it to explode. The explosion knocked the victim down, and started a fire in the immediate area.

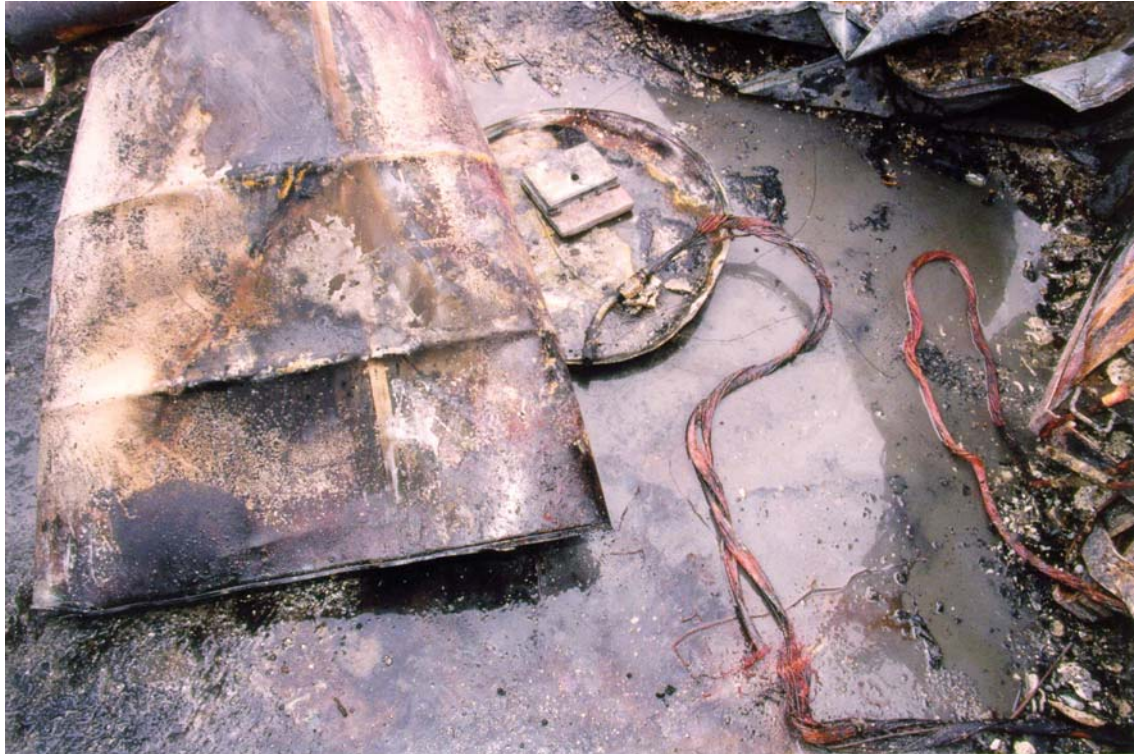
The victim was at the location to repair a large garbage truck, which was brought to the shop for repairs at 7:00 am. Several items were to be added to the rear of the truck and another item needed to be welded on the main box. There were two heavy pieces of steel that needed to be welded together and then attached to the truck. The base piece was approximately 6 inches by 6 inches and then a second piece was attached to the top. The garbage truck was backed up to the building near a large overhead door on the east side of the building. Another employee noticed the victim welding, with a 'stinger' in his hand just minutes before the explosion. The employee also noticed a large 55-gal drum at the rear of the truck, which was being used by the victim when he was welding.

An employee heard the first explosion and saw the building on fire near the back of the garbage truck and the overhead door. The employee ran to the area at the rear of the truck and attempted to move the victim, but was unable to. He then ran and called for help. The local fire department received the call at 10:35 am with a reported fire and explosion. When the fire department and county sheriff arrived on the scene, the entire building was in flames. As they began to control the blaze, they were told that one person was still in or near the structure. A short time later the victim's body was located near a garbage truck parked on the side of the building. The victim was found at the rear of the truck laying face up on the ground. The body had sustained major damage as a result of the fire. The victim was removed and taken to the hospital and an autopsy was performed. Autopsy revealed that the victim died from a severe blow to the head and was not killed by the fire. The top of the drum had the impression of the steel piece that was being made for the back of the truck. There were two heavy pieces of steel welded together. A small section of the welding wire was attached to the item. Apparently, the victim was working on this at the time. There were also some areas on the drum where hot

metal from the welding process had attached to the top of the drum in the location where the impression was found.

The steel item had not been added to the rear of the truck prior to the fire. The top section of the 55-gallon drum was found in the fire debris. The bottom of the barrel was found at the rear of the truck near the victim's body. A heavy steel plate item that was to be added to the rear of the truck was found lying near the drum bottom. According to the State Fire Marshal's report, it appeared that the drum exploded and the bottom stayed in the location where the drum had been.

The State Fire Marshal concluded that the explosion took place when the victim was welding two sections of heavy steel together on top of the 55-gallon drum. The victim had apparently attached the ground lead from the welder to the barrel, which may have caused the barrel to heat up during welding, to the point of igniting the flammable material inside. Another more likely scenario is that the welder simply burned through the lid of the barrel with his welding rod, and directly ignited vapors inside the barrel.

**Recommendation #2: *Employers should ensure that welding should not be performed on used drums, until they have been thoroughly cleaned.***

Discussion: Welding and other hot work should not be performed on used drums, barrels or other containers prohibited until they have been cleaned thoroughly (29 CFR Part 1910 and 1926). Cleaning should be done to be certain that there are no flammable materials present or any substance such as greases, tars, acids, or other materials which when subjected to heat might produce a flammable or toxic vapor. In this case the victim used an old barrel as a worktable, in retrospect, not a wise idea when arc welding. Even a very small amount of residual fuel, oil, or gasoline vapor, when mixed with appropriate air, became an deadly mixture inside the barrel.
