## **FACE INVESTIGATION**

**SUBJECT:** Maintenance machinist trainee entangled in revolving shaft of vertical boring mill

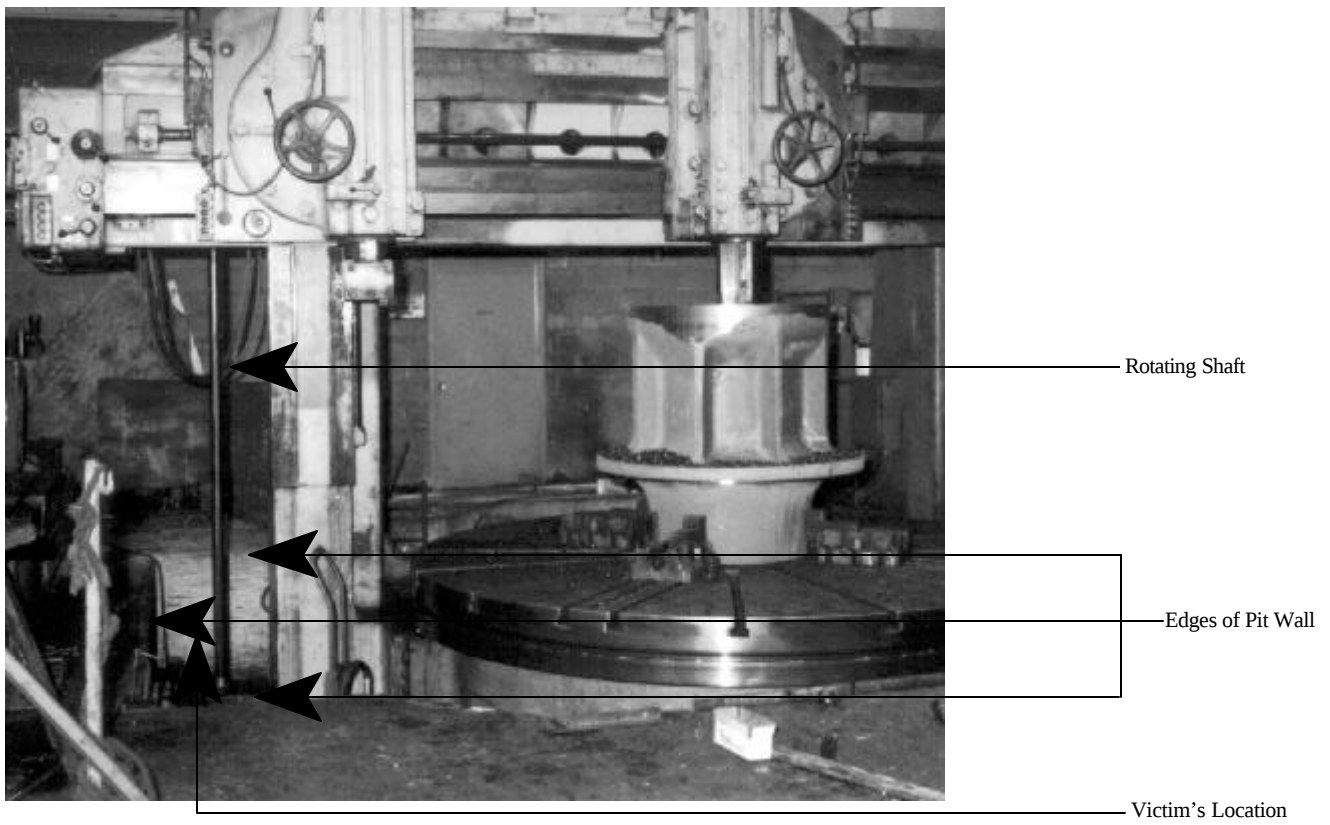
**FIGURE 1**

approximately 24 feet long and 20 feet high, and was in a 32-inch deep concrete pit. (See Figure 1.) A 12-foot wide mill turntable was positioned between two 5-foot long, 12 feet high rectangular steel pillars that held the upper portion of the machine. An unguarded 2 ½ inch diameter metal shaft extended vertically 9 feet from a baseplate on the pit floor to the upper portion of the machine. The shaft was positioned 16 inches from the pillar and rotated 3-4 times a minute. A half-inch wide smooth keyway extended the entire length of the shaft. The machine control panel that held the emergency stop button in front of the turntable, approximately 20 feet from the rotating shaft.

The victim and a co-worker were drilling holes in the perimeter walls of the machine pit to install a platform floor over the pit. The co-worker left the area to answer the telephone, after telling the victim to shut the machine off and wait. The victim was positioned in the pit beside the rotating shaft when the sleeve of his jacket was caught and pulled by the shaft. He was whirled several times around the shaft, striking his body against the machine pillar and the pit wall. A second co-worker who was working about 40 feet away heard the victim yell, turned in his direction, and saw him caught on the shaft. The co-worker ran to the control panel, hit the emergency stop button, and went to call 911. The first co-worker ran to the victim and attempted to suspend his body until rescue workers arrived. He was transported to the emergency room, where he was pronounced dead. An autopsy was conducted, and tests were done for drugs and alcohol.

**Recommendation #1: Employers should enclose/guard mechanical power-transmission equipment (e.g., vertical drive shafts), where the potential exists for an employee to become entangled or caught in the equipment.**

Discussion: The victim was working in proximity to an unguarded rotating vertical drive shaft when he became entangled and crushed against the machine's frame. Exposed mechanical power-transmission equipment poses a serious hazard to employees and all such equipment should be identified throughout the plant and appropriate enclosures/guards installed to prevent inadvertent contact with the equipment. OSHA standard 29 CFR 1910.212(a)(1) requires machine guarding to protect employees from the hazard of rotating parts. A machine guard enclosing the shaft would have prevented inadvertent contact with the revolving part.

**Note: the one shaft involved in the incident has been enclosed subsequent to the incident.**
