**SUBJECT:** A yard hand was killed when he was crushed between the mast and the rollover protective structure of a forklift.

## SUMMARY

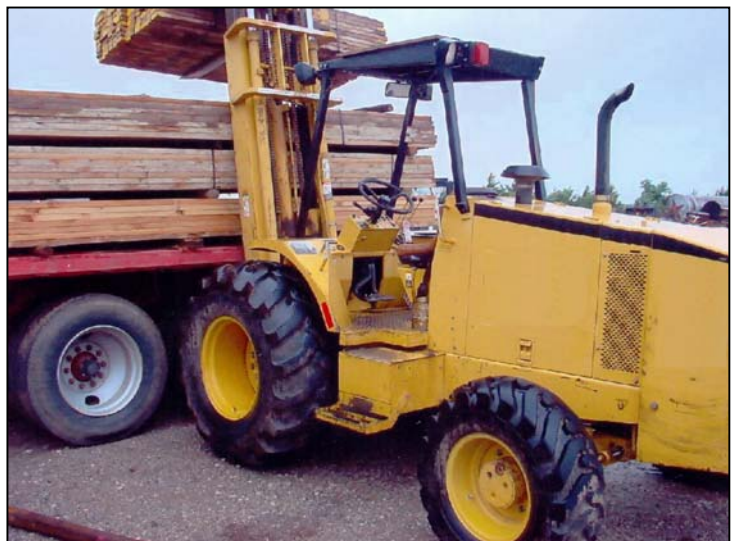
Figure 1. Forklift involved in the incident

**Incident Scene:** The employer used the incident site to store, load, and unload construction materials. The yard surface was composed of a gravel/chat/soil type mix. A company 40-foot flatbed trailer had been loaded with lumber, and the victim was assigned to redistribute the load. There were three employees, including the decedent, at the site when the incident occurred—a truck driver and two part-time yard hands. The victim was using a 6,000-pound lift capacity, rough terrain forklift that had been owned by the company for five years (Figure 1). The incident occurred early in the workday around 7:45 a.m.

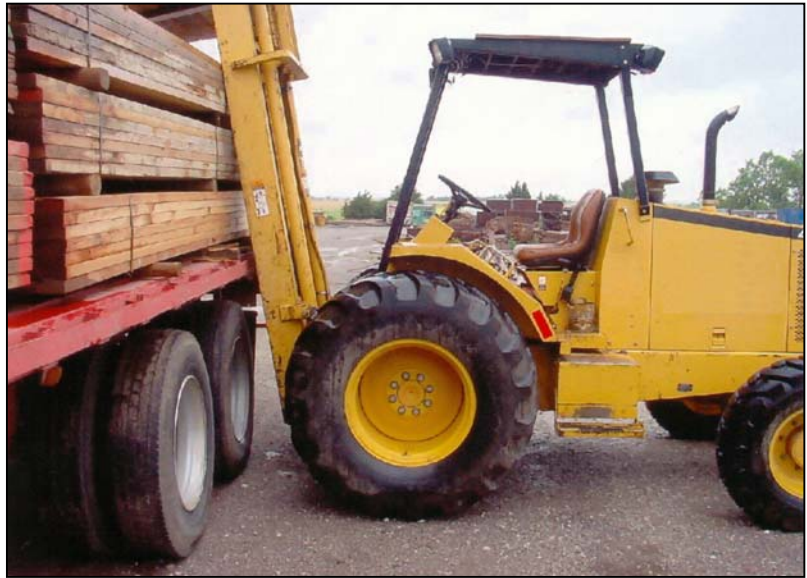
In an attempt to move one bundle of wood forward to even the weight, the victim raised the bundle in the air, well above the height of the trailer and its load. The forklift was only a few inches from the edge of the trailer at this time (Figure 2). Leaving the engine running, the decedent stepped out onto the front left fender of the forklift and reached across to remove four spacers. His body was positioned between the forklift mast and the

Figure 2. Forklift's position prior to incident.

top edge of the ROPS. Unable to reach the blocks from the forklift fender, he stepped across to the edge of the trailer with one foot and was able to remove three of the four. He then attempted to move across the front edge of the operator's compartment to the right fender. As he did, his foot engaged the tilt control lever and the mast began to move back, as the forklift was still running. The decedent had no time to react and was crushed. The decedent was wearing regular work boots, but the wet conditions may have contributed to his foot hitting the lever. In the operator's compartment was a caution label with the operating requirements to be performed prior to leaving the operator's seat: "Before leaving operator's seat; lower working units to the ground, place transmission gear selector lever in neutral, place reverser lever in neutral, engage parking brake, and stop engine." It was determined that both yard hands routinely used the forklift fenders to reach loads on the trailers.

**Recommendation #2: Employers should ensure that forklift operators do not position themselves between the uprights of the mast, outside the running lines of the truck, or work under elevated forks or loads.**

Discussion: The OSHA standards for powered industrial trucks also indicate that authorized operators shall not place arms or legs outside the running lines of the truck or between the uprights of the mast. Furthermore, no one should pass or work under elevated portions of the truck under any circumstances, unless the forks have been chained and locked out to an overhead hoist, crane, or beam capable of supporting the weight. When the truck is running, the operator must remain inside the operator's compartment; power should be shut off when leaving a powered industrial truck unattended. Proper instruction and supervision of employees will give workers the knowledge of these and other safe operating procedures to prevent misuse of equipment.
