SUBJECT: County road maintenance worker died when he was run over by a rotary cutter

SUMMARY

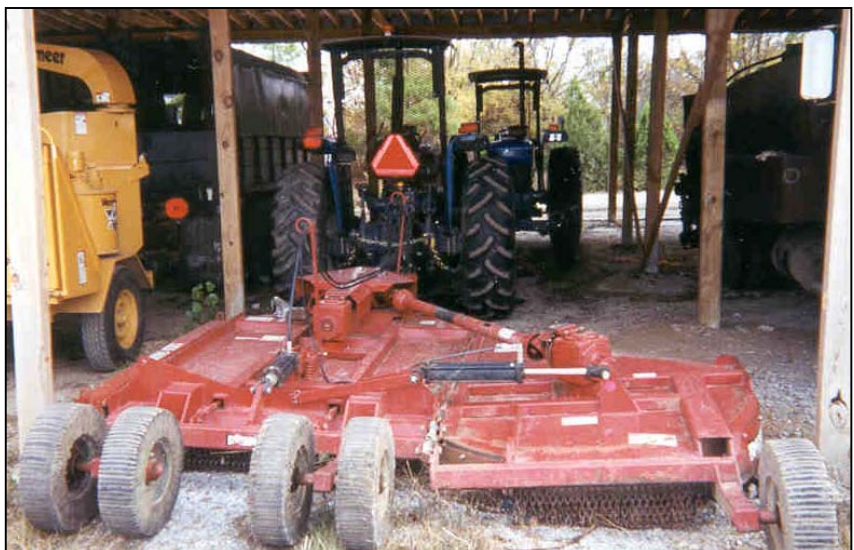
Figure 1. Rotary cutter and tractor

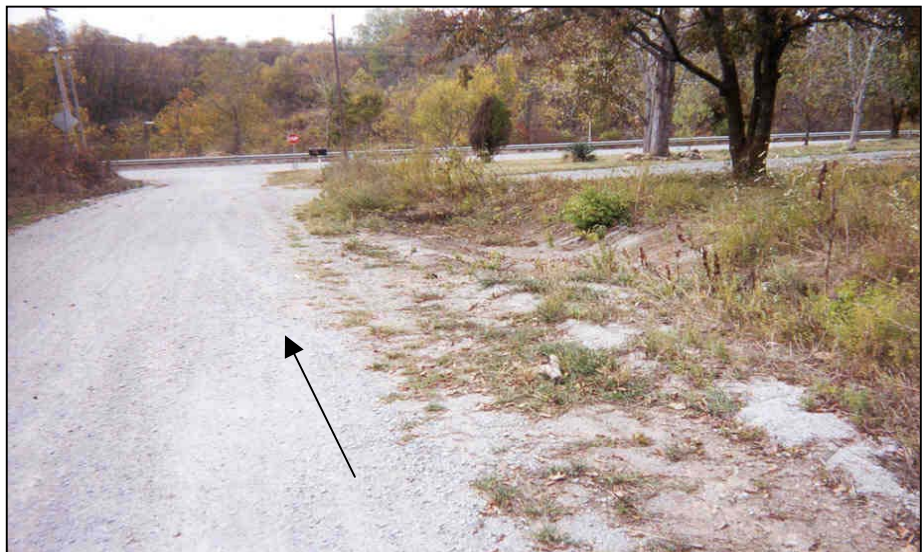
Shortly after noon, the victim had mown along the south side of the east-west gravel-surfaced road and had made the turn at the end of the cul-de-sac to mow along the north side (Figure 2). As he was passing an area in which three homes were located, he noticed some toys in the path of the cutter. The victim shifted the transmission to neutral and dismounted the tractor, leaving the motor running and the PTO engaged; the parking brake was not set. He proceeded to remove the toys from the ditch in front of the tractor. The tractor wheels were positioned on the gravel surface facing downhill on a 3% grade. The mower deck was positioned approximately 10-12 inches above ground level, and extended approximately three feet beyond the tractor's rear wheel on the right side of the vehicle. When the tractor began to roll, the victim ran around the mower deck to the right side of the tractor and tried to climb up to the driver's seat. Unable to climb onto the tractor, the victim fell to the ground and was run over by the rotary mower. He was killed instantly. The tractor continued to roll approximately 20 feet, dragging the victim under the mower deck, before coming to rest in the ditch near a drive on the north side of the road. The body was trapped beneath the vehicle for approximately one hour.

Figure 2. Direction of travel on the cul-de-sac the victim was mowing
