SUBJECT

A 67-year old maintenance worker for a feed and seed retail store was killed when he was crushed by a forklift that ran off a loading dock and overturned onto him.

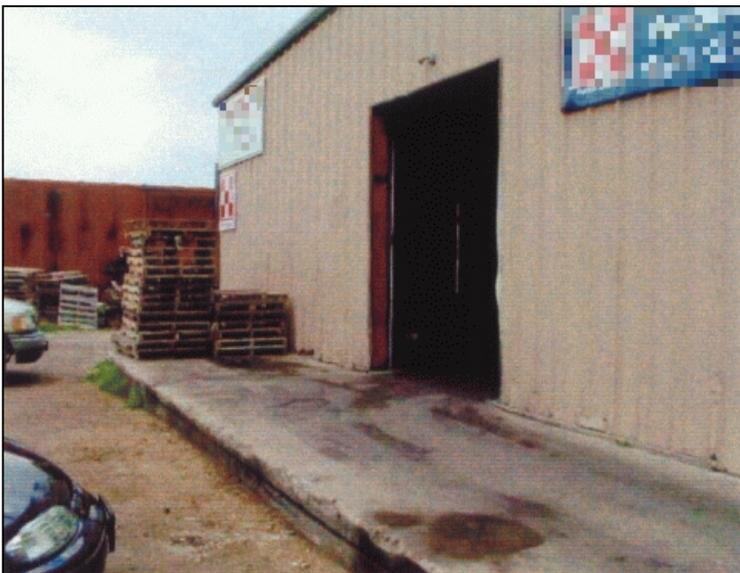
Figure 1. Loading Dock

On the day of the fatal incident, the weather was cool and clear, and the working surfaces were dry. The deceased worker arrived for work at approximately 8:00 a.m. While waiting for customer orders, he was moving an empty pallet to the north end of the loading dock. The concrete loading dock, which was on the west exterior of the building, was approximately 8 feet wide, 65 feet long and 10 inches tall. It was not sloped. The worker was using a 1991 model 5000-pound capacity Clark BPX 25E propane-powered forklift, which weighed 8830 pounds, to move the pallet. The pallet became jammed on the forks, and the victim dismounted the forklift to remove it. The forklift was positioned at a slight angle and approximately two feet away from the edge of the dock with the forks elevated approximately five feet. When he dismounted, the victim did not set the hand brake or lower the forks, and he left the forklift in reverse gear. As he was attempting to dislodge the pallet, the forklift began to roll backward toward the edge of the dock, and co-workers who witnessed the event called out to alert him. He immediately jumped off the loading dock to the ground and ran alongside the forklift toward the operator's seat in an attempt to stop the vehicle before it rolled off the dock. As he tried to climb onto the forklift to press the brake, the rear left tire rolled off the edge of the dock causing the forklift to tip toward the operator. He was struck by the forklift and fell face down onto the gravel drive. The overhead guard came to rest across

his upper back. The forklift did not fall completely off the loading dock; the left front wheel remained on the dock.

Recommendation #1: Employers should develop and implement a written program that includes policies regarding the use and safe operation of forklifts.

Discussion: OSHA regulations and manufacturer operating manuals provide guidelines for the safe operation of a forklift and other powered industrial vehicles that should be incorporated into a formal program. Additionally, the employer should establish written training and use authorization policies that should be clearly communicated to all personnel. OSHA regulations require that the forks be fully lowered, controls neutralized, and the brakes set to prevent movement of a forklift whenever the operator is dismounted but near the forklift. In addition, operators are required to be trained, licensed, and evaluated periodically. The establishment and implementation of a written powered industrial vehicle program may have emphasized and evidenced management’s commitment to safety and provided a mechanism for better communicating the policies and practices to affected personnel.

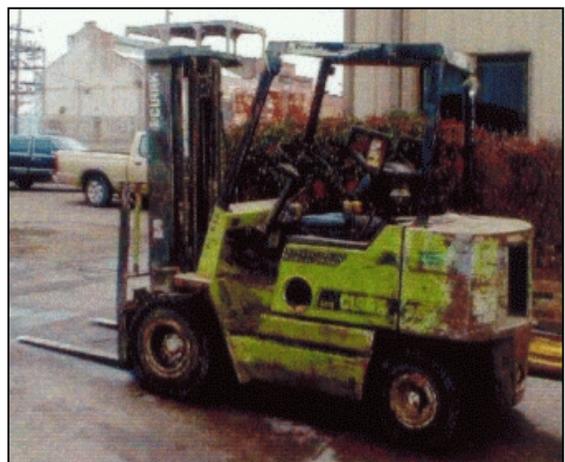
Figure 2. Forklift the Victim was Using

A 67-year old maintenance worker died on February 28, 2000 from multiple crushing injuries received when he was pinned by a forklift that ran off a loading dock and overturned onto him. The victim was operating the forklift on a low-level loading dock that was not sloped. He dismounted the forklift to remove an empty pallet that was apparently jammed on the forks. He did not take the forklift out of gear, lower the forks, or set the hand brake before getting off it. As he attempted to remove the pallet, the forklift began to move in reverse, and the victim ran after it to try to prevent it from rolling off the dock. As the worker attempted to climb onto the vehicle, the rear left wheel rolled off the dock and the forklift overturned. The worker was crushed beneath the forklift's overhead guard.

Recommendation #2: Employers should ensure that all employees receive at least some awareness training regarding the hazards of unfamiliar equipment, such as forklifts, and an understanding of the training and authorization requirements for operation of the equipment.

Discussion: The worker reportedly disregarded instructions to not operate the forklift. The fact that he assumed he could operate the vehicle safely but failed to do so may indicate a lack of understanding of the hazards and controls associated with using the forklift and a lack of appreciation for the instructions or the gravity of the instructions that he apparently violated. Adequate introductory training regarding the equipment and safety policies and practice in place may prevent a similar occurrence.
