**Investigation Report
April 4, 2000
99OK00101**

Sign installation crew foreman dies after 30-foot fall from upper catwalk of billboard.

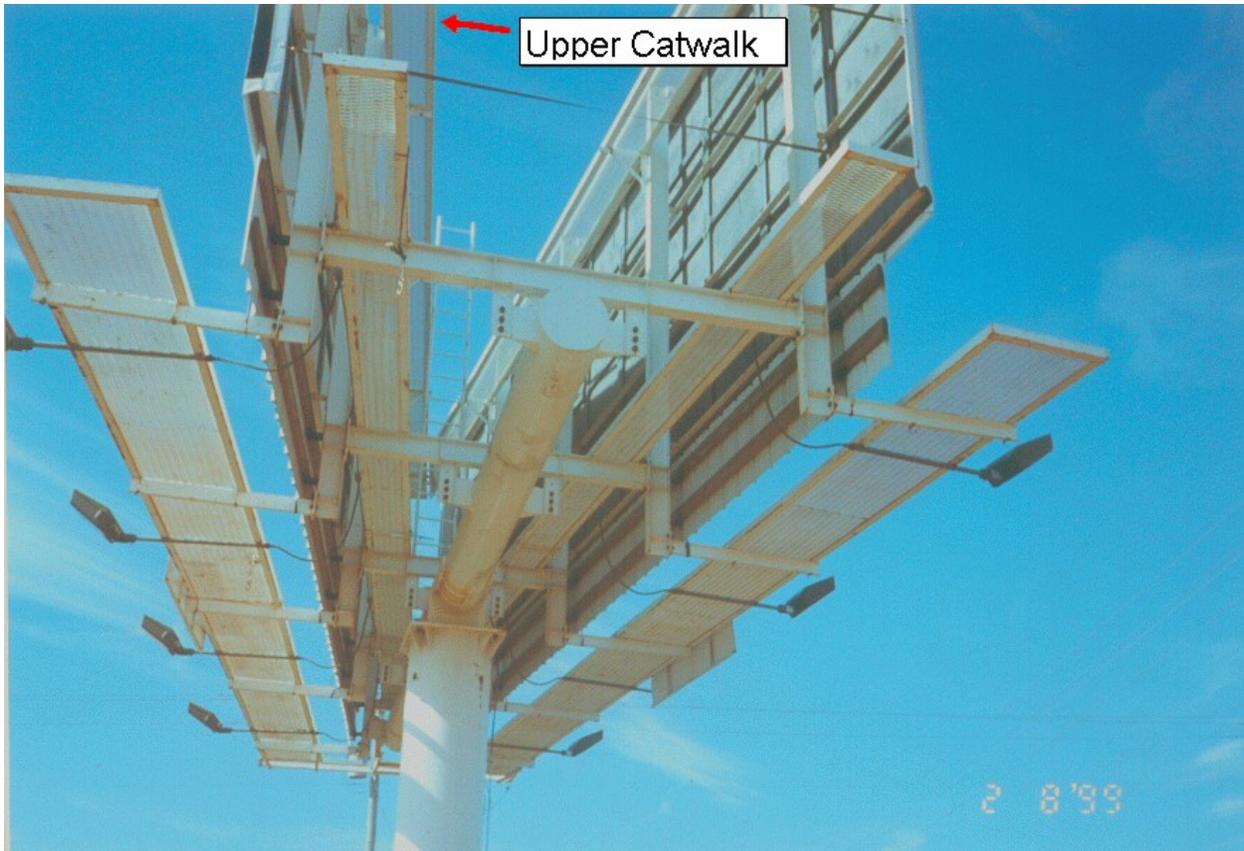
Figure 1. The victim fell from the upper catwalk on the billboard. The two sign surfaces of the billboard join together on one end forming a “V” shape.

Recommendation #1: Employers should ensure that all exposed sides of catwalks/platforms are guarded by standard railings with toeboards.

Discussion: At the time of the incident, the crew was installing a vinyl sign on an existing billboard structure. The workers were working from an unguarded catwalk located inside and at the top of the billboard. The upper catwalk was 30 feet high and 12 inches wide. The catwalk should have been guarded by a standard railing 42 inches high with toeboards on all sides (except at the entrance to the opening) with the passage through the railing either provided with a swinging gate or other safety system.
