FACE Investigation Report

SUBJECT: Farmer Dies of Burn-Related Injuries After Being Trapped in a Burning Hay Baler – Oklahoma.

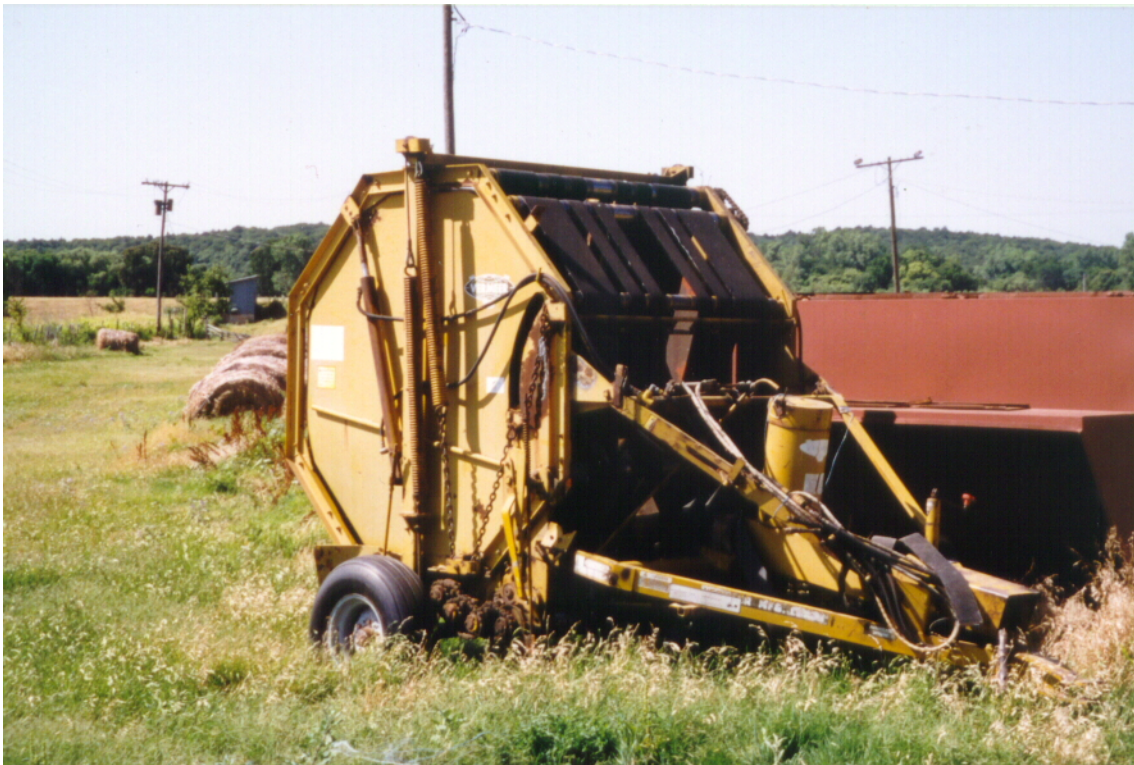
Figure 1. Round hay baler involved in incident.

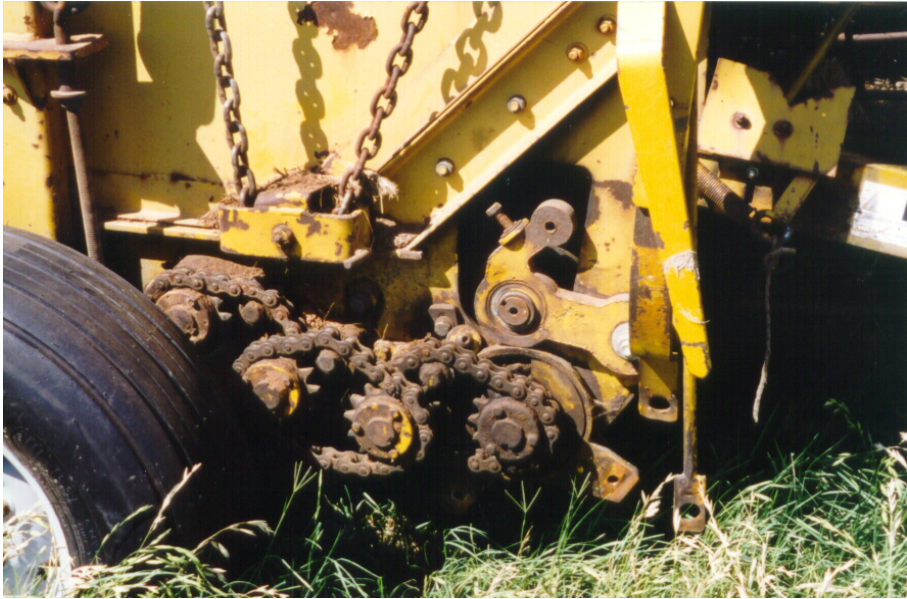
Discussion: In this incident, twine and hay became entangled around a roller and a fire ensued when a bearing became dry. Balers should be serviced and maintained in accordance with the manufacturer’s specifications. Proper baler maintenance includes removing all hay and chaff that accumulates during baling. Removing materials such as dirt, grease, rust, hay “juices”, and oil coated on rollers will aid in the rollers not wrapping and will decrease the risk of fire. Chains, belts, rollers, pickup and twine mechanisms, windguard, and other components must be in good condition and properly adjusted for the baler to work safely, efficiently, and reliably. Balers should be stored in a dry, sheltered place, tension in the belts released, twine removed, rollers cleaned, and chains and rods should be lubricated according to manufacturer’s specifications.

Figure 2. Area shown is the area in which the fire started. The protective shields were removed after the fire.

Recommendation #4: Employers (including persons who are self-employed) should ensure that machinery is maintained according to manufacturer’s specifications, including removal of excess hay, twine, grease, etc. on a regular basis.

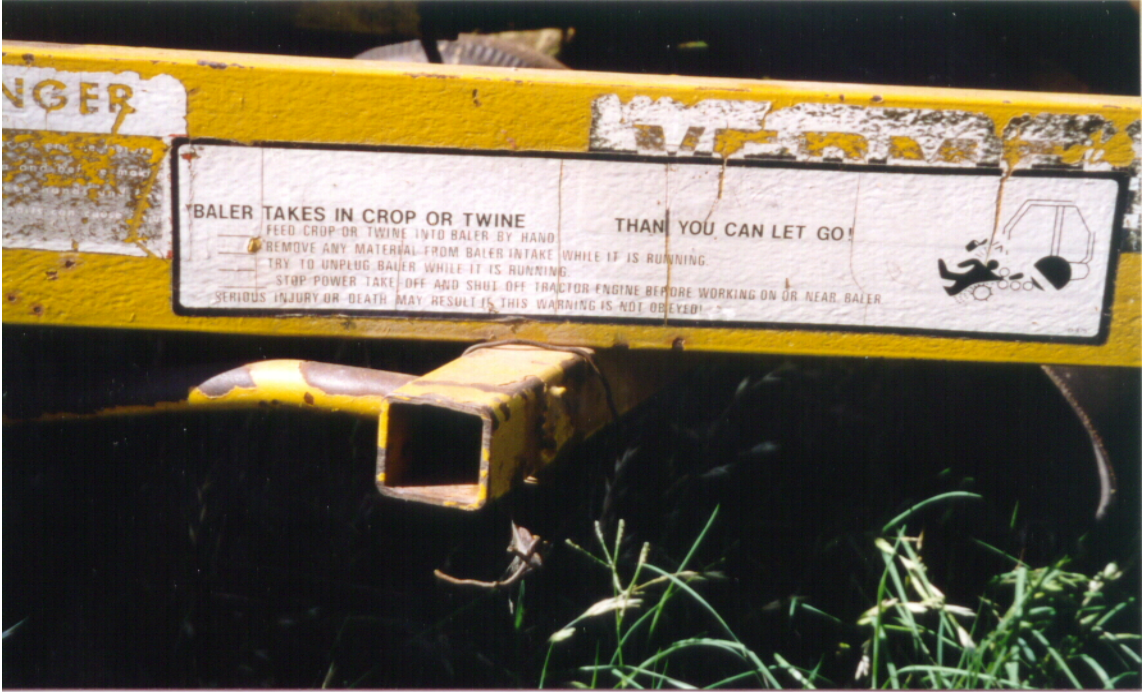
The baler was marked with safety decals that were sent along with other safety information from the baler manufacturer. The safety decal on the baler warned users to always disengage the PTO and shut-off the tractor engine before working on or near the baler.

Figure 3. Additional safety warnings placed on the baler.

Recommendation #1: Employers (including persons who are self-employed) should ensure that safe work practices are followed, including disengaging the PTO and shutting off the engine, prior to working on agricultural machinery.
