FACE Report Number: 2004-03

Seventeen-Year-Old High School Student Working as a Warehouse Laborer in Work-Based Learning Program Dies After Forklift Tips Over and Crushes Him - Tennessee

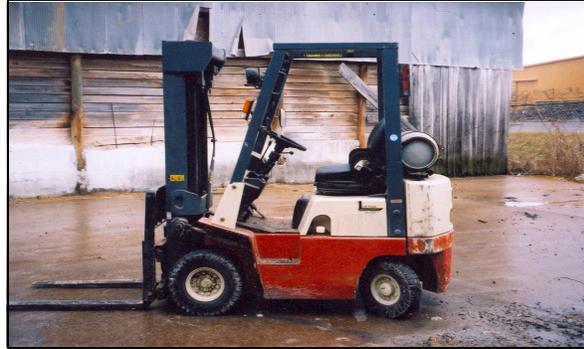
Photo 1. This photo illustrates the forklift used on the day of the incident

Equipment: The sit-down type 2-ton propane powered forklift (Photo 1) had been purchased new by the company. It was approximately 2 years old and was equipped with a seat belt and a rollover protective structure (ROPS). The forklift had pneumatic tires and lifting capacity of approximately 3,000 pounds. The manufacturer's operator's manual was located in a pocket behind the operator's seat. The equipment dealer inspected the forklift following the incident and determined that it was in good working order.

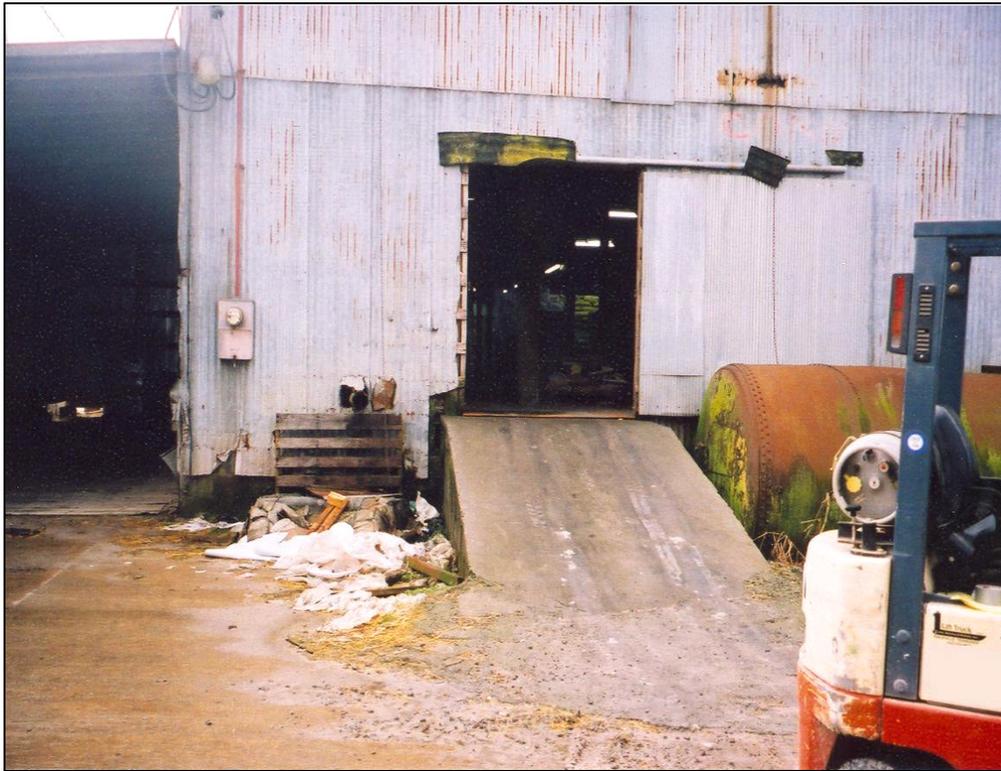
Photo 2. This photo illustrates a close-up of the ramp to the warehouse

The ramp had an 18.6% grade. It measured 7-foot ¼ inches wide, 39 ½ inches high at its point of entry into the warehouse, and 18 feet long (Photos 2 and 3). The entrance/exit of the warehouse was narrow, measuring 70 inches in width. However, a post and an abandoned grain feed dispersal bin located inside left just enough room for the forklift to pass through. Old scrape marks on the forklift and on the post and grain bin inside the warehouse in the only area where the forklift could pass through may be indicative of the tight fit. The local manager said that forklift operators had to speed up to make it up the ramp and then had to slow down at the entrance to fit through the narrow passage after passing through the warehouse door. The ramp's surface was patched and rough where the ramp joined the flat, level parking lot. The local manager informed the DSR investigator that the co-op was being relocated and therefore the rough pavement in the transitional area where the level parking lot met the ramp, and the confined areas in the warehouse, although identified as problematic, had not been changed because of the planned move.

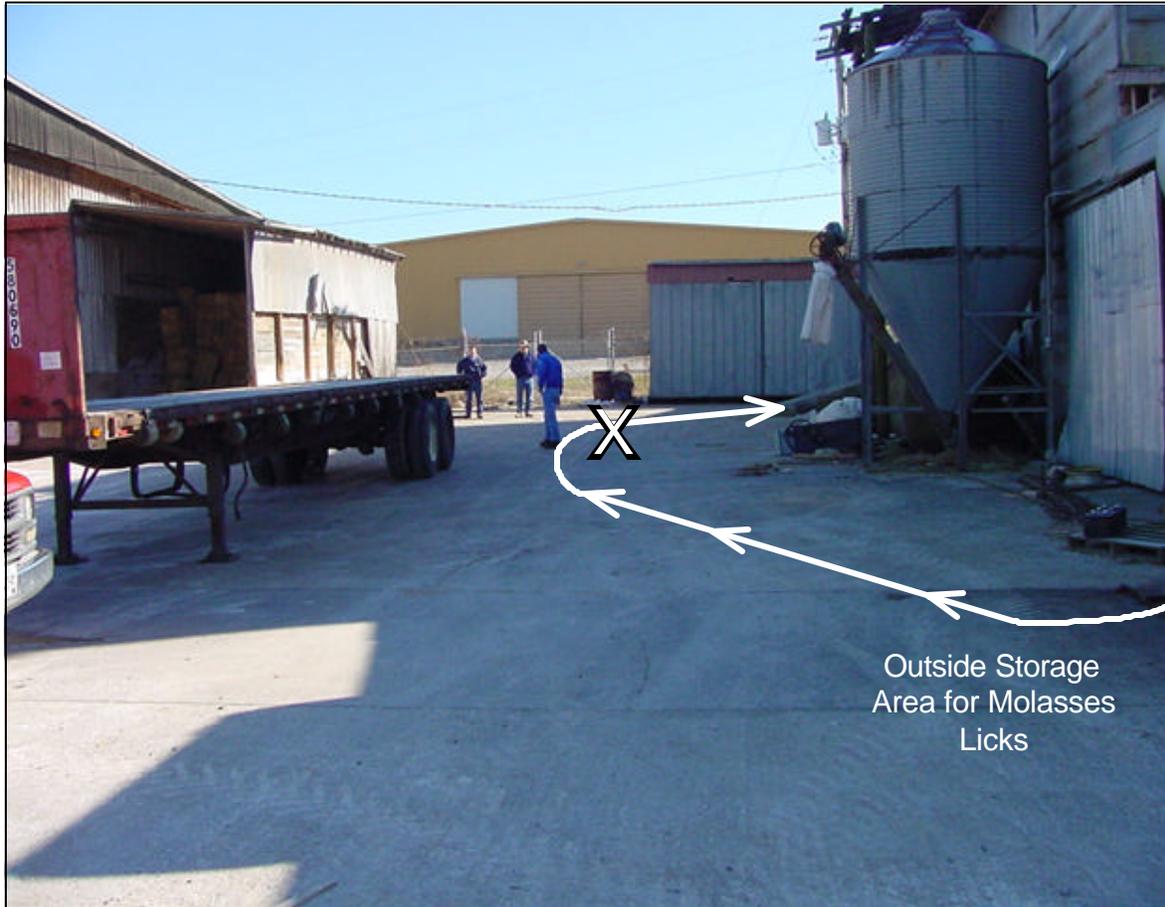
Photo 3: This photograph illustrates the parking lot, warehouse and ramp, and other co-op buildings. Lines on the photo approximate the travel path of the forklift on the day of the incident. An "X" marks the approximate location of the forklift that had tipped over. Photograph courtesy of the Tennessee Department of Labor and Workforce Development, Division of Occupational Safety and Health.

that the victim was traveling toward the warehouse ramp on a level surface of the parking lot and made a sharp right turn to enter a narrow ramp leading up to the warehouse. It is surmised that this is when the forklift tipped over onto its left side. The forklift was not loaded but its forks were raised approximately 20 inches so the forks would not dig into the ramp. There was a single 12-foot skid mark located on the parking lot where it is surmised that the victim started into a right turn toward the ramp.

Discussion: Employers should perform an assessment of the travel routes used by forklift operators, including warehouse access/exits, ramp design, the condition of the concrete at the end of the ramp, and the parking lot over which forklifts must travel. According to Swartz² “Operating environments that include railroad tracks, rough pavement, holes in the roadway, uneven surfaces, ramps, grades, or other less than desirable features can be dangerous.”

Improving travel surfaces to make them less rough, making access ways wider, and requiring truck drivers to move trucks after off-loading would improve travel pathways for forklift operators. Employers should also consider marking a route with yellow paint that provides forklift operators with guidance regarding specified pathways and appropriate turn radiuses. Employers should also consider posting signs warning forklift operators to drive at slow speed and to use their seat belts. A sign should also be posted warning truck drivers to park their vehicles away from forklift travel routes.

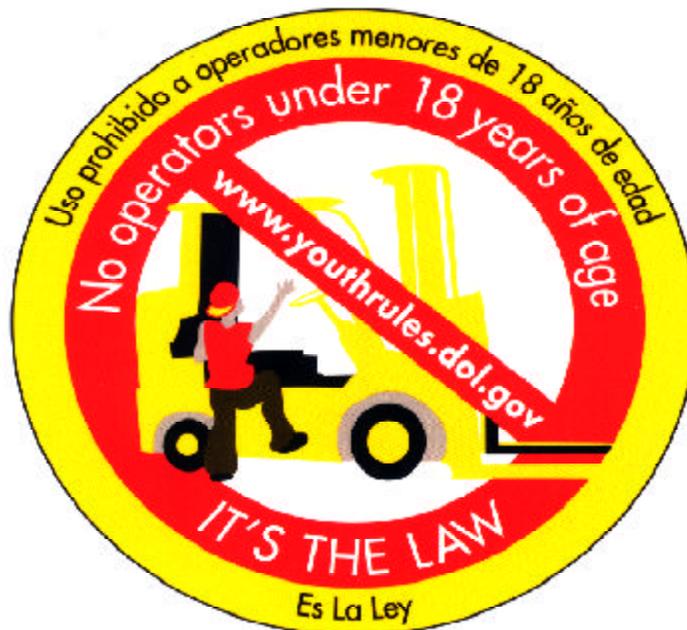
Photo 4. This photo illustrates the sticker “NO OPERATORS UNDER 18 YEARS OF AGE. IT’S THE LAW,” which is available from the local Wage and Hour office of the U.S. Department of Labor or from the DOL website www.youthrules.dol.gov/posters.htm.

Discussion: Employers can obtain a sticker that alerts employees that young workers are not to operate forklifts. Employers can obtain stickers in English and Spanish that indicate “NO OPERATORS UNDER 18 YEARS OF AGE. IT’S THE LAW,” from the local Wage and Hour Office of the U.S. Department of Labor (Photo 4). These stickers can be downloaded from the internet and should be affixed in a conspicuous place on forklifts. As an additional safety precaution, employers should ensure that keys used to operate forklifts are in the possession of only selected workers whom they have authorized and trained to operate forklifts. A supervisor should be assigned to ensure, through periodic inspections, that only authorized and trained operators are operating forklifts.
