# Equipment Operator Struck and Killed by Skidder – South Carolina

FACE 9316

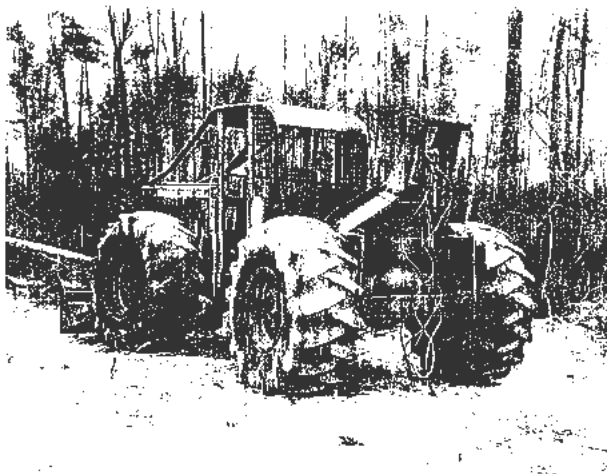
Figure. Skidder Machine (not to scale).

On the day of the incident, the crew began work as usual about 8 a.m. The tree feller proceeded to his work area in the woods, while the log-loader operator and tractor-trailer driver prepared their vehicles for the day's activities. The victim drove the skidder (Figure) to a previous cutting site. He soon returned pulling a number of logs into the landing area, which had a slope of less than 5 percent. The victim unhooked the logs and drove away from the landing area around the idled log-loader. As the victim drove the skidder around the loader, it ran over two logs laying on the ground. One log was 6 inches in diameter, while the other log was about 14 inches in diameter. Although the incident was unwitnessed, it is assumed that when the skidder ran over the logs, the victim lost his balance, then fell or jumped from the skidder cab before being struck and run over by the left rear tire. The log-loader operator looked up while trying to start the loader, and saw the unmanned skidder in front of the two logs barely moving towards the woods. The loader operator ran to the skidder and shut off the machine, then went looking for the victim. He found the severely injured victim on the opposite side of the log-loader. He asked the tractor-trailer driver to call the emergency medical service (EMS). The EMS and county coroner arrived in approximately 30 minutes, and the coroner pronounced the victim dead at the scene.

**Discussion:** Although the skidder machine—a 1979 Timberjack-Unit 7140—used to move logs from the cutting site to the landing area was equipped with a rollover protection system (ROPS), it was not equipped with a seat belt or other type of restraint system. OSHA standard 29 CFR 1910.266(c) (6)(viii) for pulpwood logging states that “Seat belts shall be provided on mobile equipment.” Employers should ensure that seat belts are installed and used on all appropriate mobile equipment.
