Laborer Dies of Carbon Monoxide Poisoning During Sandblasting Operations in Virginia

FACE 9131

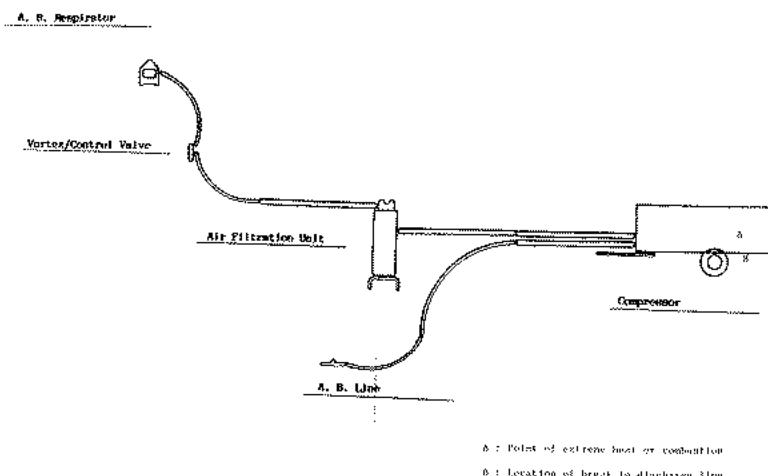
Figure.

The victim had been assigned the task of sandblasting two wrought iron chairs the day before the incident. The victim performed the sandblasting operations at the dealership as necessary, but not on a daily basis. The sandblasting unit consisted of a diesel-powered air compressor, two 1-inch-diameter air discharge lines (one to the air-blasting nozzle, one to the air-filtration unit), the air-filtration unit, a vortex/control valve (to control air flow and cool the air), and the abrasive-blasting airline respirator (a continuous flow airline Type "CE" respirator, with a hood and facepiece that covered the wearer's head, neck, and shoulders to protect against rebounding abrasive) ([Figure](#)). The air compressor had been purchased by the dealership 5 years before the incident.

- the vanes of the compressor's radiator were clogged
- the engine of the air compressor was extremely low on oil to the point where it had seized and could not be started at the time of the investigation
- evidence of combustion or extreme heat was present at the back end of the compressor (opposite the two discharge lines)
- the main discharge line was broken in an area located underneath the evidence of combustion or extreme heat
- three electrical safety relays—that would detect high ambient, oil, or discharged air temperature and automatically shut the compressor down—had been bypassed
- the filter in the filtration unit offered no protection against toxic gases; it could only filter out solid particulates and liquid aerosols.
- a black, oil-like residue was present in both discharge lines and, to a greater extent, in the air filtration unit.
