**SUBJECT:** A maintenance mechanic died when the forklift he was working on slipped off a jack and fell on him.

**SUMMARY**  
**California FACE Report #03CA005**

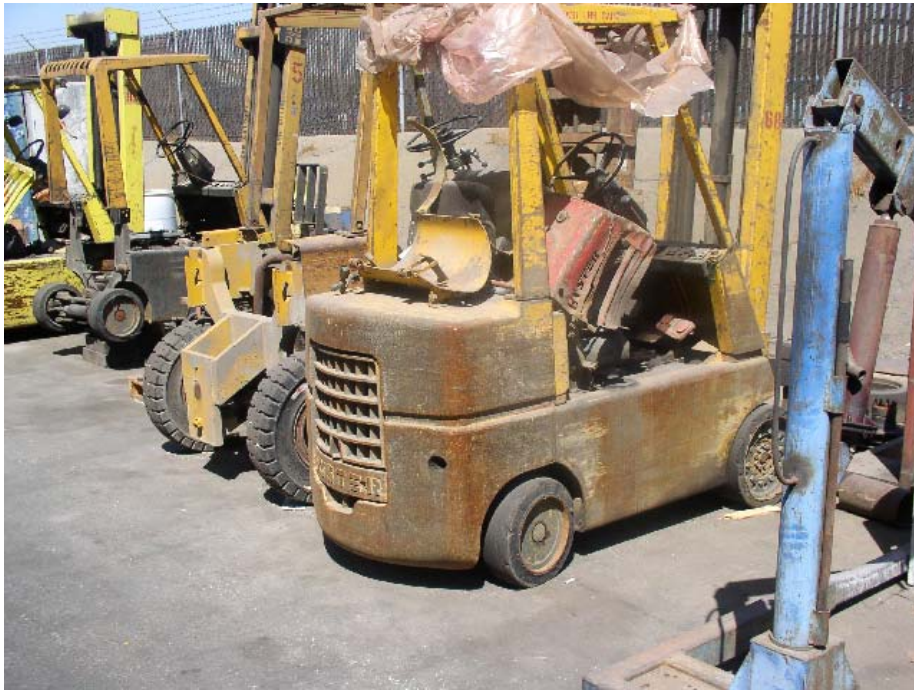
03CA005  
Exhibit #1

View of a forklift similar to the one involved in the incident.

The site of the incident was a manufacturing plant of agricultural fencing and wire products. On the day of the incident the victim was assigned to replace the starter on an industrial forklift that weighed approximately 9,000 pounds (**Exhibit #1**). The forklift was located on a slight incline in the maintenance yard outside the maintenance shop (**Exhibit #2**). The concrete ground was partially wet due to an early morning rain. The victim used a hydraulic jack rated for 8,000 lbs (**Exhibit #3**) to raise the rear of the forklift. The forks were lowered and the front wheels were on the ground so the jack did not lift the entire weight of the forklift.

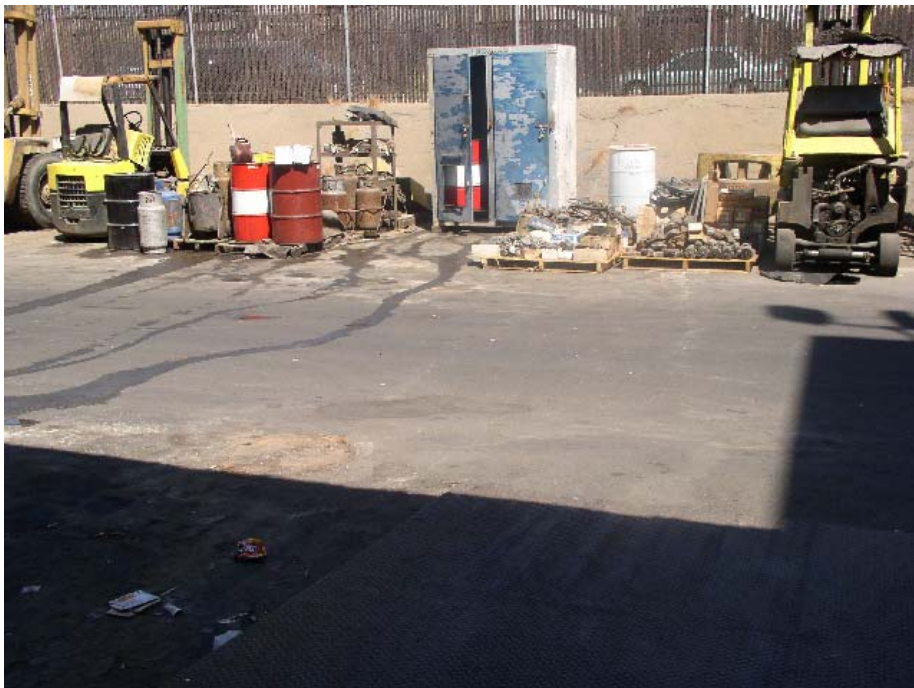
03CA005  
Exhibit #2

View of the area where in the maintenance yard where the incident took place.

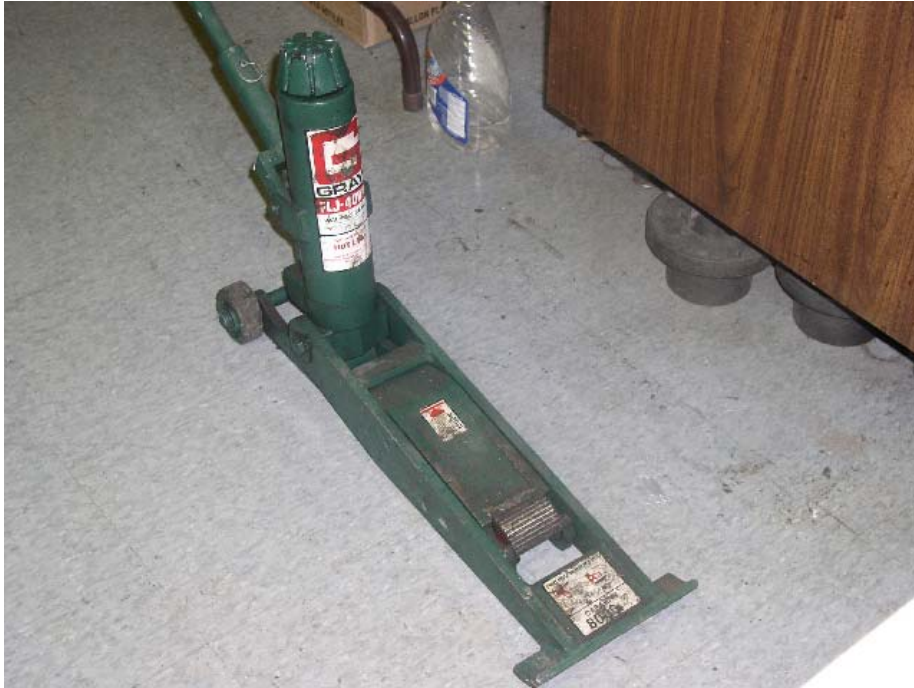
Exhibit #3

A picture of the jack used in this incident.
