A Machine Operator Died When His Glove Caught in a Wire Drawing Machine

SUMMARY

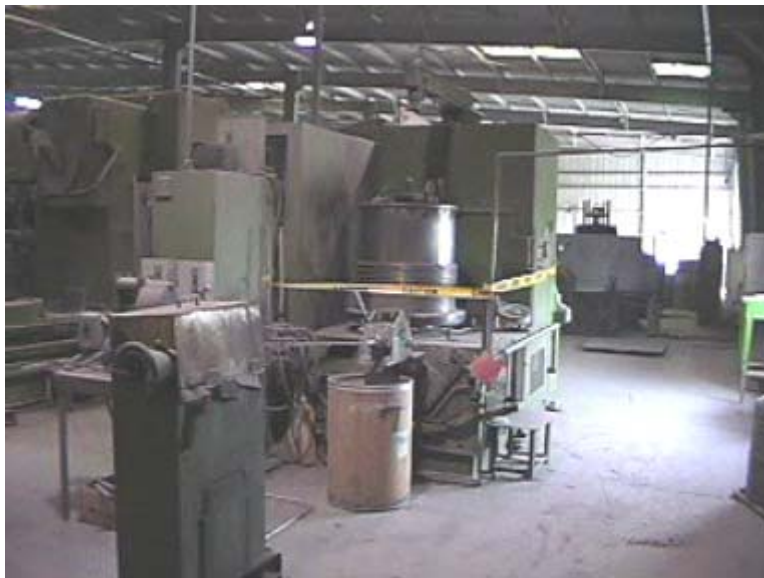
Exhibit #1
View of the wire pulling machine and reducing dies.

The site of the incident was a large industrial machine shop that spooled wire after drawing it through dies to reduce it to specific diameters. The machine used to complete this process was called a "wire drawing" or "wire pulling" machine (exhibits [#1](#) & [2](#)). The machine took larger size diameter wire and pulled it through sets of dies to reduce its diameter to a desired size. The pulling mechanism on the machine was a drum (exhibits [3](#) & [4](#)). The operator fed the wire through the dies and a safety stop bar ([exhibit #7](#)), and then wrapped the wire around the drum. The drum would then rotate pulling the wire through the sets of predetermined dies ([exhibit #1](#)). As the drum continued to rotate, the wire was fed off the top of the drum through directional guides and into the spooling mechanism. It then spooled the finished wire onto a wire holding device ([exhibit #2](#)). The wire holding device was then removed from the machine and the finished product would then be stored or shipped.

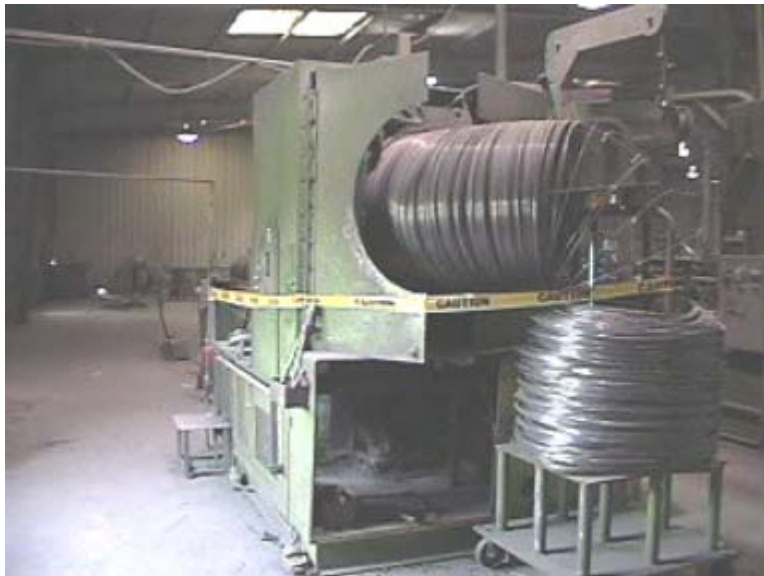
Exhibit #2
View of the wire pulling machine and the wire holding device.

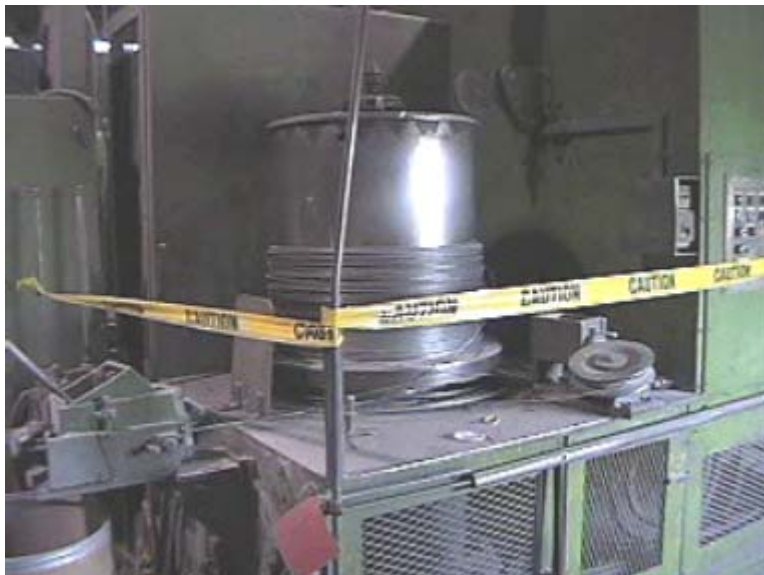
The paramedics and police arrived within minutes. CPR was administered and continued while the victim was transported to the hospital. The victim failed to regain consciousness or spontaneous respirations and was pronounced dead at the hospital. Examination of the incident site revealed that the victim reached into the area of the rotating drum and got his glove caught in the wire. This action pulled him into the machine between the drum and the machine housing.

Exhibit #3
View of the rotating drum the victim got caught in.

Recommendation #1: Ensure that all machines are properly guarded.

Discussion: Machines that have moving parts that can create a hazard for employees should be guarded. Guarding protects the employee from getting caught in moving parts and protects the machine. Had proper guards been in place on this machine, this incident might have been prevented.

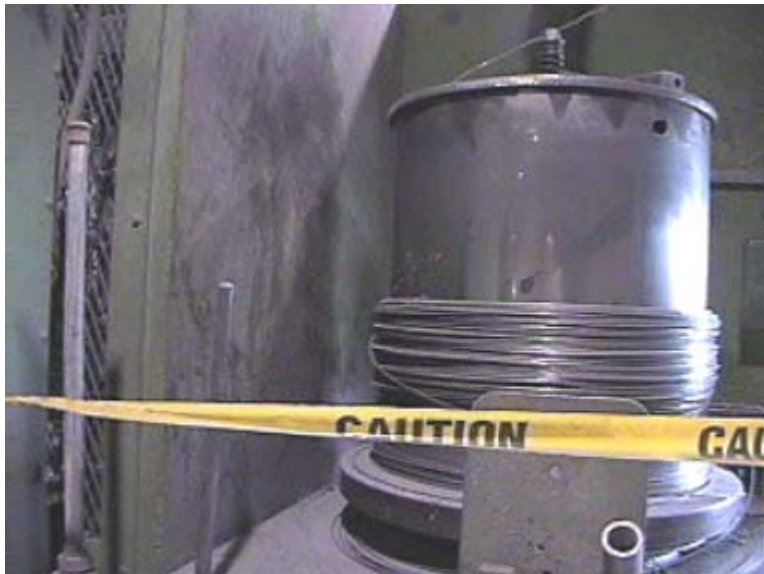
Exhibit #4
View of the rotating drum showing the area where the victim got pulled into.

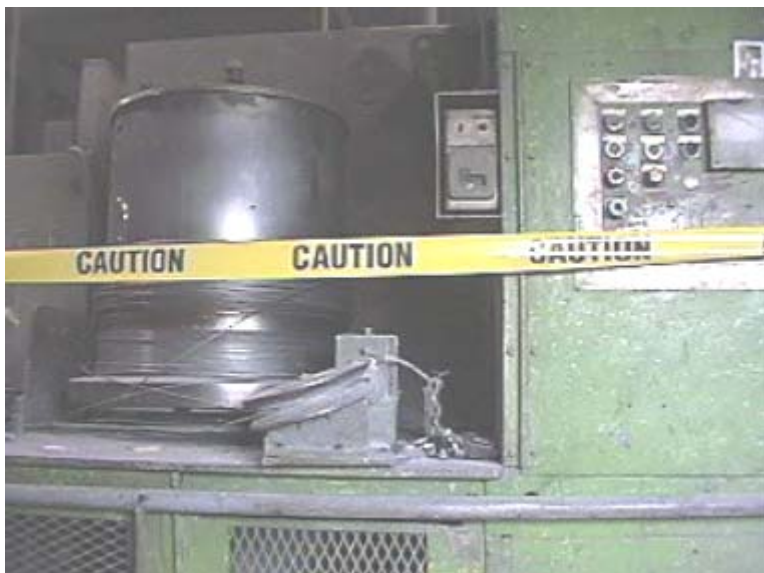
Exhibit #5
View of the rotating drum in proximity to the machine control panel.

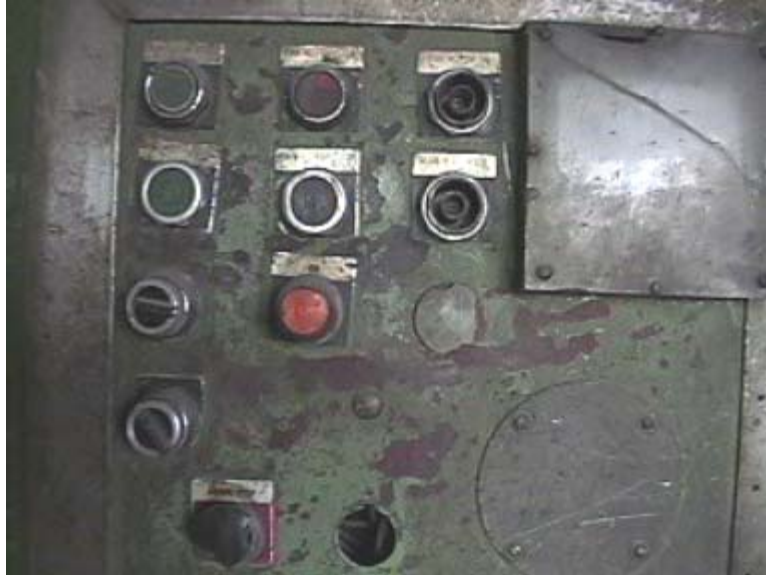
Discussion: The machine involved in this incident had a safety bar that should have automatically shut off the machine when the operator applied pressure to it. This device was non-operative and wired to the face of the machine. The control panel on this machine did not have proper identifying markings on the control buttons to designate their emergency shut off function. When controls are not properly marked the wrong button could be pushed by mistake. Improperly installed, non-functional, or mislabeled safety devices could contribute to an accident. Workers should not be allowed to operate machines that have identified hazards such as disabled and improperly labeled emergency shut off switches.

Exhibit #6
View of the machine control panel

Recommendation #3: Ensure that all emergency shut off devices and switches on machines are properly installed, maintained in working condition, and properly labeled so the operator can identify them in an emergency.

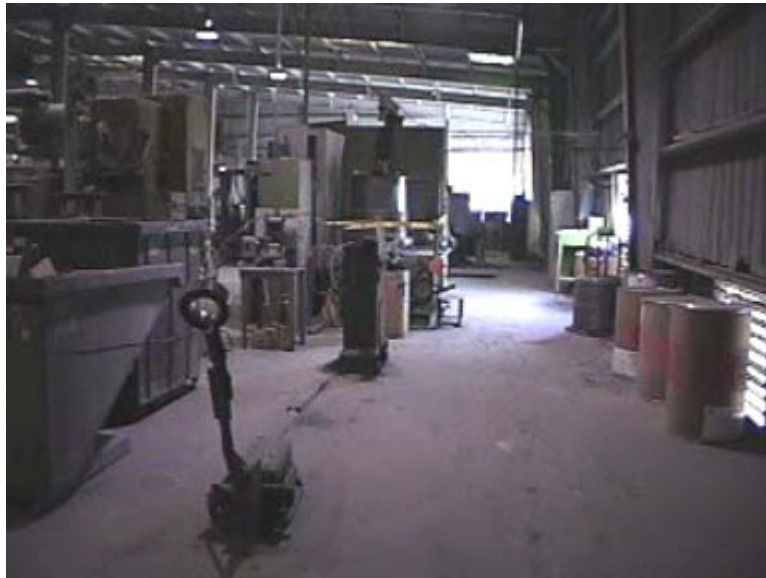
Exhibit #7
View of the safety bar the wire goes through before the dies.

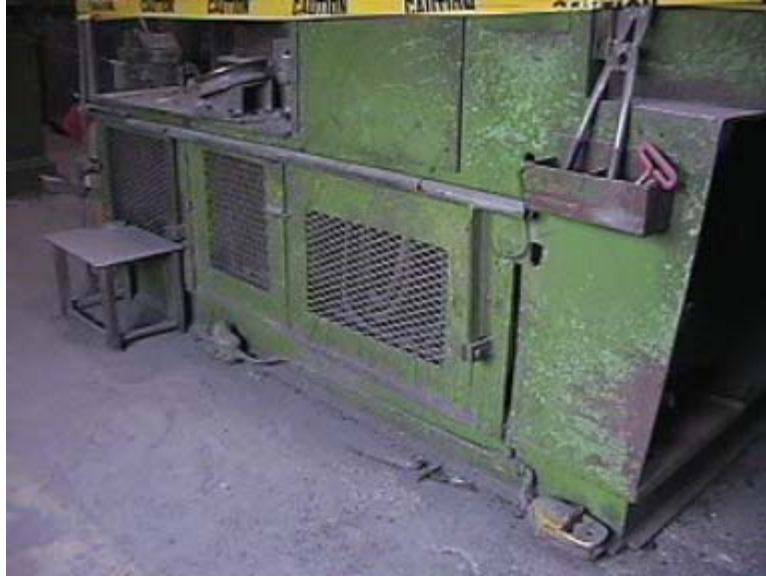
The machine had a safety stop bar hinged across the front of the machine that had been disconnected ([exhibit #8](#)). The bar was designed to prevent personal injury by shutting off the power to the machine when pressure was applied to it. If a worker were pulled into the machine, pressure caused by the worker's body against the safety stop bar would shut off the machine. The machine had no identifying marks to indicate its brand name, serial number or age.

Exhibit #8
View of the inoperative safety bar wired to the machine.
