MIFACE INVESTIGATION: #02MI140

SUBJECT: Farm Hand Run Over by Tractor While Starting the Tractor While Standing On the Ground

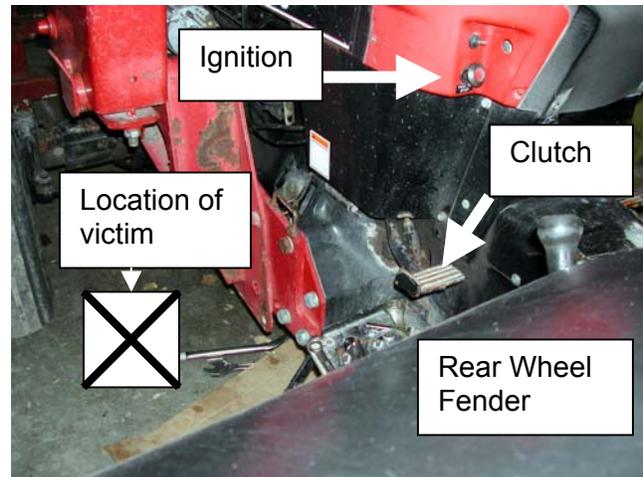
ton fruit tanks onto a flatbed truck. After he was finished, he took the tractor to the shop. The forklift hydraulics were drifting during the loading operation and he may have been attempting to adjust the forklift position when he started the tractor. While standing on the ground in front of the rear tire, he pressed down on the clutch and started the

tractor (See Figure 1). The tractor was left in gear and the tractor's rear wheel ran over the victim, causing crushing injuries to his pelvis. He was found by another employee and taken to the hospital for surgery and stabilization. The next day, a blood clot developed and he died.

Figure 1 – Possible position of victim

- Tractors should only be started when the operator is on the tractor platform sitting in the operator's seat.
- Employers should provide annual operator training to tractor operators.
- A farm safety plan should be established for the agricultural operation that includes work rules such as starting the tractor from a seated position on the operator's platform.

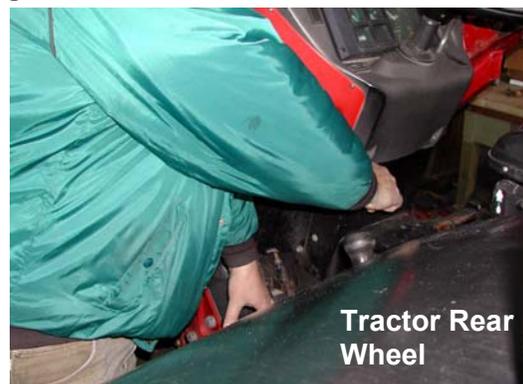
The victim placed the tractor on the apron and apparently thought he had placed the tractor in PARK. The operator did not set the brakes or chock the wheels. The tractor did not have a neutral start safety switch on the transmission that requires it to be in neutral to start the tractor or a safety switch attached to the operator seat that could shut off the tractor's function when the operator left the seat, therefore, the tractor could start when in gear and the clutch depressed. The tractor did have a safety switch on the clutch that required the clutch to be depressed to start the tractor.

While standing on the ground, the victim stood in front of one of the rear wheels, depressed the clutch, and turned the ignition key to the ON

Figure 2 – Possible position of victim

position (See Figure 2). The engine started, the tractor moved forward and knocked the victim to the ground. The rear wheel ran over the victim's pelvis. The tractor continued forward, going down a hill, crossing a street and was stopped by colliding with a truck in a valley below (See Figure 3).

- Tractors should only be started when the operator is on the tractor platform sitting in the operator's seat.

The operator's seat of farm tractors and machines provides a workstation from which the operator can maintain proper control of the machine. When a tractor engine is started in gear, it may move suddenly and run over anything in its path. Proper control is necessary not only during operation of a tractor or machine but also whenever an engine is started. While seated in the operator's seat an operator should check the engine throttle position, disengage the clutch and shift the transmission into neutral or park before the engine is started. Setting the brakes will prevent the tractor from rolling before the operator engages the transmission. Before starting a tractor engine, the operator should also ensure the power take off is disengaged. Performing these steps will reduce the likelihood of a tractor or machine accidentally moving forward or backward after the engine starts. In addition, if a tractor or machine does unexpectedly begin to move after starting, an operator seated in the seat will not be in danger of being run over and will be in position to maintain safe operating control.

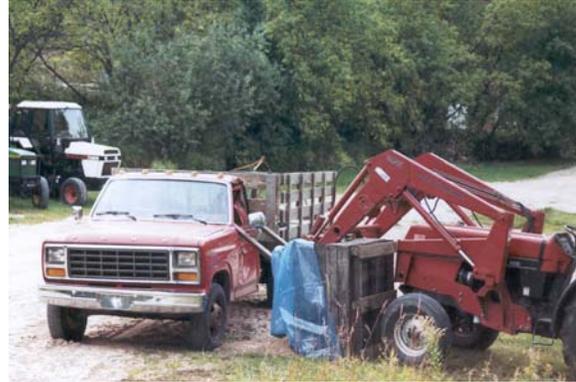
Figure 3 – Final resting spot of tractor
