# MIFACE INVESTIGATION: #02MI119

## SUBJECT: Inside Wireman Electrician Electrocuted Working on Exterior Light Pole

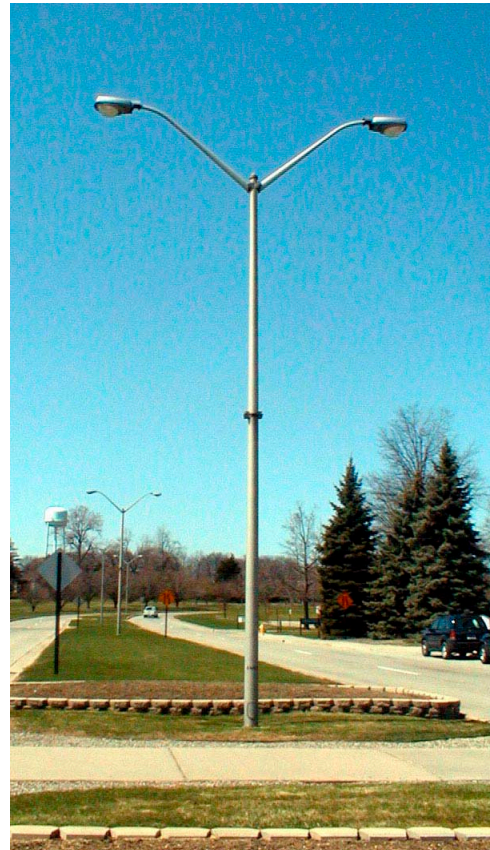
Figure 1 Light pole involved

On September 9, 2002 a 41 year-old journeyman electrician was electrocuted while he was working on an exterior light pole (Figure 1). He and his partner were replacing non-functioning lights on two-light light poles. One of the new lights installed did not work. His partner was at the top of the pole in an aerial work basket checking the ballast. The victim was kneeling on damp grass at the base of the light pole so he could open the handhole to inspect the wiring and fuses. He was not wearing or using any protective equipment. The wires were energized and carried 277 volts of electricity. Although exactly what occurred is not known, it is possible that the plastic cover over the fuse inside the pole was broken, and when he reached into the handhole to extract the wires, he made contact with the electricity. It is also possible that he extracted the wires from the handhole, and as he attempted to untwist the plastic cover over a fuse, it broke in his hands. However it happened, he made contact with the electricity. When his partner realized what had happened, he descended immediately and severed the victim's contact with a wooden board. Emergency medical care was given at the site. He was pronounced dead at the hospital.

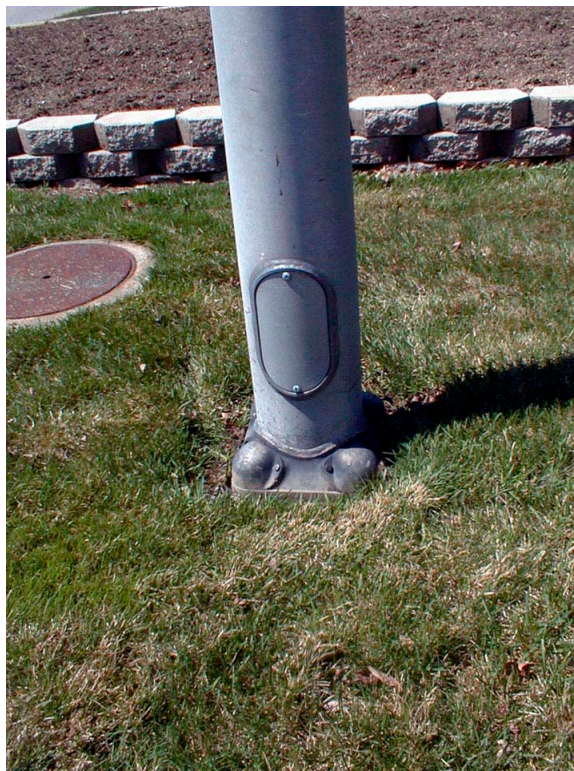
Figure 2. Handhole

The exterior lights at this facility were set low in the ground for aesthetic reasons, so the handhole was close to the ground (Diagram 1). The handhole was also small, making it difficult to see inside and access the wires and fuses (Figure 2). The author of this report has not been able to find any guidelines or standard practices that would govern the size of light pole handholes or their placement in the light pole relative to the ground. The victim was a large man, over 300 pounds and over 6 feet tall, which made it yet more difficult for him to access the handhole. He knelt on the damp grass to access the opening. He was not wearing or using any type of protective equipment such as non-conductive gloves or a non-conductive mat. There was no ground fault circuit interrupter (GFCI), because GFCI's such as would be found in a residential setting are seldom used in a commercial setting. The type of GFCI used in a commercial application would not have prevented the fatality. That type of GFCI would be installed to prevent equipment damage, not prevent injury.

It appears the fuse holder was damaged or had become brittle, so that it was either broken inside the light pole or broke in his hands as he tried to open it. Over time, plastic-based items lose their elasticity and become brittle, particularly those exposed to the elements. Injuries and fatalities are seldom if ever caused by one factor, but rather by the contribution of several factors. In this case, it is suspected that a faulty fuse holder contributed to the fatality.

Appropriate personal protective equipment should be readily available and its uses and limitations fully known and accepted by the workers. Workers should use it as appropriate. The worker used no personal protective equipment such as rubber gloves or a non-conducting mat. The proximity of the handhole to the ground exacerbated the hazards of the situation.

The workers had not locked out the electricity to the light pole on which they were working. They did not need the lines to be energized to check the fuses. The circuit was located approximately a block away. Workers who perform hazardous tasks can develop a cavalier attitude over time. The company's electrical permit and lockout procedures should be stressed and strictly enforced regardless of the voltages involved. Safety training should stress that all voltages are potentially lethal.

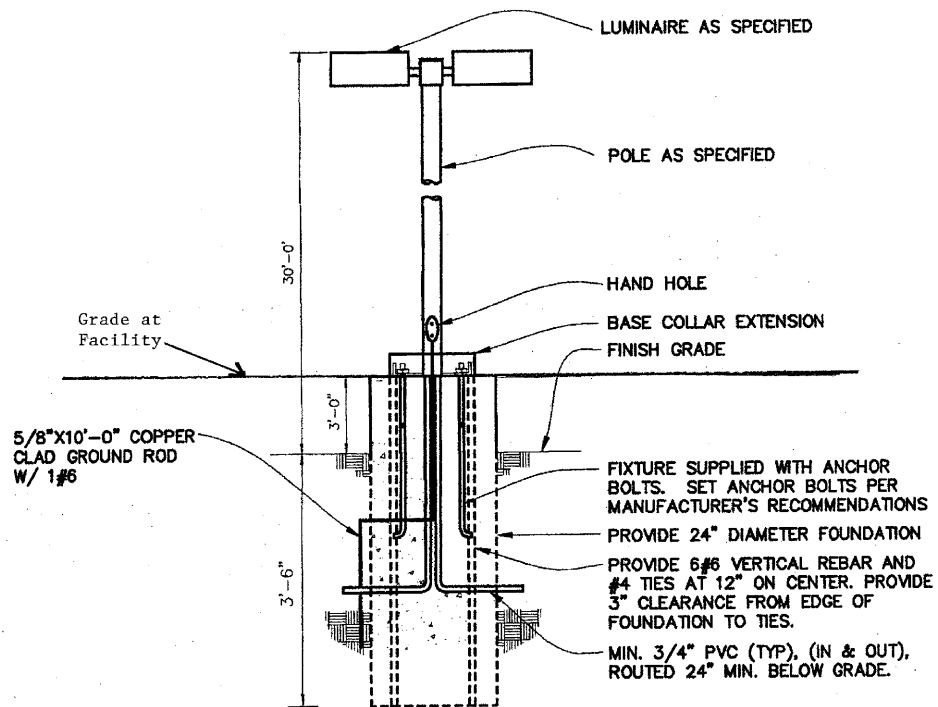
Diagram 1

**EXTERIOR POLE BASE DETAIL**  
NO SCALE
