MIFACE INVESTIGATION: #01MI056

SUBJECT: Grader Operator Run Over by Rear Tire While Jumpstarting Grader

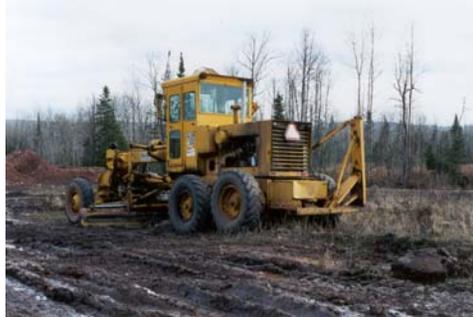
On July 30, 2001, a 63-year old male died from injuries sustained when he was run over by the rear wheel of a grader. A coworker driving a bulldozer was spreading gravel and the grader was following the bulldozer leveling the gravel. The grader stalled and would not restart. The bulldozer drove behind the grader, and pushed the grader to a location where the bulldozer could be used to jumpstart the grader. The victim attempted to jumpstart the grader with jumpstart cables but was unsuccessful because the grader was in 1st gear. The victim left the cab. He stood between the rear tires and used pliers

to jumpstart across the solenoid. When the engine started, the grader moved forward, running over the victim with the rear tire. The coworker shut down the grader after the blade struck a bank of dirt and stopped moving. The coworker ran to the highway and flagged down a car to call for emergency assistance. The motorist's cell phone could not get a signal. While the coworker was using the motorist's cell phone, another company employee arrived with a load of gravel. The truck driver drove to another area on the road, contacted the office. The office called for an ambulance service (911 emergency service is not available). The ambulance personnel arrived 15 minutes after being notified of the incident. The victim was declared dead at the scene.

- Employers should discourage jumpstarting equipment; if absolutely necessary, jumpstarting a piece of equipment should be allowed only from the battery while the operator is in the equipment cab.
- Company policy should prohibit use of equipment if not in proper working order, remove from service all equipment in need of repair until repairs are made, strictly enforce employee reporting of defective equipment.
- Equipment owners should ensure that an owner and/or operator manual is available on the equipment and for use in service/maintenance procedures.
- Employers must ensure that a person with a valid certificate in first aid training is present at the worksite to provide first aid.
- Company management should consider developing a joint health and safety committee.
- Employers should provide all field personnel a means for emergency communication in case of injury.

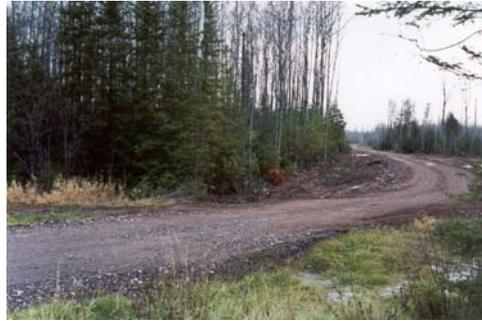
The company had purchased land and was putting in a road back to an area where there was future home construction. The road construction operation had been going on for approximately 3 months. The road was dirt covered, and the two employees working at the site were laying gravel/rock on the road surface. A dump truck had previously delivered a load of gravel. The bulldozer was distributing the gravel, and the grader was leveling the gravel on the road. It had been raining that morning. The ground was muddy.

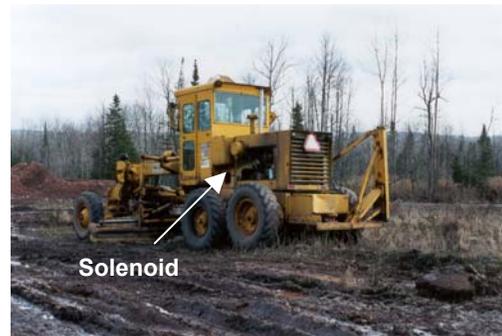
The victim usually used this grader when he performed work at the company. The grader was at a different location in the morning of the incident. The grader was jumpstarted in the morning with a pickup truck, and driven on the road by the victim to the incident location. While spreading the gravel behind the bulldozer, the grader stalled. The victim exited the grader cab. The grader location would not allow the bulldozer to get close enough to use the bulldozer battery to jumpstart the grader. The bulldozer drove around to the back of the grader, and pushed the grader forward to place it in a position to be jumpstarted by the bulldozer. The grader operator retrieved jumper cables from his truck while the dozer operator came along side next to the grader, approximately 5 feet away. The grader was facing west, the bulldozer operator was facing east.

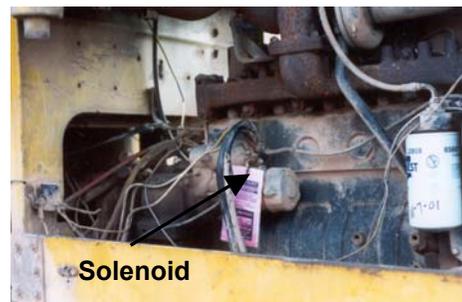
The victim placed the jumpers on the bulldozer battery and the positive jumper lead on the grader solenoid, and the negative on the grader frame. The victim did not use the battery to jumpstart the grader; he hooked directly to the solenoid. The solenoid regulates the power from the battery to the starter. This was the first time the dozer operator saw the victim jumpstart directly from the solenoid. The victim climbed inside the grader cab and attempted to start the grader. With the bulldozer running, it was probable he could not hear if the engine was turning over.

The victim apparently did not notice that the grader was in gear when he exited the cab to attempt a jumpstart from the ground. Standing in an unsafe position between the rear tires, the victim used pliers to jumpstart the grader. He placed the pliers across the positive terminal and the starter switch terminal on the starter solenoid. Jumpstarting across the solenoid eliminates the safety switch capabilities. Because the grader was unintentionally in gear, when the engine started, it began to move forward. The victim was unable to get out of the way of the back rear tire, and he was knocked to the ground by the rear tire and run over.

The company does not discourage jumpstarting equipment, only that an operator must be in the cab during the procedure. MIFACE recommends that the company discourage jumpstarting a machine. If the machine requires a jumpstart, it is likely that the machine is in need of service, and should be taken out of service and returned to the shop. MIFACE also recommends jumpstarting should be authorized only when necessary to return the machine to the shop, and only the equipment battery should be used to jumpstart the machine.

The company tagged the equipment with a safety alert warning tag which alerts the employee to the dangers of jumpstarting at the starter and starting the equipment while standing on the ground. The tag recommends keeping the starting system in repair, and keeping the starter solenoid cover in place. The company had not placed a solenoid cover on the solenoid. Jumpstarting from the solenoid bypasses all safety switches; the equipment battery should be used to perform the jumpstart.

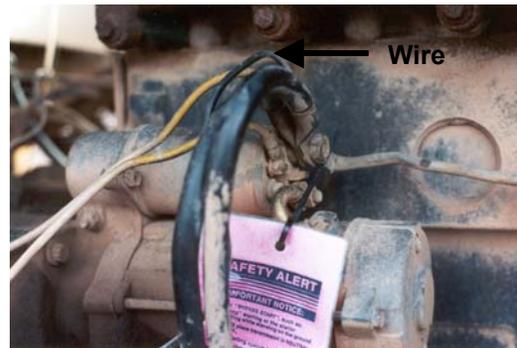
Figure 2

The job was finished the next day using a bulldozer to spread the gravel. When the grader was removed from the location, the grader required several jumpstarts while being loaded on a trailer for transport back to the company office. The grader operator who removed the grader from the incident site determined the cause of the repeated stalling of the grader. He noticed that when the grader fan was blowing, it would pick up the wire (Figure 2) that feeds power from the battery to the ignition inside the operator cab. This lost wire connection from the solenoid caused the grader to stall, and made it appear that there was a dead battery.
