MIFACE INVESTIGATION: #01MI015

SUBJECT: Farmer Pinned Beneath Tractor Overturned To the Rear

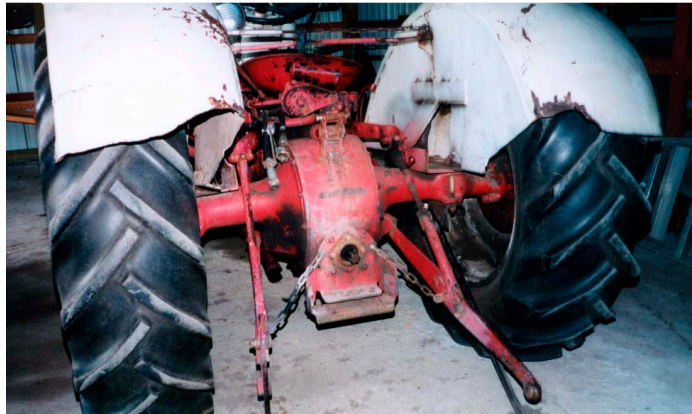
On February 11, 2001, a 40- year old part-time male farmer was killed when his 1950 agricultural tractor overturned to the rear while attempting to free a stuck pickup truck from a frozen, muddy field. The victim and a helper were working together to free the truck. The victim attached a log chain from the rear bumper of the pickup truck to the top link connection of the tractor's three-point hitch. The helper started the truck and placed the truck in reverse gear, ready to assist the victim, who was using the tractor. While attempting to pull the truck out of the mud, the front of the tractor bounced up and down several times, then upset to the rear, landing on the victim. Unable to assist, the driver of the truck ran to the victim's house, and called 911. The Fire Department responded, and determining that the victim had no vital signs, contacted the medical examiner. The medical examiner pronounced the victim dead at the scene.

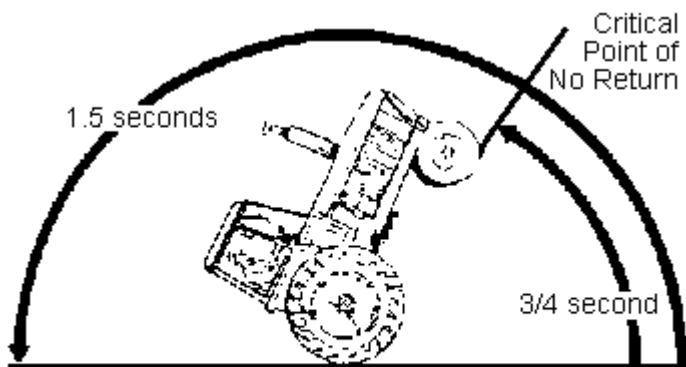
For a tractor to stay upright, its center of gravity must stay within the tractor's stability baseline (an imaginary line drawn between points where the tractor tires contact the ground). A tractor's center of gravity is a point where all parts balance one another. The center of gravity is located closer to the rear axle than the front axle. Normally, a tractor's center of gravity is located about 2 feet in front of and 10 inches above the rear axle resulting in approximately 30% of the tractor weight on the front axle and 70% of the weight on the rear axle. A tractor's center of gravity does not move – but its relationship to the stability baseline can change. If the distance between the center of gravity and the stability baseline is reduced, then the potential for an overturn (either side or rear) is increased.

Rescue time in a rear turnover is 3/4 of a second. You can't always stop it in time.

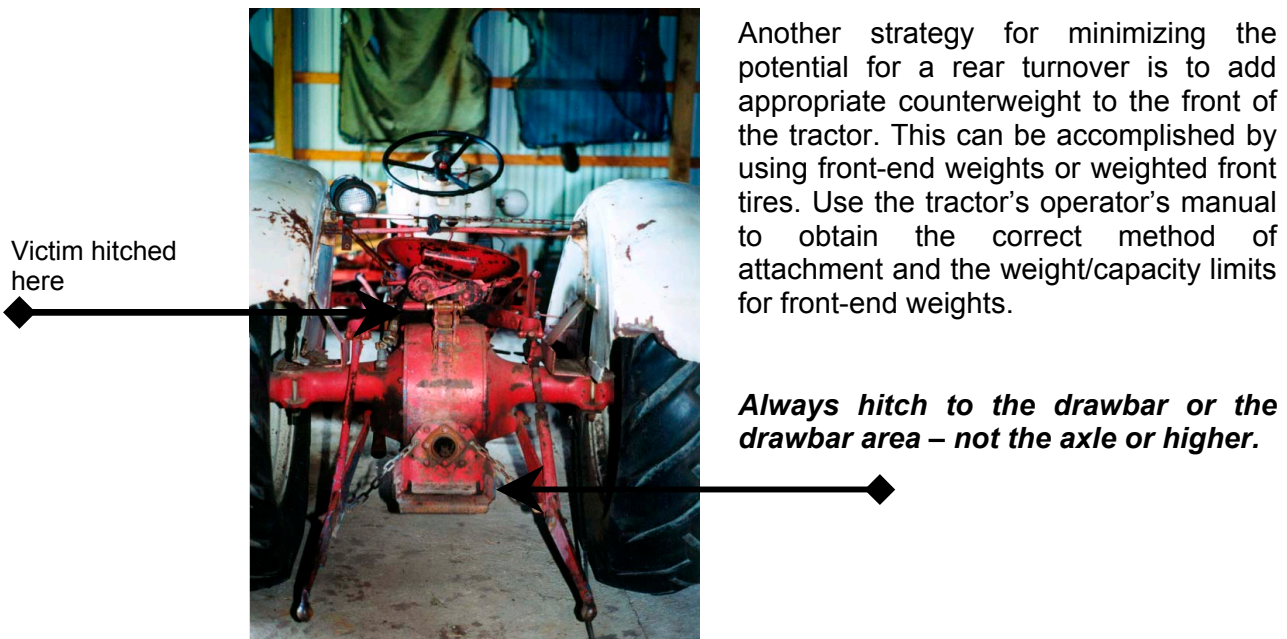
When a load is hitched to the drawbar, if the front end of the tractor lifts, the rear drawbar will lower. As the drawbar lowers, the angle of pull and the leverage the load has to tip the tractor rearward is lowered. This action prevents the tractor's center of gravity from passing the rear stability baseline.

When a load is hitched high on the tractor or attached directly to the rear axle, less power is required to lift the front end of the tractor than to move the load or slip the wheels, which may result in a overturn through rearward rotation. Hitching a load to the rear axle of the tractor may also be a factor in a tractor rear overturn. The angle of pull and leverage do not reduce as the front end raises because the location of the hitch point (rear axle) stays constant throughout the rearward tip.
