# NJ FACE INVESTIGATION REPORT

FACE 03-NJ-100

## **DPW Employee Dies After Falling Off The Trailer Hitch of a Leaf Vacuum**

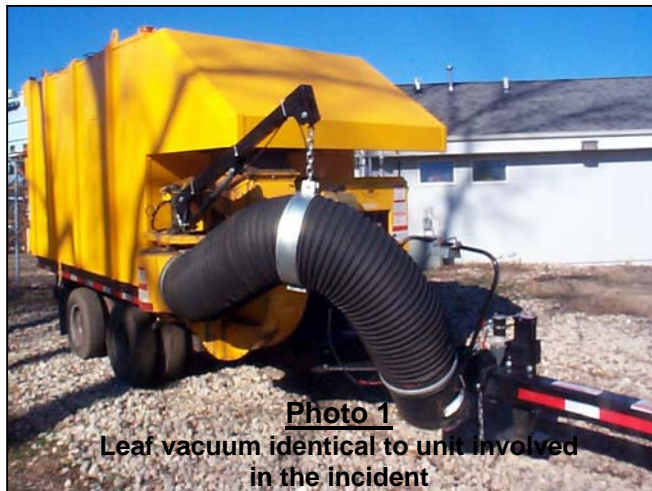
The leaf vacuums were large, trailer-mounted machines that were towed by a township dump

truck. The vacuum consisted of a large, box-like metal container to hold the leaves, a diesel engine attached to a vacuum impeller (rotor blade that creates the vacuum), and a large rubber hose used to vacuum the leaves. The model involved in the incident was rated to hold 14 cubic yards of leaves and had listed dimensions of 9.9 feet high, 8.4 feet wide, and 15.8 feet long. An 85-

horsepower, water-cooled, diesel engine drove a six-blade, 32-inch diameter impeller that moved 22,000 cubic feet of air per minute. A 16-inch-diameter, 8.3-foot-long reinforced rubber suction hose was mounted on a swinging boom, which supported the weight of the hose to make it easier for the operator to position. The trailer was hitched to the tow vehicle with an approximately 8-foot-long towing hitch (tounge). A hydraulic lift at the base of the machine tipped the container backward for dumping.

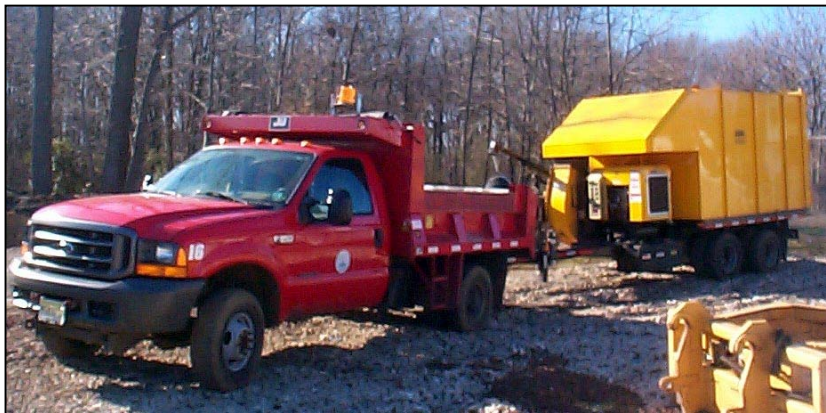
**Photo 2**  
Identical leaf vacuum and pickup truck

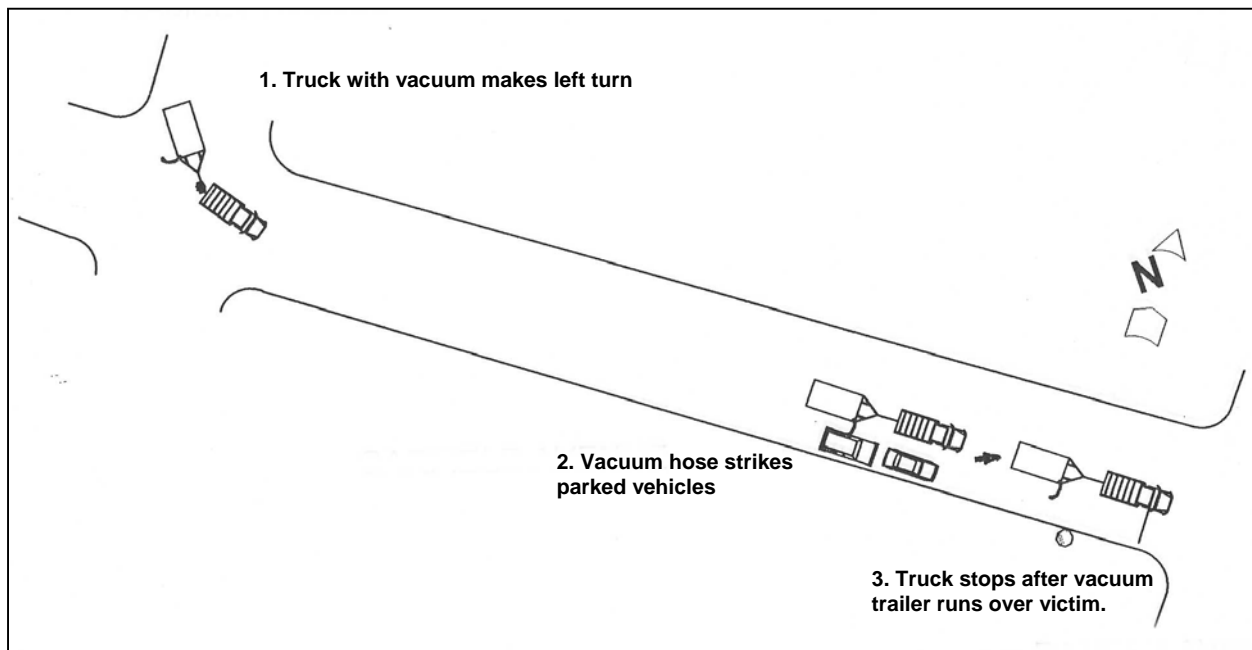
work, filling about one quarter of the vacuum with leaves. At approximately 2:20 p.m., the crew had just picked up a pile of leaves when the driver noticed another pile on a nearby street. The victim, who weighed 242 pounds, was riding on the trailer hitch and holding the vacuum hose, which was not secured to the truck. A small piece of diamond-plate steel had been welded to the trailer hitch, providing a seat for a worker to sit on when traveling between piles of leaves. The driver needed to make several turns to get to the next pile of leaves, and made a left turn down a road with cars parked alongside the curb. As he drove past the parked cars, the vacuum hose swung away from the machine and struck the cars. The driver reported feeling a vibration in the truck, stopped, and got out. He found the victim lying on the street, behind the trailer that had run him over.

**Diagram 1**  
**Police graphic illustration of incident**  
**(descriptive comments added)**

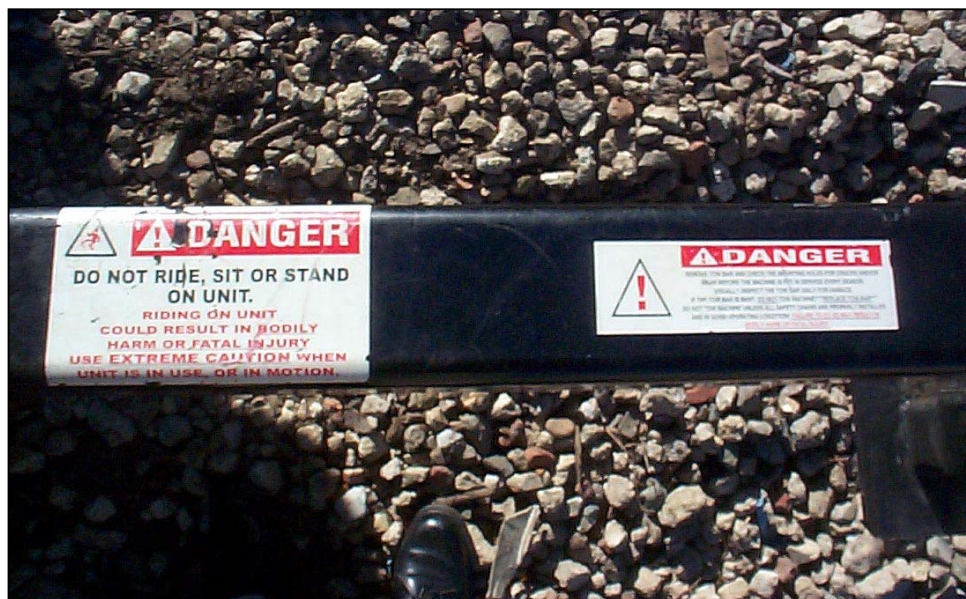
- The driver involved in the incident was driving with an expired license. (Police)
- The leaf vacuum was not registered with the NJ Department of Motor Vehicles. (Police)
- The leaf vacuum trailer had a number of maintenance defects, including inoperative brakes, an inoperative trailer break-away device (which activates the brakes if the trailer detaches), under-inflated and flat tires, and burned-out signal lights. (Police)
- An unauthorized retrofit was made by welding a piece of steel diamond-plate onto the trailer hitch as a seat. A manufacturer's warning label stating not to ride on the tongue had been removed. (NJDLWD)

**Photo 3**  
Warning labels on identical trailer

**Recommendation #3: Employers and employees should not modify machines unless a qualified engineer and/or machine manufacturer reviews and certifies the safety of the modification.**

**Discussion:** The leaf vacuum in this incident was improperly modified by welding a piece of steel diamond-plate to the trailer tongue, providing a seat for the operator. Following their investigation of this incident, the NJDLWD Office of Public Employees Safety conducted a survey of all the municipal DPWs in New Jersey State. They found 83 instances of missing warning labels, issued 36 citations for lack of training, and found two similar modifications to other leaf vacuums. This indicates a widespread hazard. The NJDLWD ordered these problems corrected. NJ FACE strongly recommends against modifying any machine without first consulting with a qualified engineer and the machine's manufacturer. This will help prevent damage, injury, legal liability, and death from improper or poorly designed modifications.

Leaf vacuum and trailer: The report stated that the trailer that the victim fell from was improperly equipped with a diamond-plate “seat” and was lacking the required warning stickers. This was incorrect. The trailer that the victim was riding on was not equipped with a seat and did have the required warning stickers. The DPW’s second leaf vacuum and trailer had these modifications. This error was due to confusion in reading the serial numbers that identified the two units.
