# NIOSH HEALTH HAZARD EVALUATION REPORT

**HETA 94-0300-2528**  
**Cape May County Board of Taxation**  
**Cape May Court House, New Jersey**

**Health Hazard Evaluation Report 94-0300-2528**  
**Cape May County Board of Taxation**  
**Cape May County House, New Jersey**  
**September 1995**

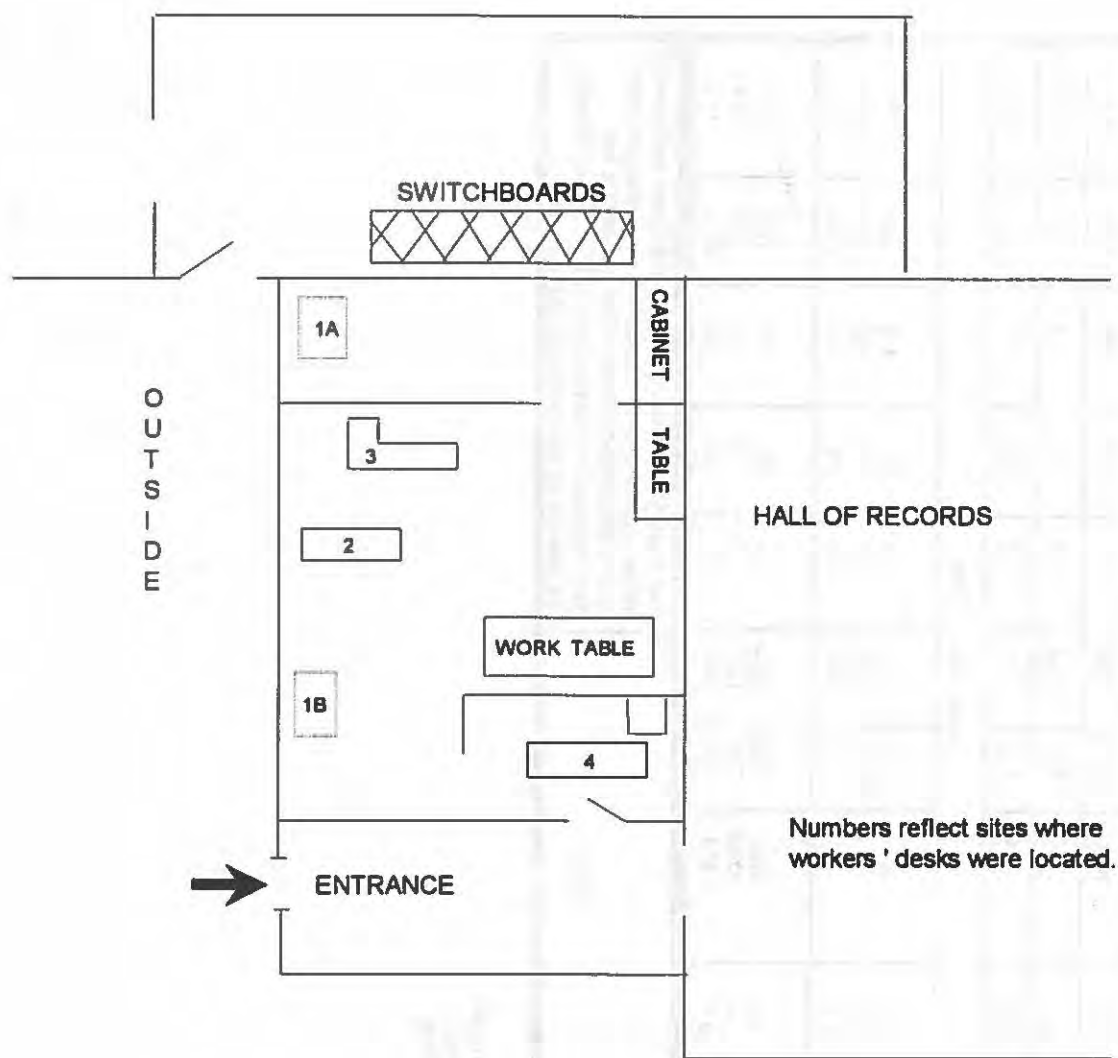
Figure 1 is a schematic diagram of the one-story CMCBT building that shows the location of the electrical switching units, Tax Office, and Hall of Records. On the days of measurement, the Tax Office, built in 1986, had four employees. The Tax Office consisted of three sections, a front area used to greet visitors, a middle area used for records review, and a back area which contained a conference/work room. Immediately behind the back rear wall of the Tax Office was the utility room that contained four General Electric AV-LINE™ Switchboards located approximately one meter from the north wall in a line parallel to the back wall. These switchboards had been installed in early 1993 and were considered by Tax Office workers to be the source of the ELF fields of concern.

Figure 1. Schematic diagram of areas in CMCBT building where measurements were taken.

In this evaluation, one possible technique to control the higher magnetic field levels in the back area, assuming movement of the switchboards to a distance further from the back wall is not possible, would be to designate the back area as storage.
