# NIOSH HEALTH HAZARD EVALUATION REPORT

**HETA 95-0273-2525**  
**Advanced Occupational Health Services, Inc.**  
**Elizabethtown, Kentucky**

**Health Hazard Evaluation Report 95-0273-2525  
Advanced Occupational Health Services, Inc.  
Elizabethtown, Kentucky  
August 1995**

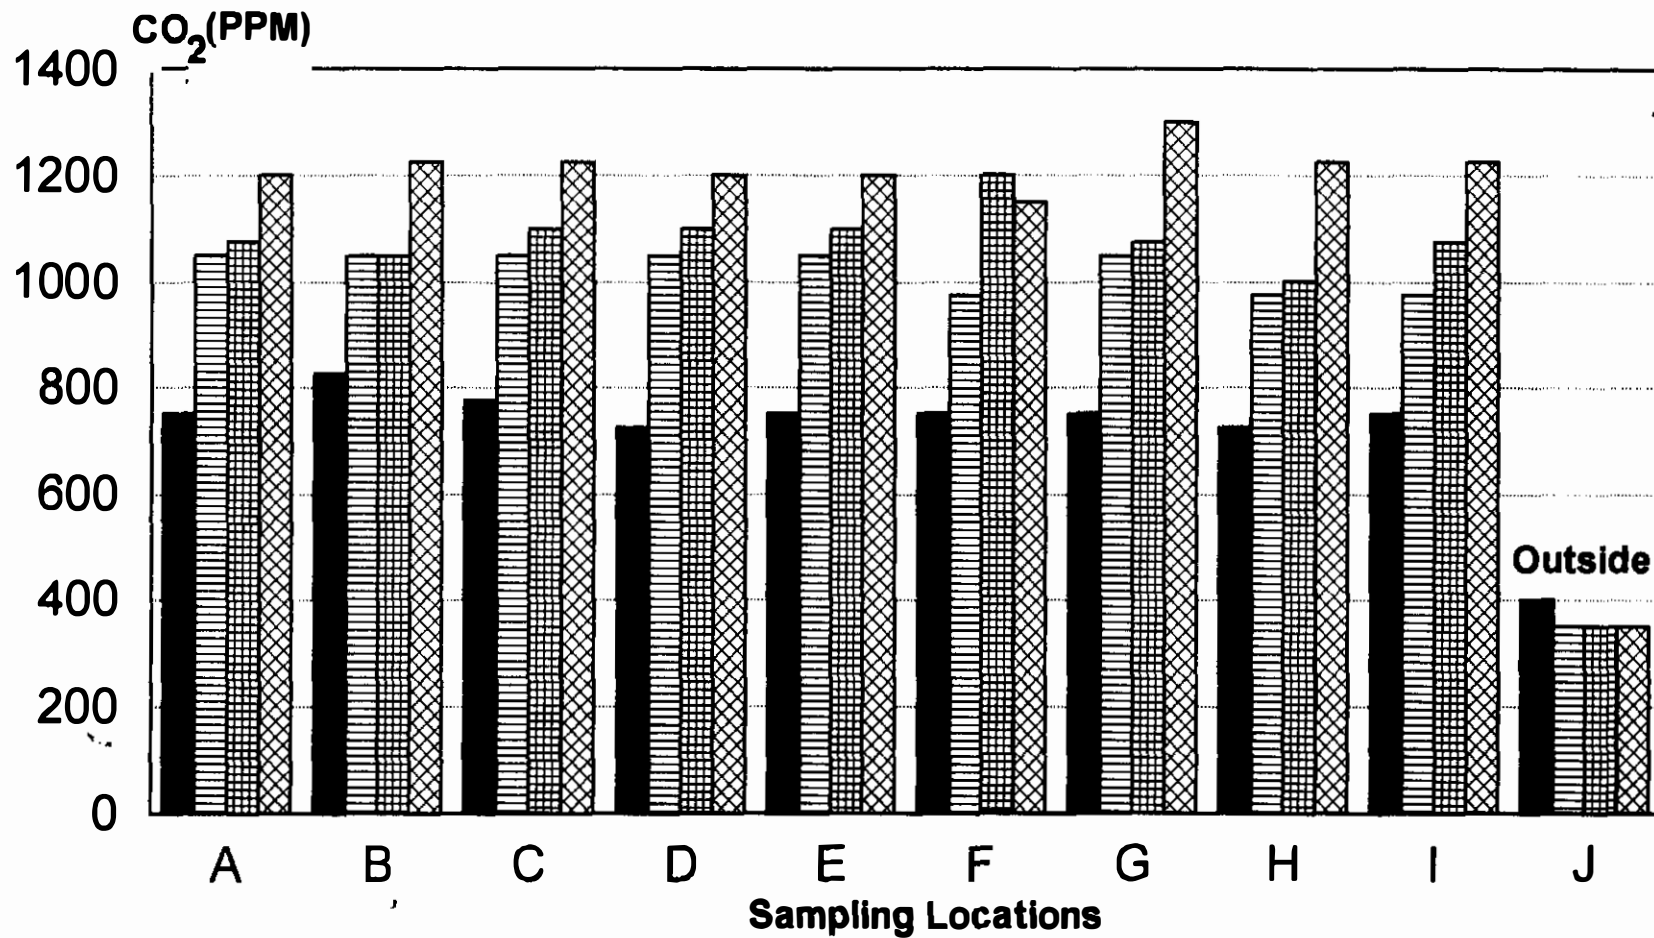
**Figure 2**  
**Carbon Dioxide Concentrations**  
**Advanced Occupational Health Services**  
**Leitchfield, KY (HETA 95-0273)**  
**Sampling Date: June 15, 1995**

As shown in Figure 2, CO<sub>2</sub> levels on June 15, 1995, gradually increased during the work day and generally exceeded 1,000 ppm throughout the facility. These CO<sub>2</sub> levels suggest that the AOHS office may not be receiving adequate amounts of outside air.

The CO<sub>2</sub> concentrations measured in the AOHS office areas were remarkably high considering that it is a sparsely populated work area (less than seven employees per 1000 ft<sup>2</sup>). More surprising were the higher-than-expected CO<sub>2</sub> concentrations at the beginning of the work day (7:40 to 7:50 a.m.), which averaged approximately 750 ppm. With the office empty overnight, combined with a very low occupant density, CO<sub>2</sub> concentrations would have been expected to be slightly above ambient concentrations.

These unusually high CO<sub>2</sub> concentrations suggest that little outside air is being introduced into the AOHS office areas by the ventilation system. The ventilation design plans for this office did not indicate whether outside air was being introduced into the building by the ventilation system.

3. Based on the unexpectedly high CO<sub>2</sub> concentrations (considering the low occupant density), the amount of outside air provided by the HVAC system should be measured. Based on these elevated CO<sub>2</sub> concentrations, it appears unlikely that the ventilation system supplying the Leitchfield was operating in accordance with ASHRAE's most recently published ventilation standard, 62-1989, Ventilation for Acceptable Indoor Air Quality on the day of this evaluation. A supply rate of 20 CFM OA/person for office spaces is recommended.
