# Evaluation of Mercury and Noise Exposure at a Lightbulb Recycler

HHE Report No. 2023-0015-3402

September 2024

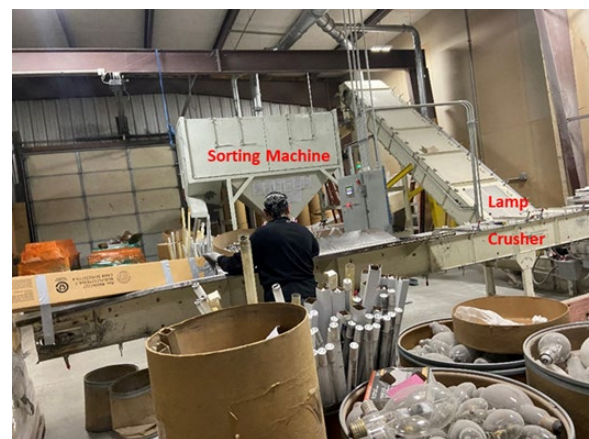
The four temporary employees in the lamp room processed mercury-containing lightbulbs. Temporary workers wore personal clothing into the lamp room as they were not issued uniforms. Employees donned tight-fitting half-mask elastomeric respirators with mercury-vapor cartridges, safety glasses, cut-resistant gloves, ear plugs, steel-toed boots, long pants, and a long-sleeve uniform shirt prior to entering the room. The employees removed the light bulbs from external packaging and ensured that all the bulbs were separated from each other. The bulbs were placed on a conveyor belt that carried them to the “lamp crusher” at the bottom of an inclined conveyor (Figure A1).

Figure A1. Lamp room conveyor, lamp crusher, and sorting machine. Photo by NIOSH.

- Install local exhaust ventilation over the conveyer in the lamp room to reduce employee exposures to mercury vapors.
- Repair the lamp room heating, ventilation, and air-conditioning (HVAC) system to improve air circulation. Also keep the lamp room temperature cool. This can help reduce mercury exposures.
- Consult with a ventilation engineer to evaluate exhaust ventilation at the retort machine and install local exhaust ventilation at the lamp room conveyer.

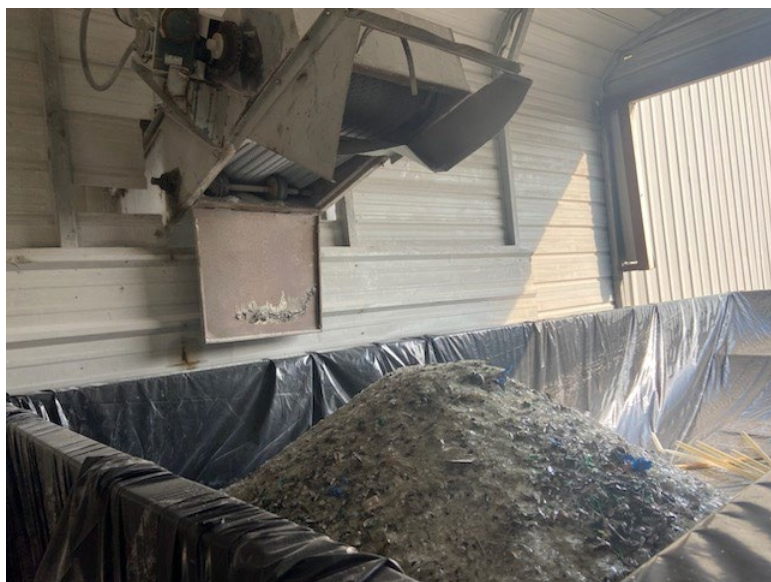
Figure A2. Dumpster filled with broken glass from the lamp room sorter. Photo by NIOSH.

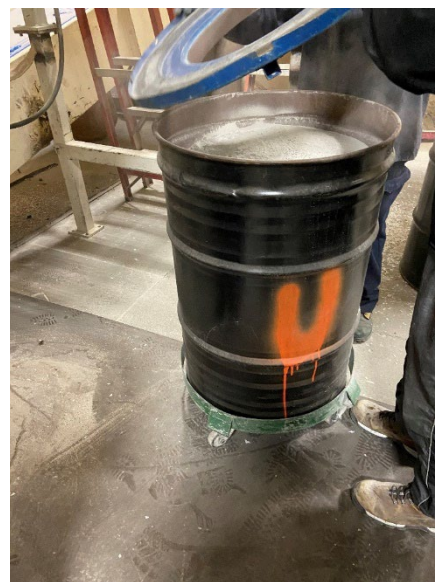
Employees broke the larger bulbs by cracking them against the sides of the conveyor. The inclined conveyor transported the broken bulbs up to a sorting machine that separated the components into metallic parts, mercury-containing dust, and glass. The broken glass was transported via conveyor to a dumpster outside of the facility for subsequent transport to an off-site landfill (Figure A2). Metallic components were separated into a box for shipping off-site to be processed. The mercury-containing dust was collected in a 55-gallon drum to be processed in the retort (Figure A3).

Figure A3. A 55-gallon drum of mercury-containing dust and very fine glass. Photo by NIOSH.

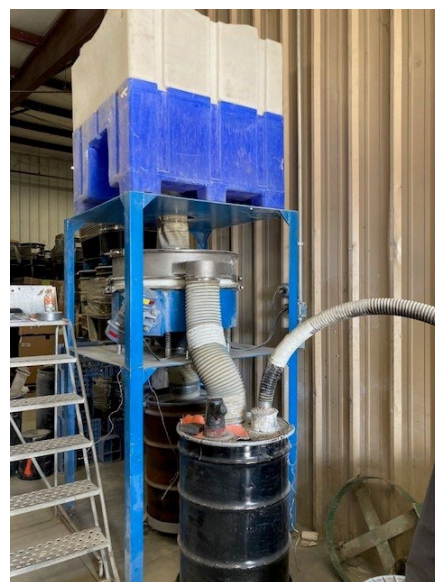
Figure A4. Shaker is designed to separate mercury-containing dusts from fine glass. Photo by NIOSH.

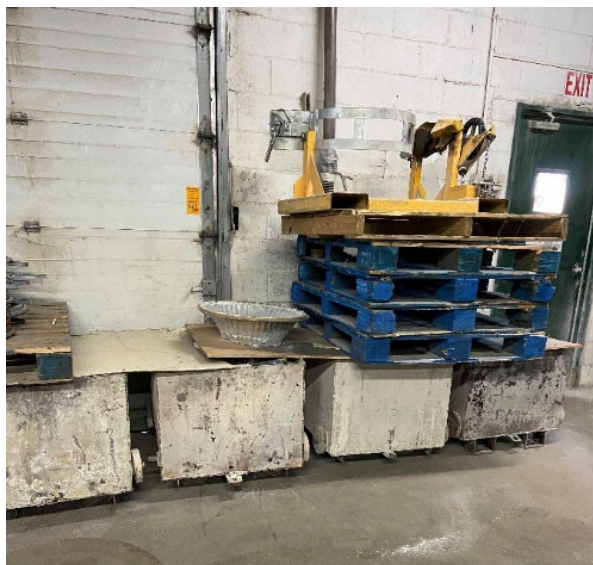
Although we were unable to observe the retort in operation, the process was described to us. The retort employee placed a metal tray full of mercury-containing dust (Figure A5) into the retort (Figure A6). The retort furnace heated the dust creating mercury vapor inside of the furnace, which was then rapidly cooled to condense the mercury vapor into liquid mercury. At the end of the 48-hour cycle, retort employees drained the liquid mercury (Figure A7) and removed the now mercury-free dust from the retort for disposal. The retort employees also disassembled mercury-containing devices and bulbs in the disassembly area (Figure A8).

Figure A5. Metal totes containing mercury dust. Photo by NIOSH.

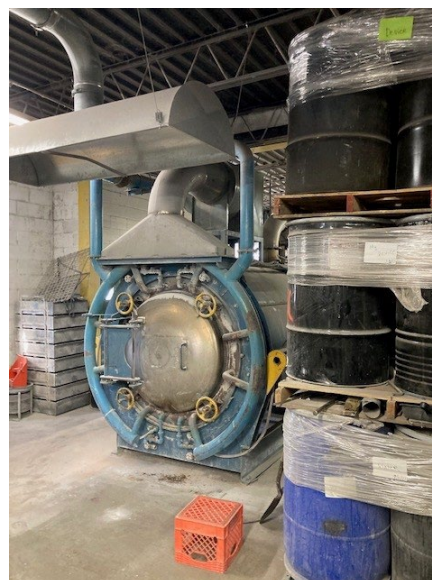
Figure A6. Front of the retort where metal trays containing mercury dust are placed. Photo by NIOSH.

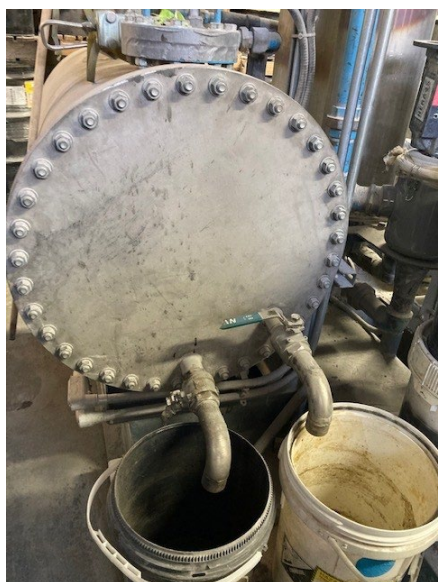
Figure A7. End of the retort where liquid mercury exits through ports into two buckets. Photo by NIOSH.

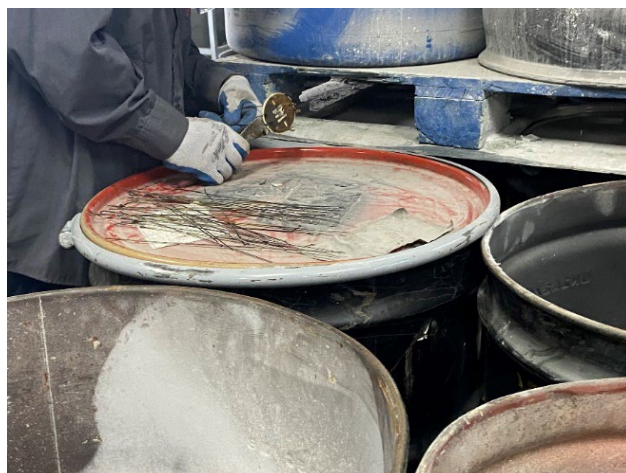
Figure A8. Removing the metal housing for mercury-containing lightbulbs in the disassembly area. Photo by NIOSH.

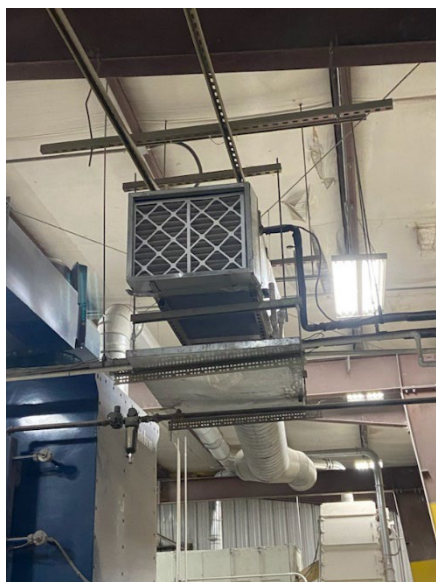
Inside the lamp room were two broken ceiling mounted air-conditioning units that had not been repaired at the time of the site visit. The supply air intakes passed through two pleated filters with a minimum efficiency reporting value (MERV) of 8 (Figure B2). These filters were changed every 2 weeks when in operation. After passing through the cooling unit, the air was supplied above the lamp crusher and the feeding conveyor, near where employees placed the bulbs onto the conveyor. The intent of these air-conditioning units was to reduce the temperature in the lamp room to reduce the rate of mercury vapor volatilization.

Figure B2. Air intake through a pleated filter, air-conditioner, and supply ductwork for one of the two air conditioning units in the lamp room. Photo by NIOSH.

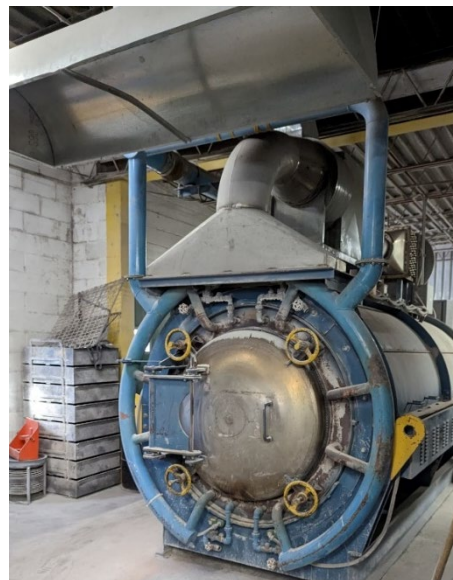
Figure B5. Two overhead exhaust hoods over the cylindrical retort furnace. Photo by NIOSH.
