# Evaluation of indoor environmental quality with limited surface sampling for metals at an office building

Report No. 2018-0046-3346  
March 2019

U.S. Department of Health and Human Services  
Centers for Disease Control and Prevention  
National Institute for Occupational Safety and Health

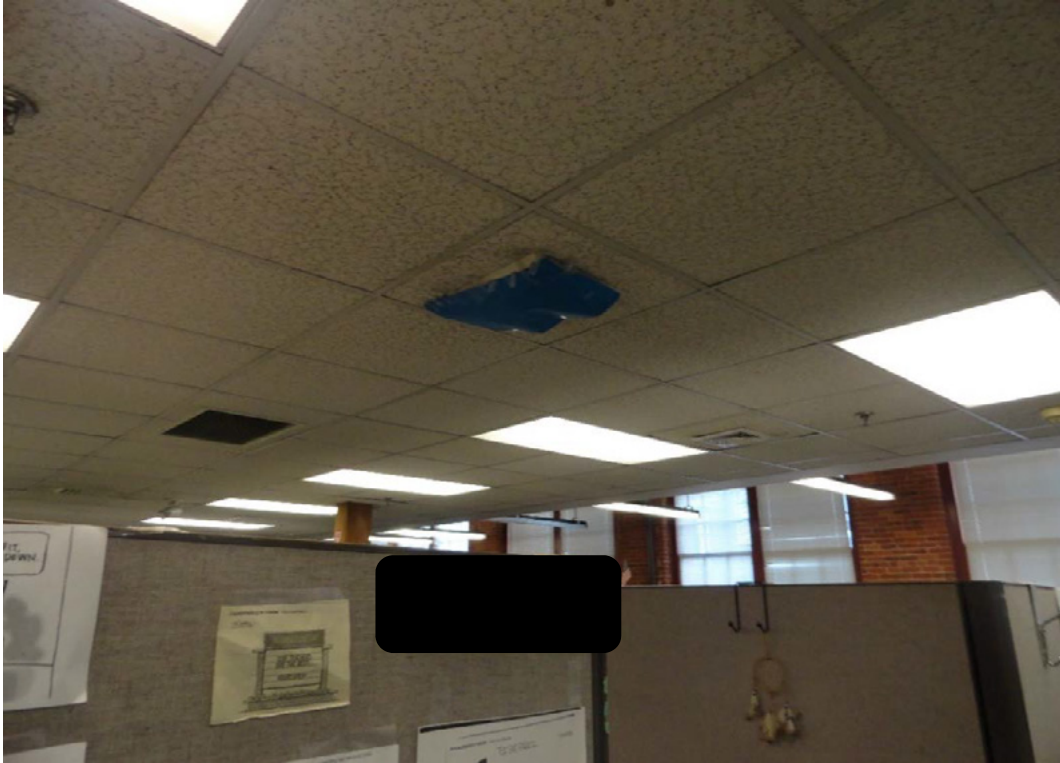
Figure B1. Vent blocked in personal workspace at office building on June 1, 2018. Photo by NIOSH.

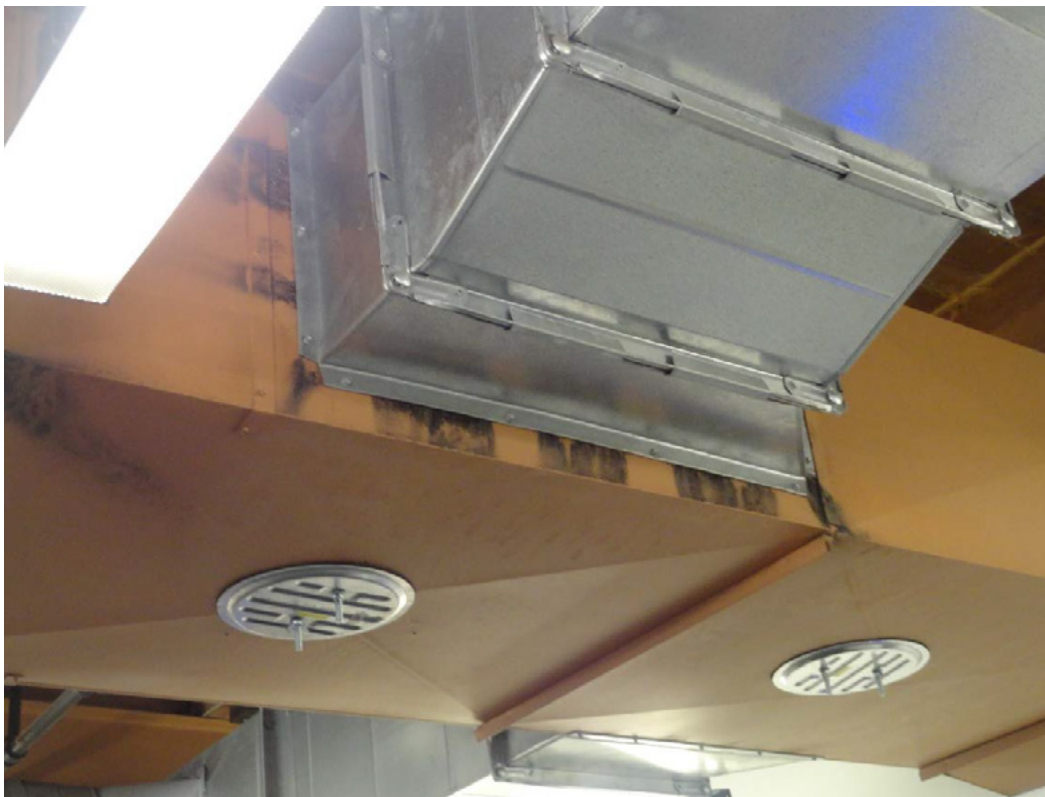
Our walkthrough indicated the HVAC was improperly functioning based on blocked vents and the presence of the black particulates at most seams and vents throughout the building. Retrofitting the industrial building to an office building and having irregular occupancy density likely contributes substantially to the unbalanced HVAC system. Poor ventilation in buildings is a common problem and is frequently caused by lack of proper attention to the building’s HVAC system. HVAC systems include all of the equipment used to ventilate, heat, and cool the building; to move the air around the building (ductwork); and to filter and clean the air. These systems can have a significant impact on how pollutants are distributed in and removed from spaces. They can even act as sources of pollutants in some cases, such as when ventilation air filters become contaminated with dirt and/or moisture, when microbial growth results from stagnant water in drain pans, or from uncontrolled moisture inside of air ducts.

Figure B2. Example of black dust from heating, ventilation, and air-conditioning system at office building on June 1, 2018. Photo by NIOSH.

3. Follow the manufacturer's recommended maintenance schedules for the HVAC system, including replacing air filters, checking drip pans, ensuring thermostats are in working order, and checking and cleaning ventilation system dampers to ensure proper functioning.

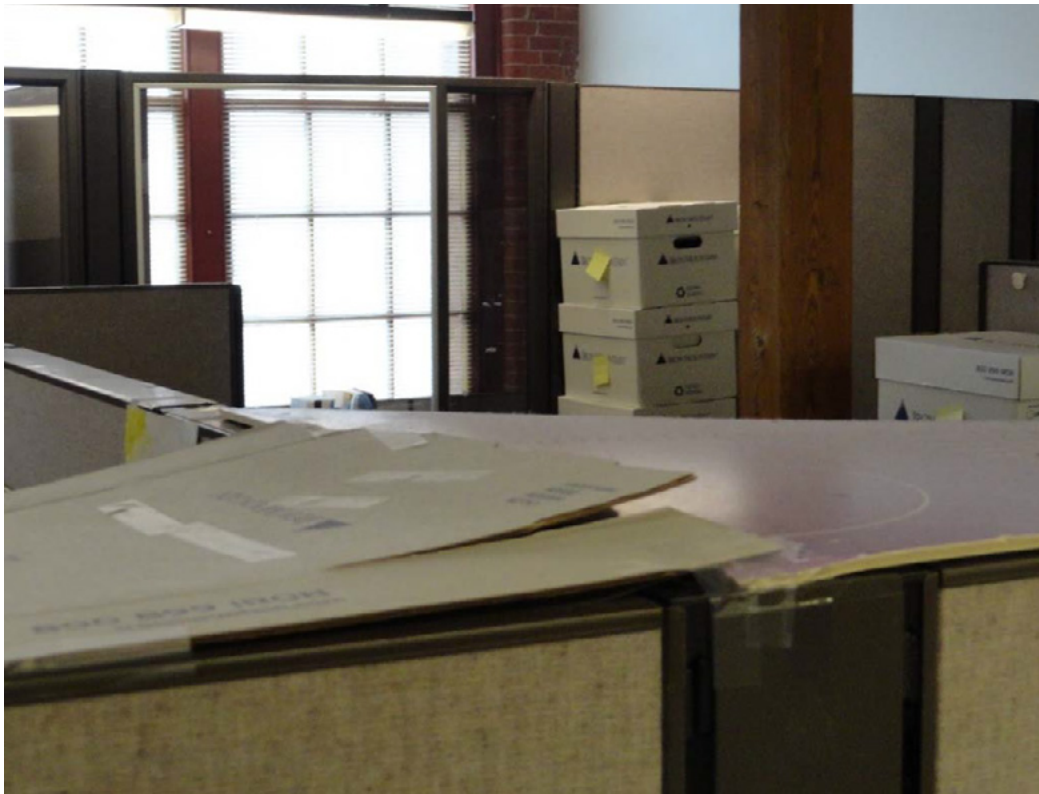
Figure B3. Personal workspaces partially covered with poster board to block dust from heating, ventilation, and air-conditioning system at an office building on June 1, 2018. Photo by NIOSH.

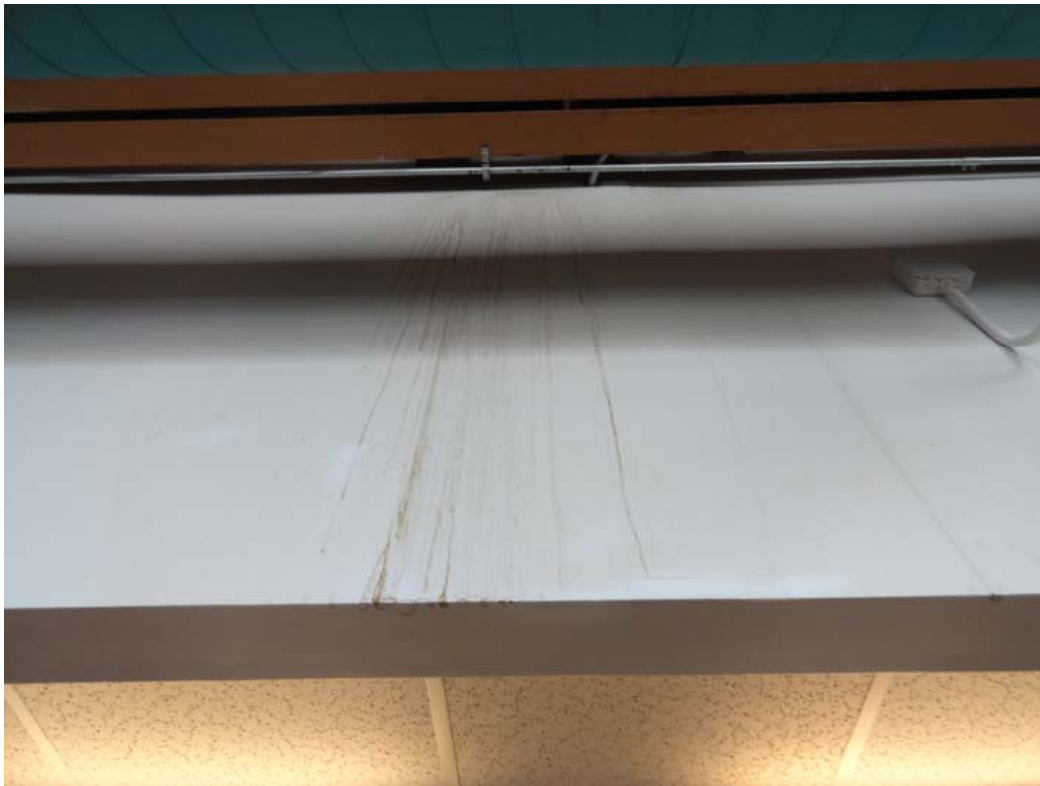
We saw evidence of recent water damage during the walkthrough. We also observed potential sources of water in individual workspaces such as fish tanks. Research has found that damp building conditions can lead to respiratory illnesses in occupants. Dampness in buildings can occur for a variety of reasons such as high indoor humidity, condensation, and roof leaks. Damp building conditions promote the growth of mold, bacteria, and other microbial agents, as well as dust mites and cockroaches. Dampness can also contribute to the breakdown of building materials and furniture. Musty odors are a sign of microbial contamination. Building occupants in damp buildings can be exposed to pollutants in the air from biological contaminants and the breakdown of building materials.

Figure B4. Evidence of recent water damage at an office building on June 1, 2018. Photo by NIOSH.

4. Maintain indoor temperature and relative humidity levels according to the guidelines discussed.
5. Routinely inspect the building for water intrusion and damage and correct these upon discovery. During and after heavy rains, walk through the building and check for water incursion.

- a. Identify any potential sources of dampness or mold through visual inspection and make proper repairs to prevent further problems from occurring.
