Evaluation of Indoor Environmental Quality and Health Concerns in a Commercial Office Building Near a Helipad

HHE Report No. 2015-0037-3283
June 2017

U.S. Department of Health and Human Services
Centers for Disease Control and Prevention
National Institute for Occupational Safety and Health

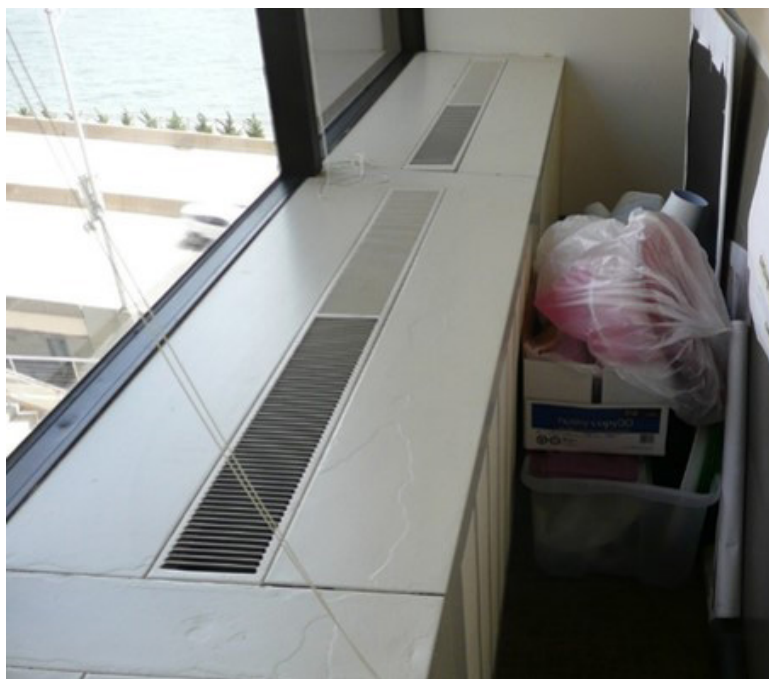
Floors 4 through 9 contained fan-coil units located around much of the perimeter of the occupied space. We saw many locations where the airflow into or out of these units was partially or completely blocked by furniture, equipment, boxes, and other objects (Figure 1). Blocking air intakes and supply vents prevented the ventilation system from working as designed. We also saw laser printers near the peripheral fan-coil units. Particulates generated by the printers could easily be pulled into the air intakes of the fan-coil units and then be redistributed throughout the space (Figure 2). We inspected the metal-mesh filters in several of the fan coil units. These filters appeared to be in good condition; however, these low efficiency air filters were not designed to remove small particulates.

Figure 1. Office supplies and boxes blocking the air intake of a peripheral fan-coil unit. Photo by NIOSH.

1. Contact an HVAC firm with experience in large HVAC system test and balance to:
 - a. complete a testing and balancing of the ventilation system that serves the employer spaces,
 - b. verify that sufficient outdoor air is supplied in accordance with ASHRAE 62.1-2016, and
 - c. verify that ASHRAE 55-2013 thermal comfort guidelines are met.
2. Stop using charcoal filters in this building's AHU because they are not likely to be effective in removing the odors. If, however, a decision is made to keep the charcoal filters, install them behind the particulate air filters and replace them according to the manufacturer's schedule.
3. Move the laser printers and other objects so that they do not block peripheral fan-coil units. Unblocking the units will help ensure that those ventilation systems are working as designed.

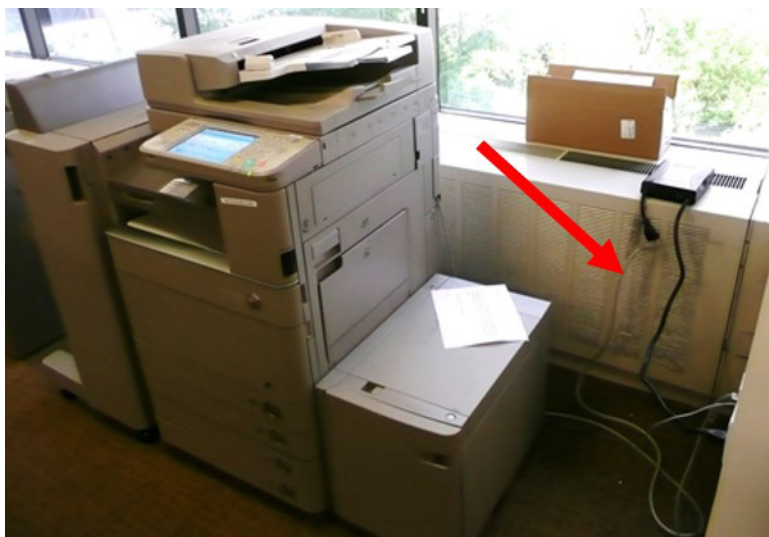
Figure 2. A laser printer located next to the air intake of the nearby peripheral fan-coil unit. The arrow points to a section of the air intake that is likely discolored by the printer's emissions. Photo by NIOSH.
