# Evaluation of Chromium, Hexavalent Chromium, Cadmium, and Isocyanate Exposures in an Aircraft Refinishing Plant

HHE Report No. 2013-0011-3278  
May 2017

U.S. Department of Health and Human Services  
Centers for Disease Control and Prevention  
National Institute for Occupational Safety and Health

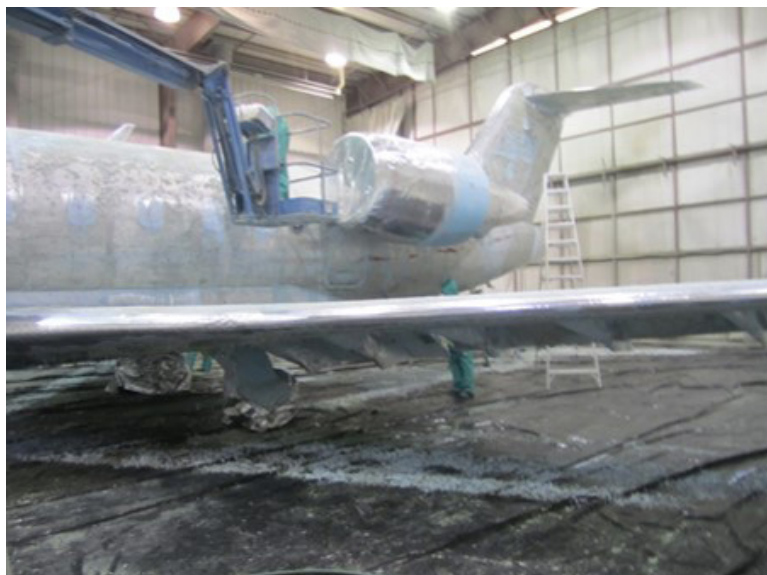
Figure 2. Liquid paint stripper applied to an airplane inside the stripping bay. Photo by NIOSH.

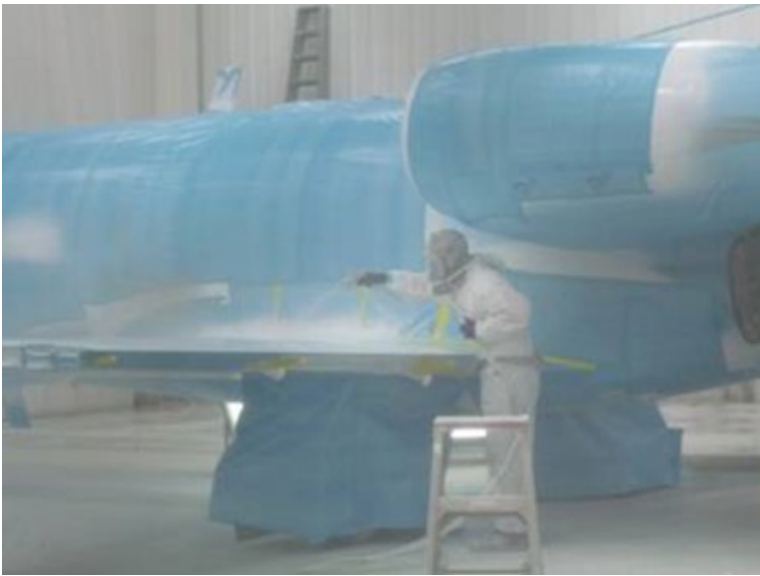
Figure 3. Employee spray painting inside a paint bay. Photo by NIOSH.

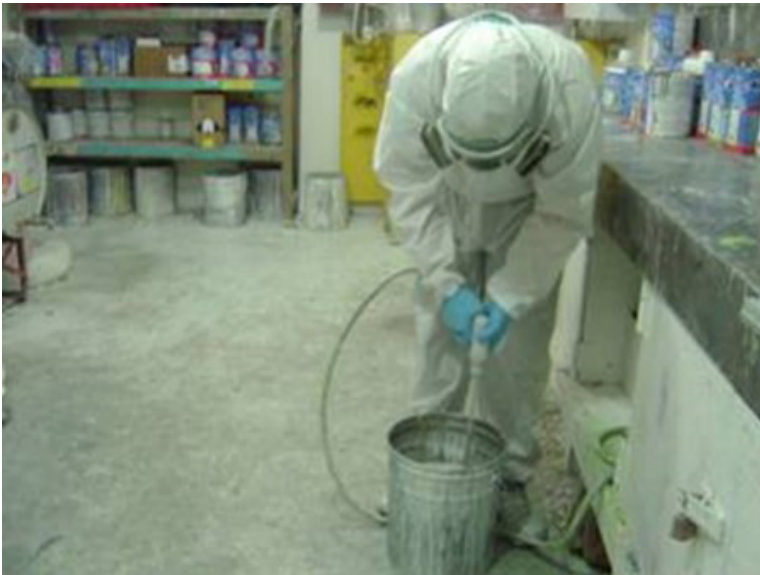
Figure 4. Employee mixing paint inside the paint mixing room. Photo by NIOSH.

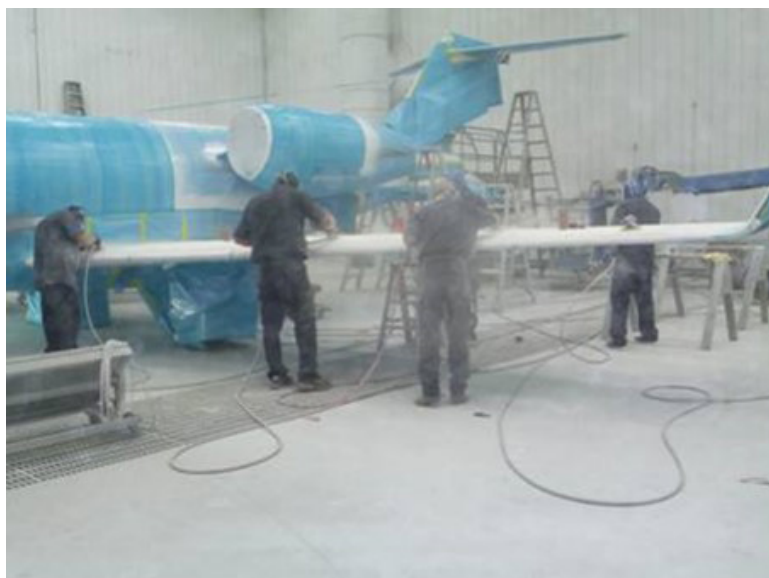
Figure 5. Employees wearing coveralls with hood, goggles, gloves, and full facepiece air purifying respirators while sanding an airplane inside a paint bay with pneumatic sanders that do not have dust control. Photo by NIOSH.

1. Use locally exhausted hand sanders in the paint bays. Empty dust collection bags on the sanders as needed throughout the work day.
2. Consult a qualified ventilation engineer to improve the ventilation systems in the stripping and paint bays. Written requirements for spray booth or spray area ventilation can be found in the [Occupational Safety and Health Administration General Industry Standards Part 1910.94](#) and in the American National Standards Institute Z9.3-2007 [ANSI/ASSE 2007] and ACGIH [2010].

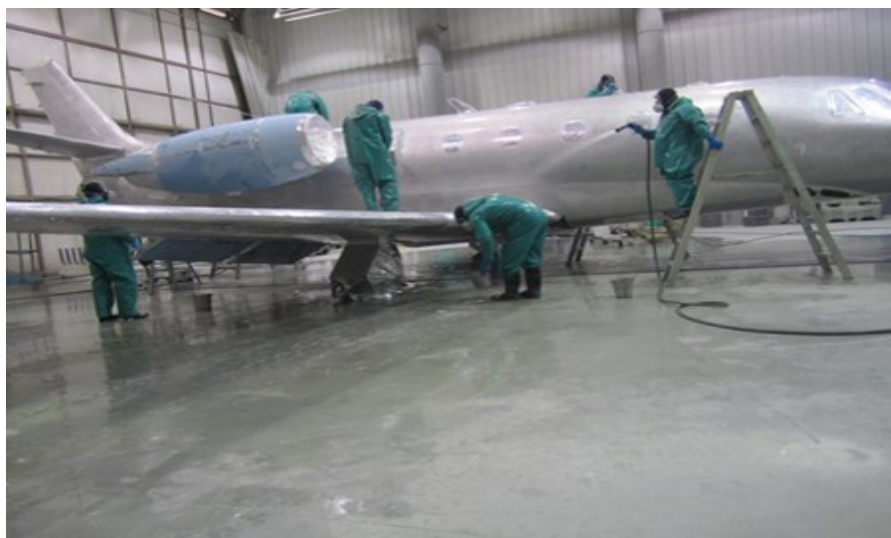
Figure 6. Employees wearing rain suits, full facepiece respirators, rubber boots, and gloves are rinsing an aircraft with water after degreasing inside the stripping bay. Photo by NIOSH.

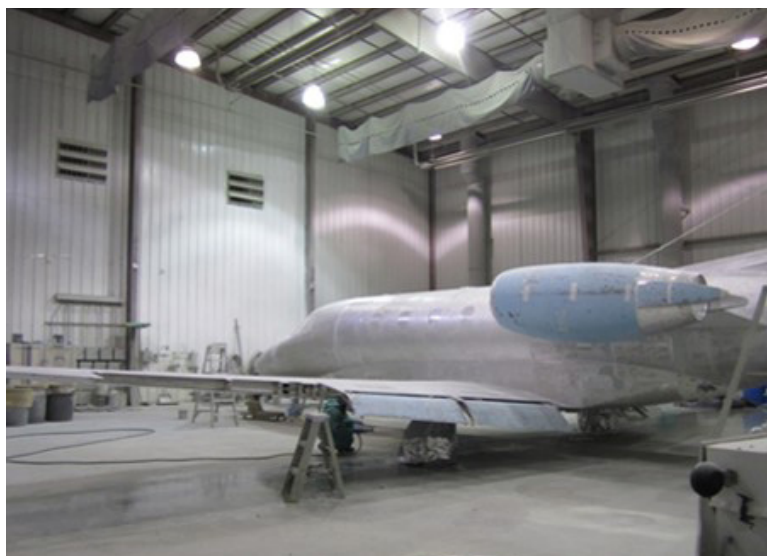
The stripping bay was approximately 75 feet wide × 72 feet long × 26 feet high. Unconditioned outdoor air was delivered through two ceiling-mounted air handling units. Each unit inflated a plastic perforated tube plenum that distributed the outdoor airflow horizontally across the ceiling (Figure 9). Another air handling unit provided heated air through two louvered supply openings on the wall opposite the bay door (Figure 9). There were six floor level filtered exhaust outlets, three along each side wall of the stripping bay (Figure 10). With all supply and exhaust fans running, the bay was observed to be under positive pressure relative to adjacent areas, meaning that air flowed from the stripping bay into adjacent areas. Ventilation smoke visualization tests showed turbulent airflow patterns, little removal of the smoke, and multiple areas of little air movement, a situation that could result in a buildup of air contaminants. We measured the air velocity at the face of each of the six exhaust outlets and found the velocities to be very consistent (approximately 1,000 feet per minute each) except for one outlet. This outlet had a face velocity approximately half that measured at the other exhaust outlets; its fan was operating at a lower speed than the others. We also noticed objects such as barrels and telescopic booms blocking the exhaust outlets.

Figure 9. An aircraft parked in the stripping bay. Outdoor air was provided by a ceiling-mounted air handler and distributed through perforated, flexible plastic ducts (top right). Conditioned air was supplied through two wall fans in front of aircraft. The location of outdoor and conditioned air supplies created turbulence and reduced the effectiveness of the floor mounted exhaust ventilation system. Photo by NIOSH.

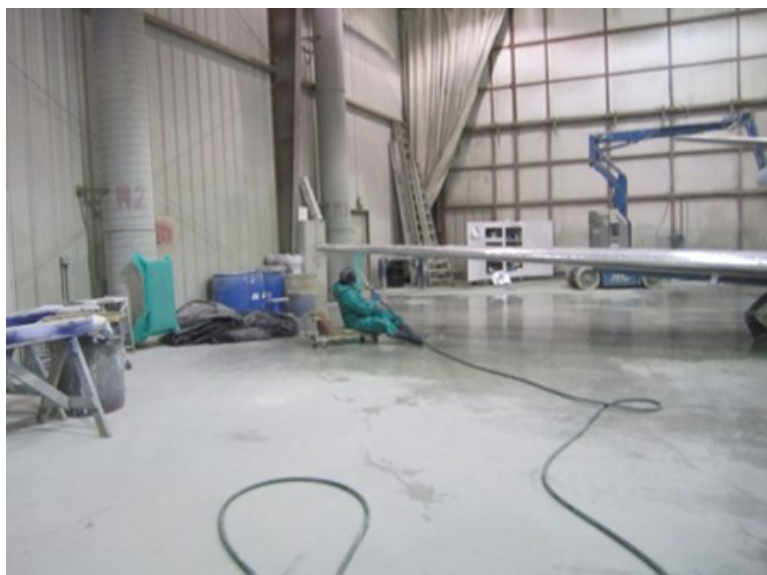
Figure 10. Stripping bay floor level exhaust with paint arresting filters (green filter media covering exhaust hood). Photo by NIOSH.

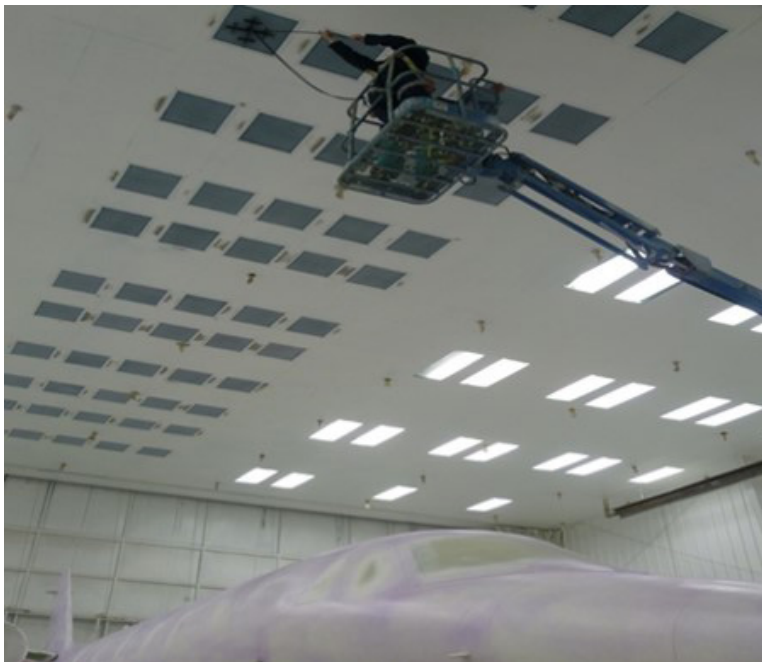
The design configuration of the paint bays was intended to deliver ceiling-to-floor airflow to the work area, and then exhaust the contaminated air out of the bay through a filtered exhaust system. Using the Roscoe fog machine, we observed that the ventilation system delivered air to the top of the fuselage, but the airflow pattern was turbulent. We also noticed little to no air movement at and below wing level, and very little capture of the fog at the floor exhaust (Figures 11 and 12).

Figure 11. Measuring air velocity and airflow through each of the supply registers in paint bays 1 and 2. Photo by NIOSH.

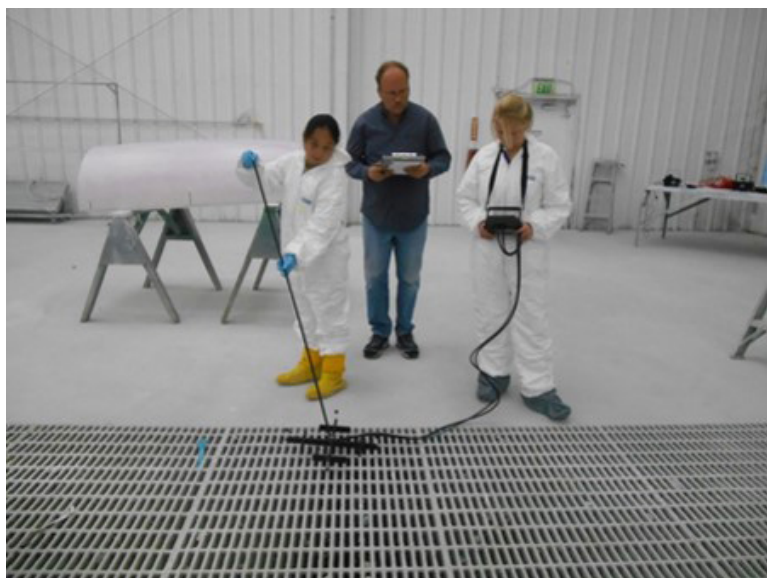
Figure 12. Measuring air velocity and airflow through a paint bay exhaust grates. Photo by NIOSH.
