# Evaluation of Environmental Controls at a Faith-Based Homeless Shelter Associated with a Tuberculosis Outbreak – Texas

Report No. 2013-0110-3218  
August 2014

U.S. Department of Health and Human Services  
Centers for Disease Control and Prevention  
National Institute for Occupational Safety and Health

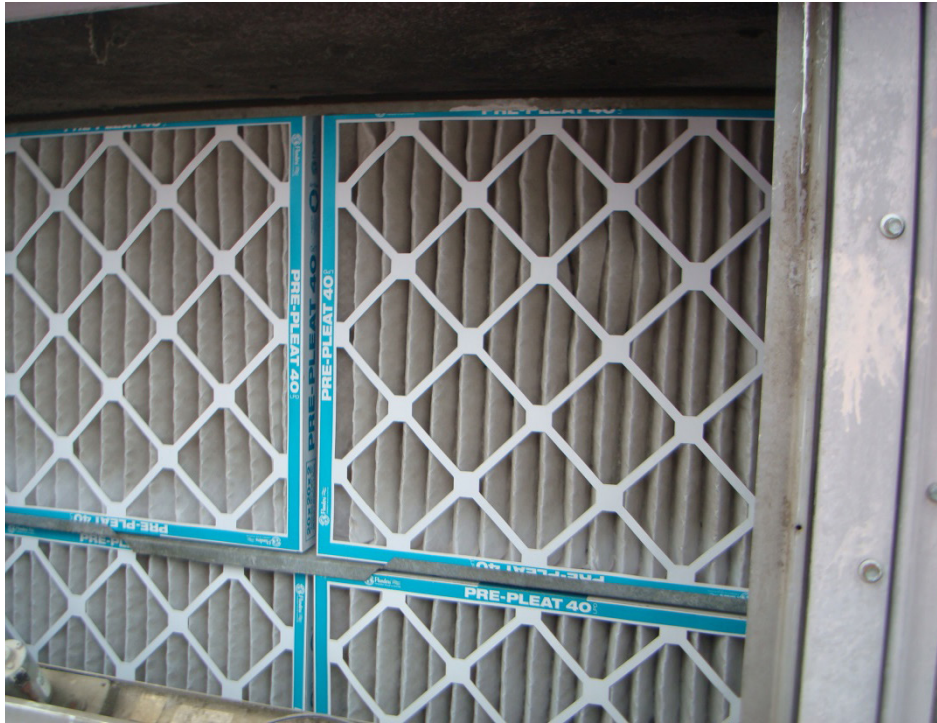
**Figure 1. Filters installed inside AHU 12 at the shelter showing a significant gap between individual filters that will allow air to pass between the filters instead of through them.**

- Install the highest efficiency air filters in the AHU that will still allow adequate airflow to meet the AHU's conditioning requirements. Adjust and balance the system as necessary to ensure proper air flows at all times when the room or curtain enclosure is used for respiratory separation and normal purposes. Ensure that adequate outdoor air is supplied to each space at all times (see Recommendation 2 above).

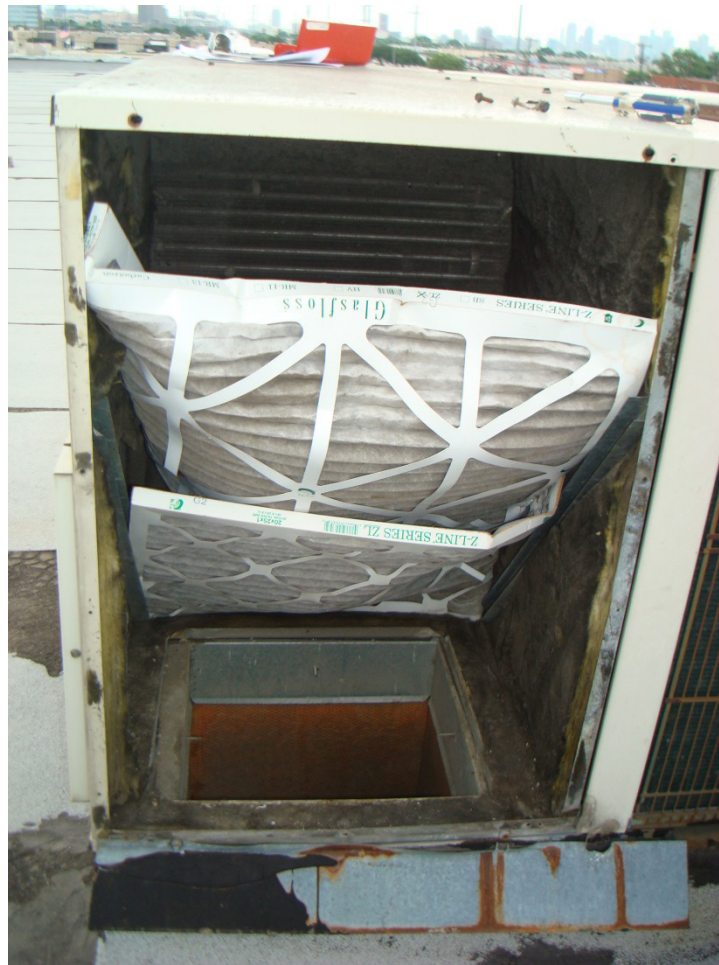
**Figure 2. Incorrect filters installed and subsequently distorted and rendered ineffective inside AHU 19 at the shelter.**

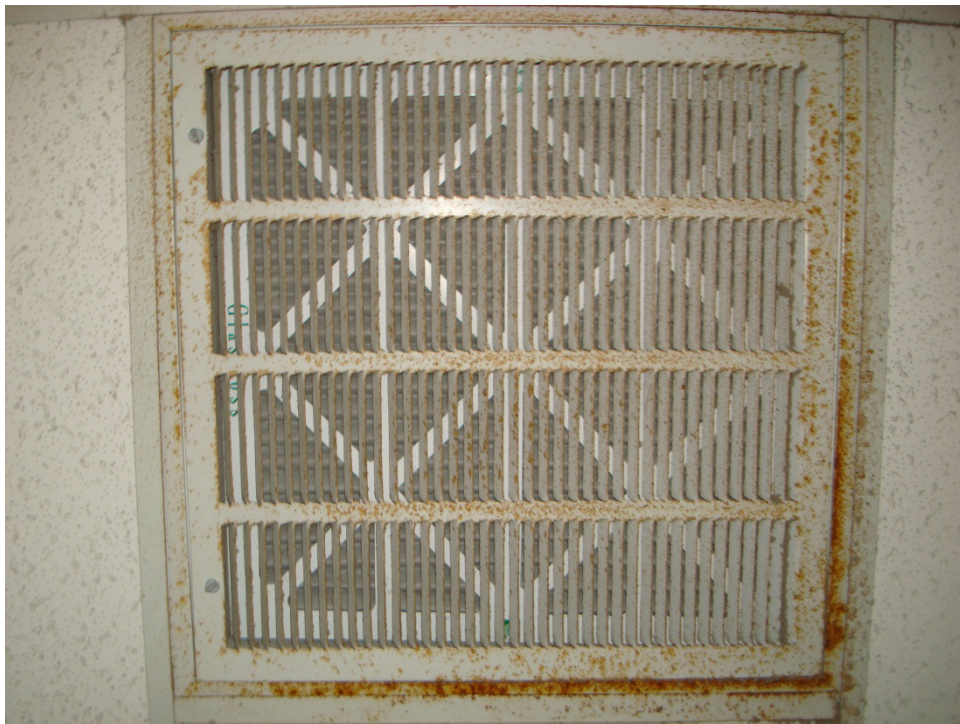
In addition to the ventilation filters in the AHUs, several return grilles on the second floor of the building had ventilation filters installed behind them. As an example, Figure 3 shows a Glasfloss Z-line filter installed behind a return grille in the Initial Program dormitory area. Many other return grilles on the second floor, particularly in the library and lounge area, had True Blue Filters (True Blue Company, Laporte, IN) behind them as well. While these filters likely provided some filtration, it was unclear whether these filters were used as replacements for filters in AHUs or in conjunction with AHU filters. If the filters behind return air grilles were meant as replacements for AHU filters, the deviation from intended design provides ample opportunity for filter bypass and air to be pulled into the AHU in the space between the return grilles and the AHU itself.

**Figure 3. Ventilation filter installed directly behind a return air grille in the Initial Program Dormitory Area of the shelter.**

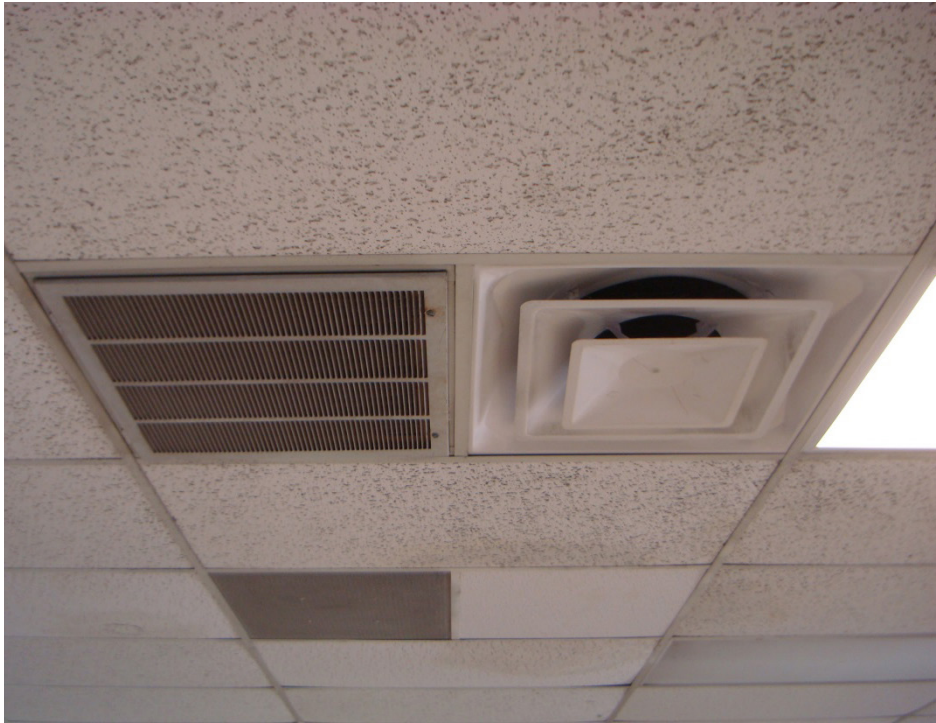
**Figure 4. Supply vent and return grille directly next to one another in the second floor lounge area at the shelter. This configuration will lead to short-circuiting of air in the occupied space.**

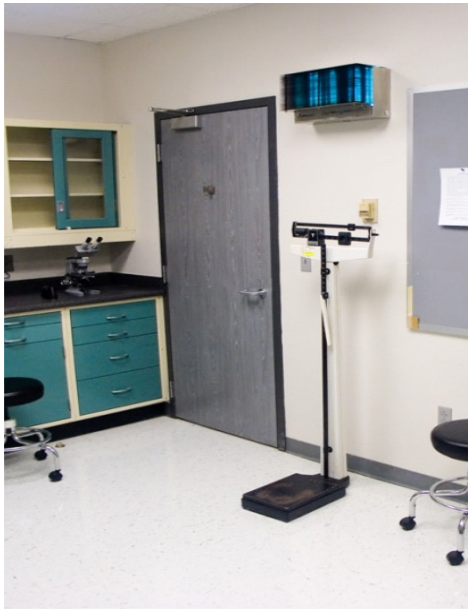
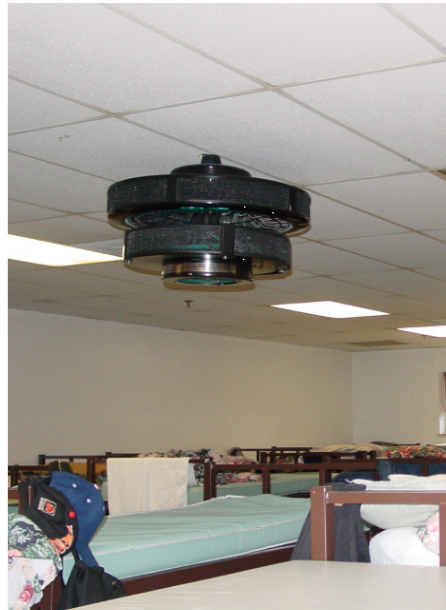
**Figure 5. Typical upper-air UVGI installations: Left–Wall-mounted fixture with louvers installed in a health clinic; Right–Ceiling-mounted fixture with an internal fan installed in a homeless shelter.**

We recommend consulting with a qualified UVGI fixture manufacturer or system engineer, familiar with the NIOSH upper-air UVGI guidelines, to design and install an upper-air UVGI system in the chapel/gymnasium area. The high ceiling height in that space provides an excellent opportunity to utilize a variety of commercially-available fixtures to create a large irradiance zone in the upper portion of the room. The ability to mount the fixtures at higher heights will also help prevent the fixtures from being tampered with and prevent unnecessary UV exposures to people using the stairs to the second floor in the area. The existing ventilation systems will also provide air mixing within the entire space that is critical for optimum upper-air UVGI system performance. Other areas where upper-air UVGI should be considered are all dormitory sleeping areas and the dining room. However, unlike the chapel/gymnasium, these spaces have shorter ceiling heights, so decisions on fixture selection and placement would be more critical. All of the upper-air UVGI systems should be designed to provide UV irradiance levels of at least 30-50  $\mu\text{W}/\text{cm}^2$  in the upper portion of the room while limiting UVC exposure to occupants in the space. If desired, NIOSH engineers are available to review proposed UVGI design strategies prior to their purchase and installation.

- Choose a qualified UVGI fixture manufacturer or system engineer, familiar with the NIOSH upper-air guidelines, to design, install and test the system. The system designer/installer should also provide initial training on exposure hazards, safety, and system maintenance.
