# Evaluating a Persistent Nuisance Odor in an Office Building – Maryland

Health Hazard Evaluation Report  
HETA 2011-0004-3128  
May 2011

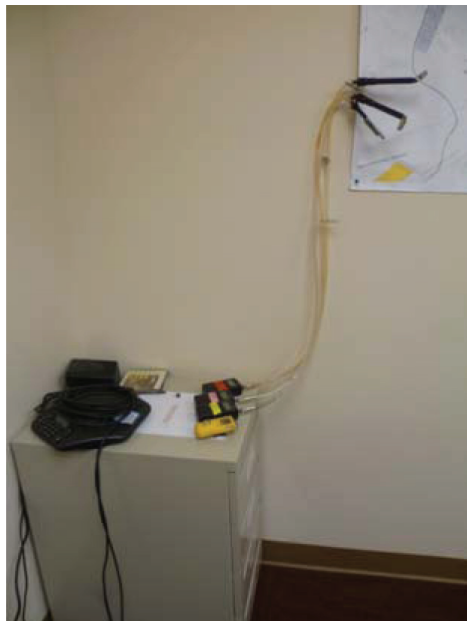
Figure 1. The air sampler inlets were positioned 5 feet above the floor to measure hydrogen sulfide, formaldehyde, and VOCs.

IEQ problems. Spot measurements were taken for CO<sub>2</sub>, temperature, RH, and CO using a Q-TRAK™ Plus Indoor Air Quality Monitor, Model 8554 (TSI Incorporated, Shoreview, Minnesota). We collected air samples for H<sub>2</sub>S, formaldehyde, and VOCs in the office conference room, at a work station, and in a non-carpeted information technology room. For comparison, we also sampled for H<sub>2</sub>S, formaldehyde, and VOCs in two nearby businesses where there had been no odor complaints. Both businesses had separate HVAC systems and were not carpeted. Figure 1 depicts the equipment used in these areas to sample for H<sub>2</sub>S, formaldehyde, and VOCs.
