# Evaluation of Worker Exposures to Peracetic Acid-Based Sterilant during Endoscope Reprocessing

Health Hazard Evaluation Report  
HETA 2006-0298-3090  
Kaleida Health–Buffalo General Hospital  
Buffalo, New York  
August 2009

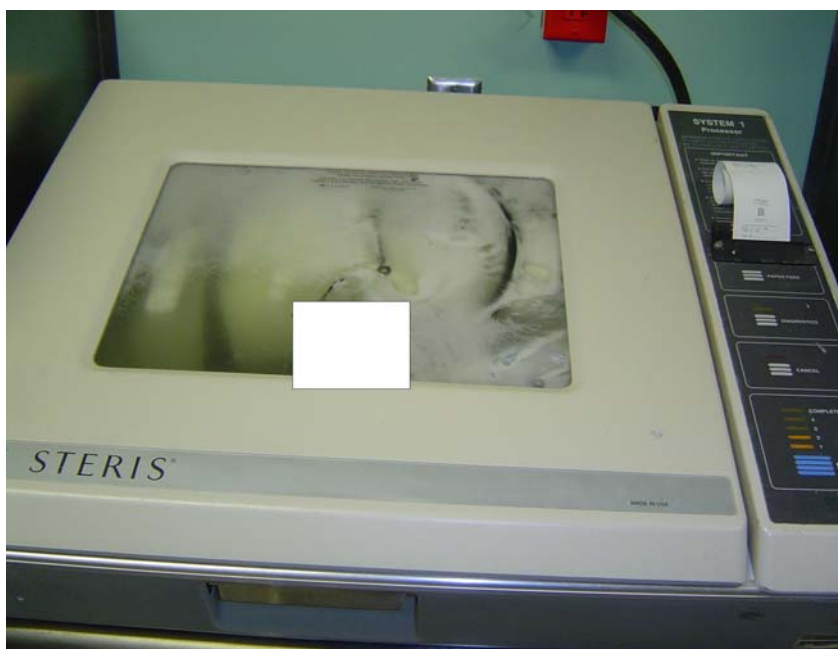
Figure 1. Steris System 1® processor in operation

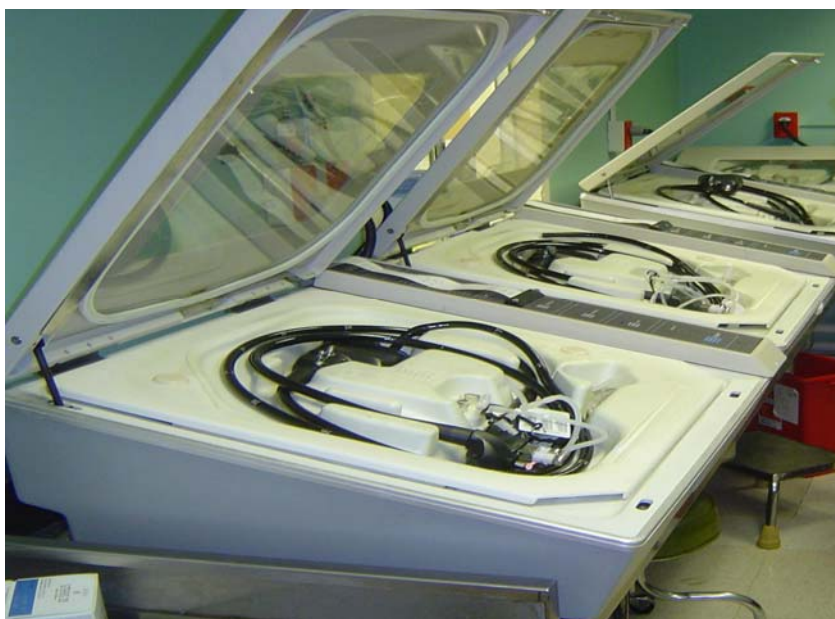
The clean side is approximately 10 feet wide by 15 feet long, with a single doorway to the corridor. Three SS1 processors are installed on a stainless steel counter near the window between the dirty and clean sides. Two processors are located along the back wall and one along the wall opposite the window. Also along this wall is a GUS® Model G17HS endoscope immersion unit, which contains approximately one-half gallon of Cidex® OPA Solution. The GUS unit is a compact, ductless vapor control system that exhausts into the room via a carbon filter. It is our understanding that the GUS

Figure 2. Row of Steris System 1® processors

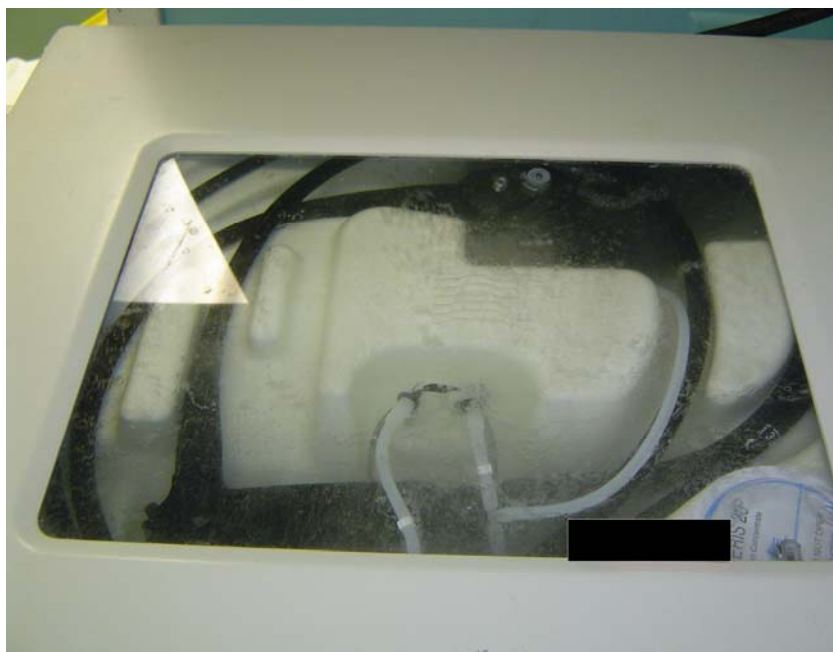
Each SS1 processor is a fully-enclosed tabletop unit. Steris 20 Sterilant Concentrate is provided in sealed single-use containers (“cups”) that hold 2.02 fluid ounces (67.5 grams) of liquid and 163.7 grams of powder. The composition of the liquid (% by volume) is 35.5% peracetic acid, 40.0% acetic acid, 6.5% hydrogen peroxide, and 1.0% sulfuric acid [Steris 1995]. The solid powder consists of proprietary builders and buffers [Alfa 2004; Steris 2007]. During the sterilization cycle, the processor aspirates the concentrated liquid sterilant, and dilutes it to a working concentration of 0.2% PAA at a pH of 6.4 and a temperature of 50°C to 56°C [Alfa 2004; Steris 2007]. When diluted, PAA hydrolyzes to acetic acid and hydrogen peroxide with a half-life of less than 20 minutes at 50°C [Steris 1995]. The 0.2 % PAA solution circulates around and through the endoscope for 12 minutes before being discharged into the sewer system. After the sterilant has been discharged from the processor, the processor flushes the endoscope four times with filtered water [Alfa 2004; Steris 2007; Steris 2008]. The technician can open the processor after the final rinse water has been discharged down the drain.

Figure 3. Steris System 1® processor in operation showing Steris 20 Sterilant Concentrate container in lower right corner of the processor.

- Minimum PPE worn while performing routine tasks involving the handling of sealed Steris cups should include tight-fitting splash-resistant goggles, acid-resistant sleeves and apron, and gloves made of butyl rubber, neoprene rubber, Viton®, or Barrier® [Forsberg and Mansdorf 2007]. Very thin gloves, as typically worn in healthcare settings, provide poor chemical resistance and mechanical strength, and should not be the only barrier between the wearer and a chemical hazard, such as PAA [Forsberg and Mansdorf 2007]. Latex gloves do not provide appropriate protection and introduce a known allergen into the workplace [NIOSH 1997].

- If sterilant remains in a cup at the end of a sterilization cycle, the technician should don additional face protection (e.g., face shield in addition to gloves, sleeves, apron, and eye protection used during normal operations). This PPE should be worn when handling unsealed cups containing any sterilant concentrate, and when disposing of expired sterilant.
