# Exposure to Lead During Bullet Recycling

HHE Report No. 2023-0030-3407

November 2024

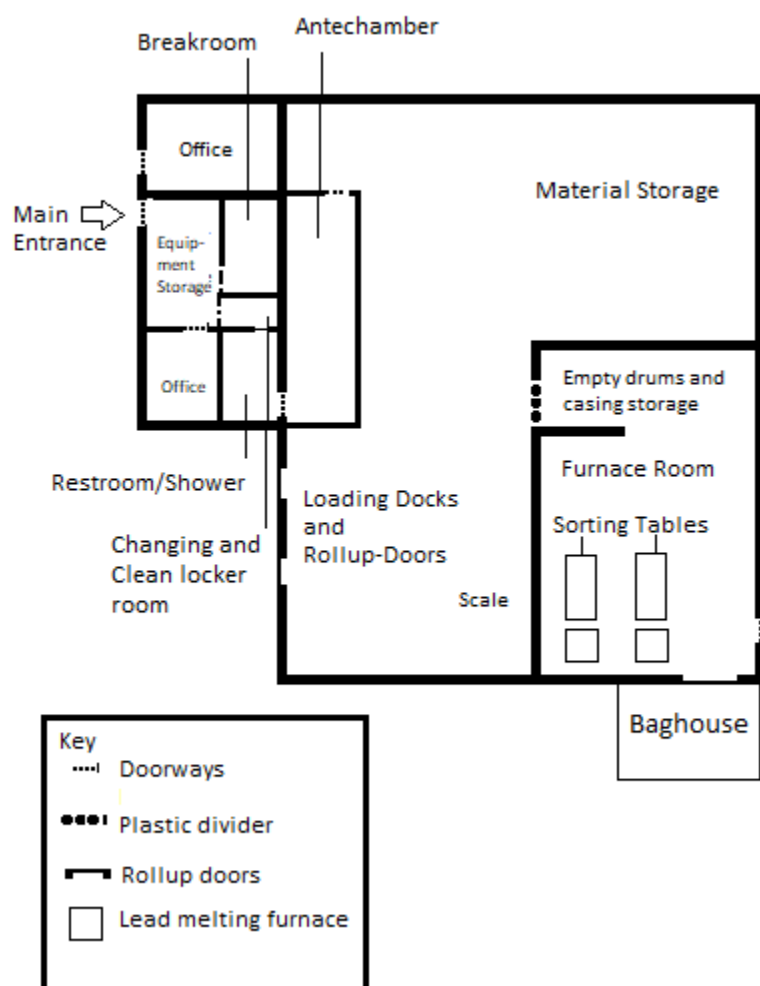
The single-story building was constructed in 1965. The building had a ducted forced-air general ventilation system, and the air intake for the office area was located on the roof. The warehouse, originally designed for stainless steel fabrication, was adapted for lead processing by adding two melting furnaces, a local exhaust ventilation (LEV) system to capture emissions from the melting furnaces, a “dirty” antechamber, a shower room, a clean locker room, and a breakroom (Figure A1).

Figure A1. Facility layout. The warehouse includes material storage and the furnace room. Figure by NIOSH.

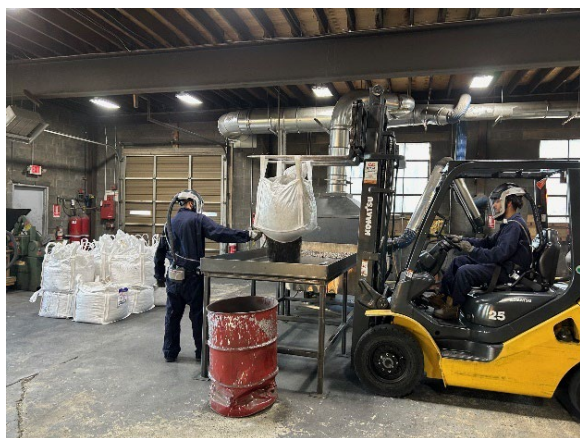
The facility received bullet casings from firing ranges in large super sacs and processed them into lead ingots. The furnace heaters were turned on at the start of the first shift. While the furnaces heated up, employees worked in the material storage and scales area receiving and weighing raw material, including the copper jackets/bullet casings, and cleaned the facility. When the next shift of employees arrived, they placed the super sacs into the furnace room, which they opened and poured onto one of two sorting tables (Figure A2).

Figure A2. Pouring a super sac containing lead and copper jackets onto the sorting table. Photo by NIOSH.

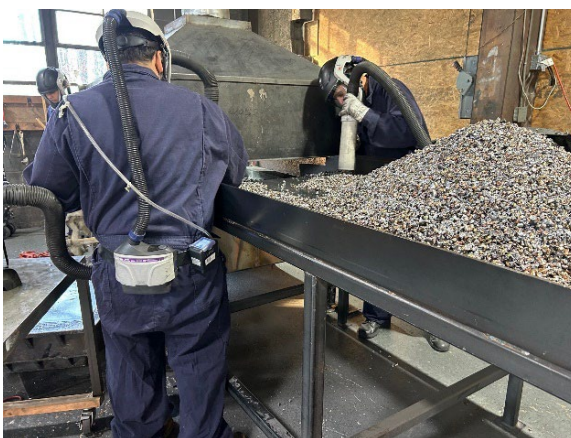
The employees used a specifically designed vacuum to remove the rubber components (Figure A3). The need for vacuuming depended on the source of the copper jackets and the quantity of rubber components in the raw material. Employees then pushed the copper jacket and lead bullet mixture into the furnace and left it for several hours to melt. A loose curtain was pulled across the doorway in front of the empty drum storage area while the lead furnaces were powered on and melting lead (Figure A4).

Figure A3. Employees vacuuming rubber from the lead and copper components. Photo by NIOSH.

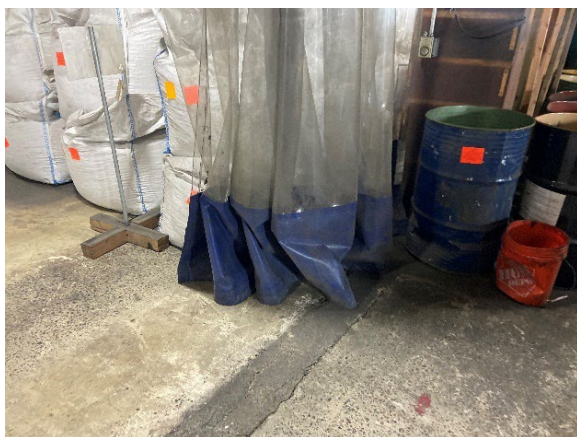
Figure A4. Loose curtain between the main warehouse and the lead melting area, pulled closed while the melting furnaces are powered on. Photo by NIOSH.

- Consider installing a more airtight barrier between the furnace area and the rest of the warehouse. This could help keep lead inside the furnace room. To offset the increased lead in the furnace room, improve the local exhaust and general ventilation systems in that area. A better barrier could lower the lead in the rest of the facility. This could possibly lessen the need to wear respirators in those areas as much. After making these changes, make sure to retest to confirm that lead levels were reduced.

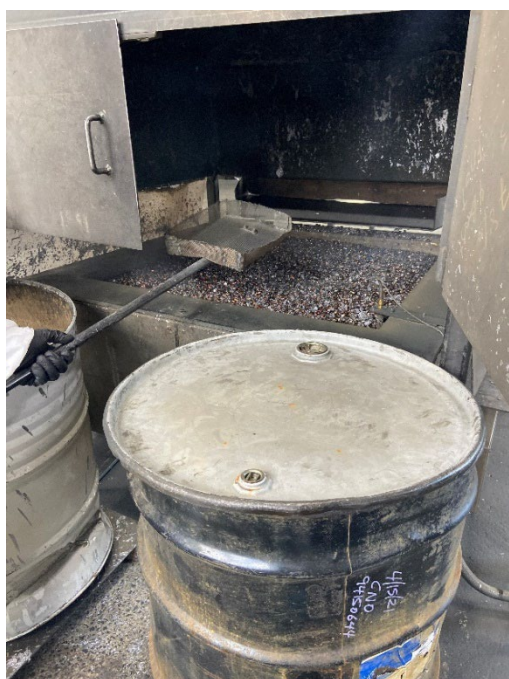
After the lead liquified, employees removed the copper jackets, which floated to the top. Employees then removed the dross (contaminants) from the liquid lead (Figure A5). An employee used a propane torch to liquify the lead inside a spigot. They then used a strainer to remove contaminants while the liquid molten lead was poured into a mold (Figure A6). The lead ingot and the barrel containing copper were left to cool and the heating cycle repeated. Forklifts were used to transport the raw material and final product around the warehouse. After the ingot cooled, employees used a forklift to remove the ingot from the mold; they then weighed and stored it (Figure A7).

Figure A5. Removing dross and copper jackets from the top of the liquid molten lead inside the furnace. Photo by NIOSH.

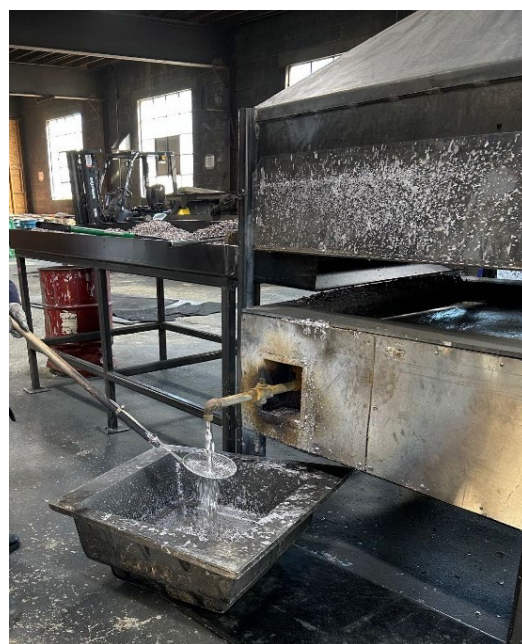
Why? Splashing molten lead could cause thermal burns. Splashes can also contaminate uniforms with lead. We saw multiple uniforms with silver-colored splashes during both site visits. These likely happened when employees filled the ingot molds.

Figure A6. Pouring liquid molten lead into mold. Photo by NIOSH.

During the straining process, we observed molten lead splash onto the employees’ coveralls as liquid lead was poured from the furnace into the mold. We observed that more molten lead may have splashed if the employee held the strainer at the mouth of the spigot, and that one spigot seemed lower than the other.

- Consider installing an automatic strainer. This way, employees do not have to be nearby while filling the mold.
- If that is not possible, consider looking into lowering the spigot closer to the mold or changing the nozzle to one that causes less splashing.

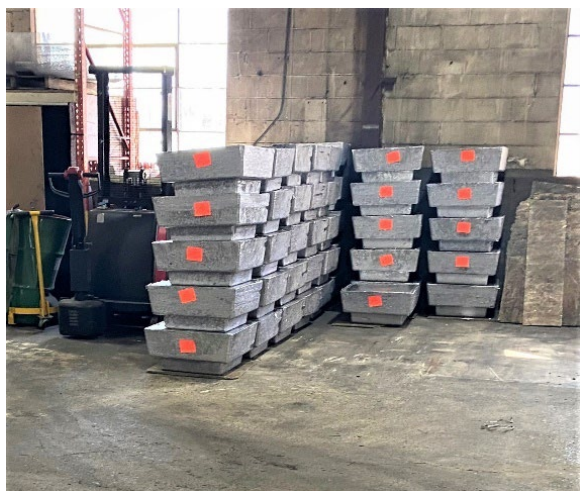
Figure A7. Lead ingots in the warehouse weighing approximately 2,000 pounds each. Photo by NIOSH.

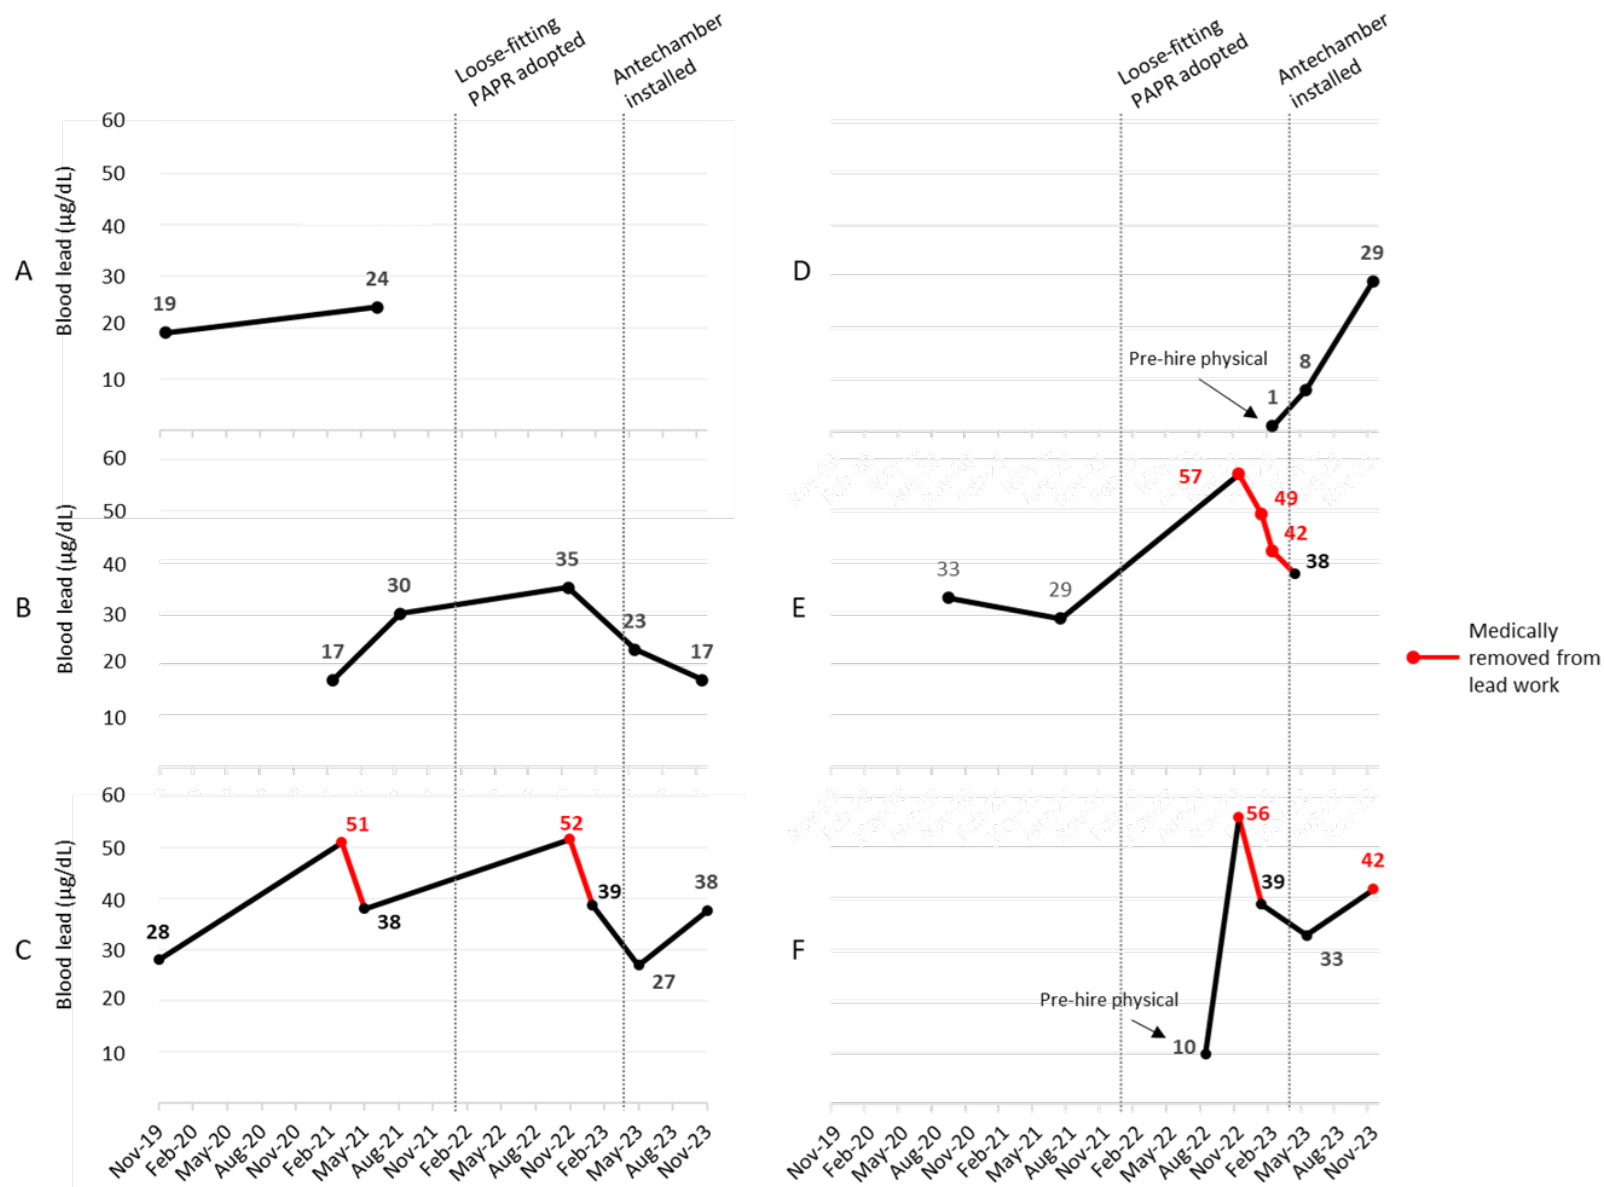
In January 2022, facility management changed provided respiratory protection from tight-fitting elastomeric full-facepiece respirators to loose-fitting hooded PAPRs. The median BLL (29 µg/dL) in the period before the change (November 2019–December 2021) was lower than the median BLL

(38 µg/dL) after the change (January 2022–November 2023). Additional BLL measurements would be needed to evaluate this trend further.

Facility management completed the addition of an anteroom in mid-April 2023. The median BLL (35 µg/dL) was slightly higher before the completion of the anteroom than afterwards (29 µg/dL). Again, more BLL measurements are necessary to evaluate this trend further. In fact, the median BLL of the four current employees increased from May 2023 (25 µg/dL) to November 2023 (33 µg/dL). Three of the four employees had higher BLLs in November 2023 than in May 2023.

Figure B1. Blood lead levels (µg/dL) of six employees during November 2019–November 2023. Not all BLLs are from current employees.

- Use health-based limits such as those recommended by the American College of Occupational and Environmental Medicine. Find these at [Workplace Lead Exposure | ACOEM](#).
- Obtain BLLs on lead-exposed employees with levels below 20 µg/dL every 2 months. Employees with levels consistently below 10 µg/dL can space out their testing to every 6 months.
- Obtain BLLs on lead-exposed workers with levels above 20 µg/dL every month.
  - If an employee has two consecutive BLLs of 20–29 µg/dL, or one BLL at or above 30 µg/dL, remove the employee from exposure to lead and test them monthly.
  - Allow them to return to lead exposure work after two consecutive BLLs are below 15 µg/dL.
- Evaluate lead controls again if an employee's BLLs cannot be kept below 10 µg/dL after initial improvements.

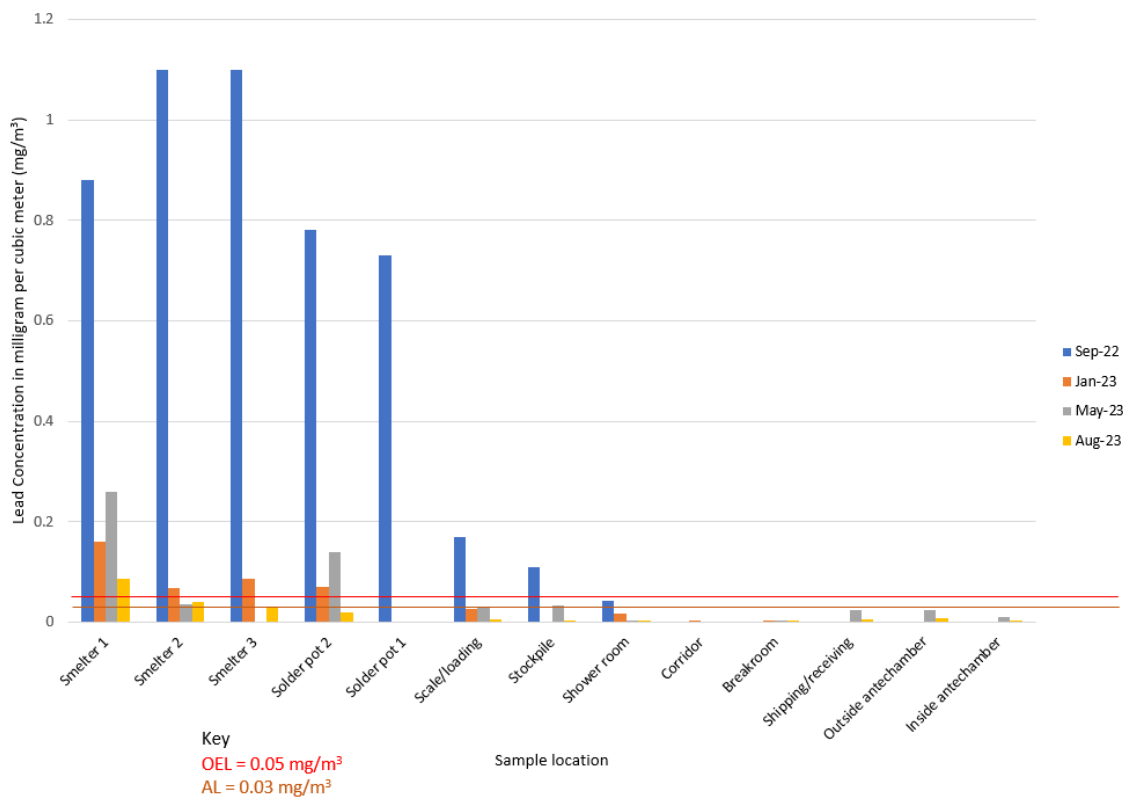
January, four of eight air samples exceeded the PEL. In May, two of ten samples exceeded the PEL. In August, of 11 samples, 1 exceeded the PEL. Personal air samples of employees working around the lead smelters had lead levels consistently above the PEL. Area samples around the solder pots were also above the PEL. The area air sampling for January, May, and August 2023 showed that areas outside of the furnace area, including areas in the warehouse (scales, stockpile, shipping and receiving, and the anteroom) were below the PEL. However, the scales area was above the OSHA AL of 0.03 mg/m<sup>3</sup> in January and May, and the stockpile area was above the AL in May.

Figure B2. Historic air sampling for lead conducted by a consulting firm from 2022 and 2023. The shower room, corridor, breakroom, shipping and receiving, outside the antechamber, and inside the antechamber were below the OSHA PEL. The only locations below the OSHA AL of 0.03 mg/m<sup>3</sup> were the corridor, breakroom, shipping and receiving, and inside and outside of the antechamber.

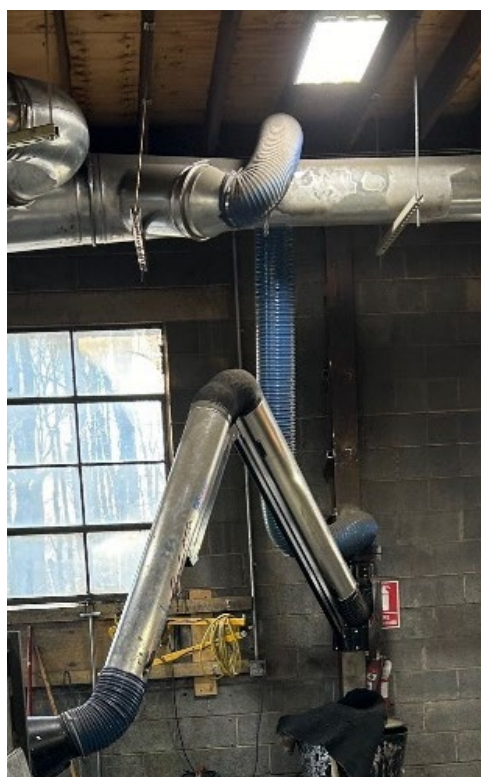
The ductwork from the two stationary furnaces was made of metal and in good condition. We observed no visible damage, noticed no 90-degree entry angles, and saw an increase in duct diameter at every new entry; blast gates were also present to close off any unused ducts. The elephant trunk-style fume hood was made of corrugated plastic and attached in the middle between the two fixed hoods. Its entry at the main duct was wrapped over the top of the duct at an awkward angle and had multiple bends and elbows (Figure B3).

Figure B3. Movable flexible "elephant trunk" style LEV hood attached via corrugated plastic ductwork to the permanent hard metal duct. Photo by NIOSH.

- Replace the elephant-trunk style duct with permanent metal ductwork. Be sure to consider fan speed for the system as a whole. Also consider duct size and entry angle for each additional component so the local exhaust ventilation system is not overburdened.

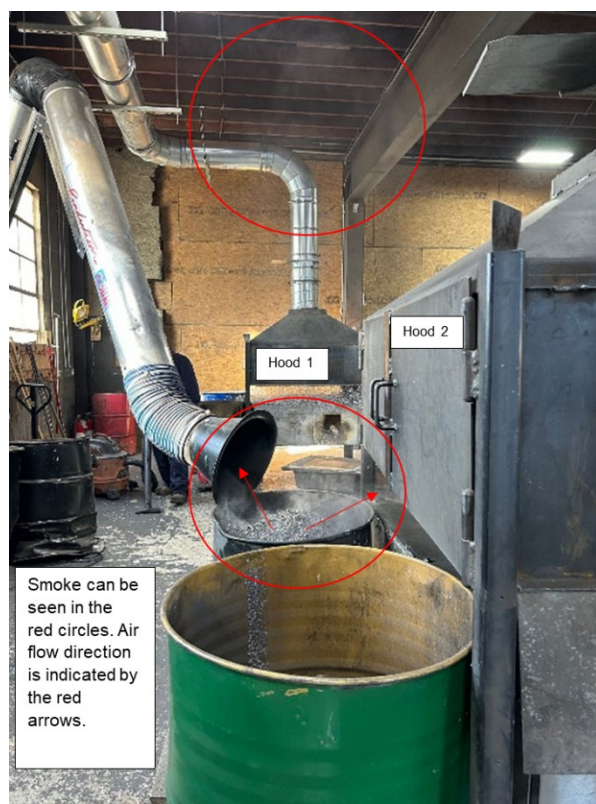
Figure B4. Two stationary fume hoods over the lead melting furnace and one elephant trunk-style duct-hood. Photo by NIOSH.

The two pyramid-style fixed fume hoods semi-enclosed the two melting furnaces (Figure B4). Each hood had two hinged doors at the front of the hood so that employees could open the hood and remove copper metal jackets and other contaminants from the top of the molten lead. The doors were each approximately 18 inches tall and 29 inches wide, leaving the face of the fume hood at 24 inches × 58 inches when open. There was an approximate 6-inch gap between the surface of the lead furnace and the bottom of the fume hood enclosure, and three of the sides were semi-sealed with Plexiglas®.

Face velocity measurements at the stationary fume hoods (with the doors closed) averaged 203 feet per minute (fpm) for Hood 1 and 195 fpm for Hood 2. Center line face velocity measurements at the elephant trunk-style moveable hood averaged 179 fpm at Hood 2 and 220 fpm at Hood 1. With the doors open, stationary Hood 1 averaged 82 fpm (55 fpm at the center measurement), and stationary Hood 2 averaged 102 fpm (87 fpm at the center measurement).

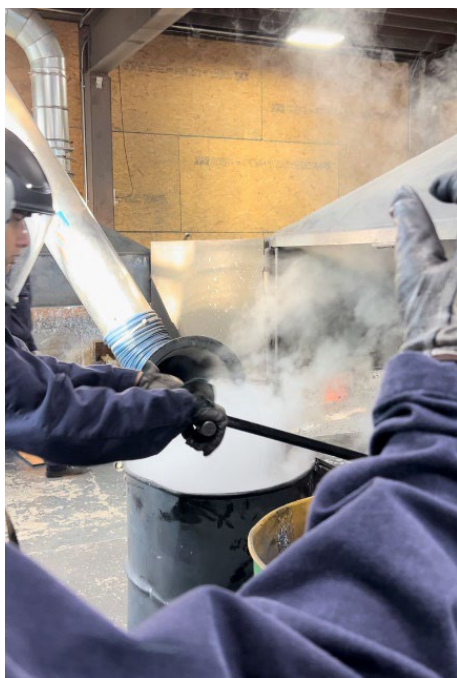
Using smoke to visualize airflow, we observed turbulent airflow around the elephant trunk-style hood and escaping smoke passing outside the edge of the stationary hood and not captured by the elephant trunk-style hood (Figure B5). This was most evident when both hood doors were open and the elephant trunk-style hood was located to the back of the barrel; however, this was also seen when it was located to the side of the copper barrel. The best smoke capture occurred when a fire blanket was placed over the top of the cooling copper barrel (Figure B6). The second-best capture was observed when a metal lid was placed over the barrel; this occurred both with hood doors open and closed (Figure B7).

Figure B5. Stationary fume hood with open doors plus elephant trunk-style hood over the barrel, emitting more smoke than when the barrel was covered with a fire blanket or the barrel was covered with a metal lid. Photo by NIOSH.

After installing permanent metal ductwork, a barrel-specific local exhaust hood would offer better direct airflow into the LEV system than the “elephant trunk” style hood because it would more fully enclose the process. An example of this style of hood could potentially be used for the barrels containing copper jackets is shown in Figure B12 and is available through the [OSHA Lead: Battery Manufacturing E-Tool](#) [OSHA 2024]. Another example for enclosing the process more fully is shown in Figure B13. In this example, the employee would be able to keep the drossing tools inside the furnace LEV by adding a “dross chute” from the furnace into the dross pot. These recommended additions should help reduce the turbulent airflow caused by the “elephant trunk” style hood and would keep the process more fully contained, reducing the amount of escaping dusts and vapors.

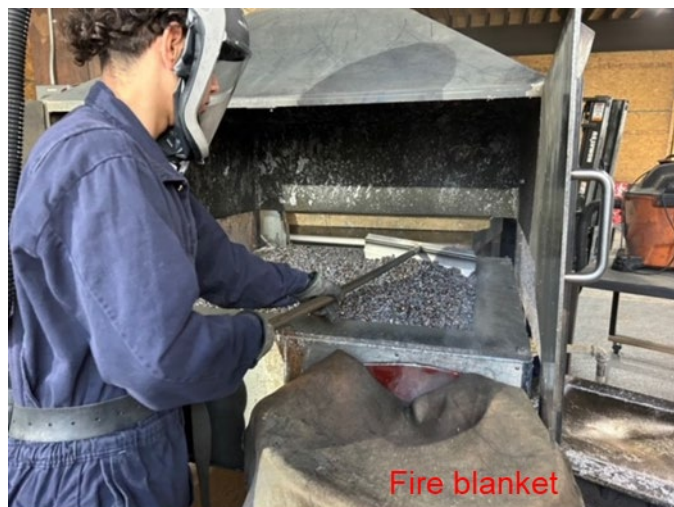
Figure B6. A fire blanket is used to cover the barrel containing cooling copper jackets to emit less smoke than the open barrel with the elephant trunk or the barrel with a metal lid. Photo by NIOSH.

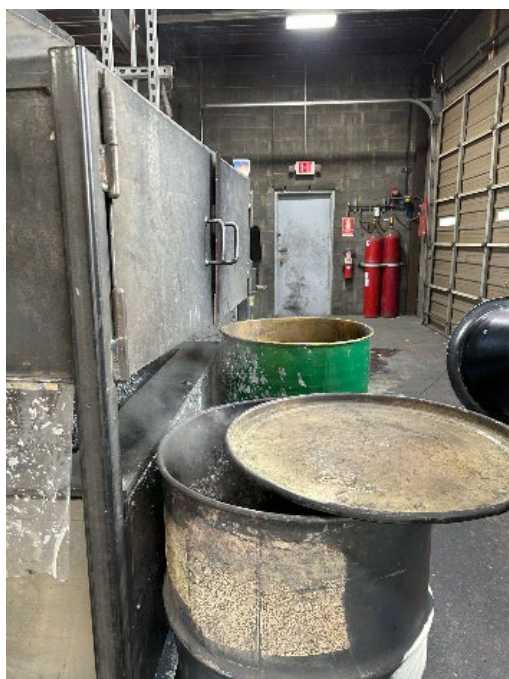
Figure B7. A metal lid is used to cover a barrel containing cooling copper jackets. In this configuration, more smoke was emitted than with the barrel covered with a fire blanket but less than when the barrel was open with the elephant trunk-style hood. Photo by NIOSH.

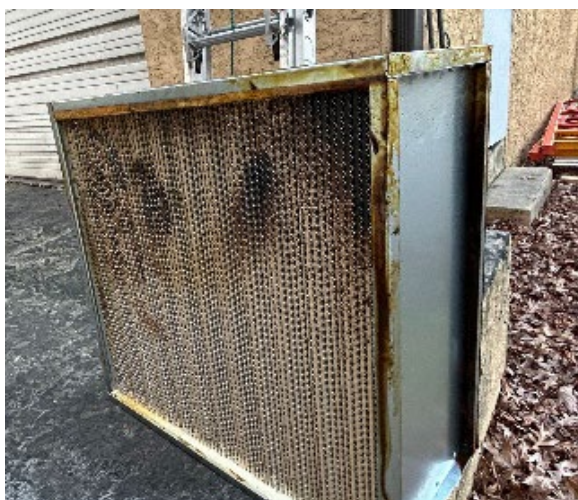
During our second site visit, the LEV system monitor indicated that the exhaust filters needed to be changed. When removed, both the pre-filter and HEPA filters were visibly soiled and wet (Figures B8 and B9). Near the end of Day 1, after the filters were replaced and backpressure was reduced, face velocity airflow increased from an average of 85 fpm to 127 fpm with doors open at Hood 2; smoke capture also improved. However, some turbulence was still visible.

Figure B8. Dirty HEPA Filter. Photo by NIOSH.

- If not already installed, consider adding an impinger with a drain to the system to reduce the moisture and saturation of the baghouse and exhaust filters.

A large amount of water vapor was introduced into ductwork with hot processes. In-line impingers, such as the Donaldson impinger with drain, are designed as the first line of removal for liquids to prevent them from saturating the dust collectors and exhaust filters. Adding the impinger back to the system (if missing) could help extend the working life of the exhaust system and reduce the filter changeout frequency.

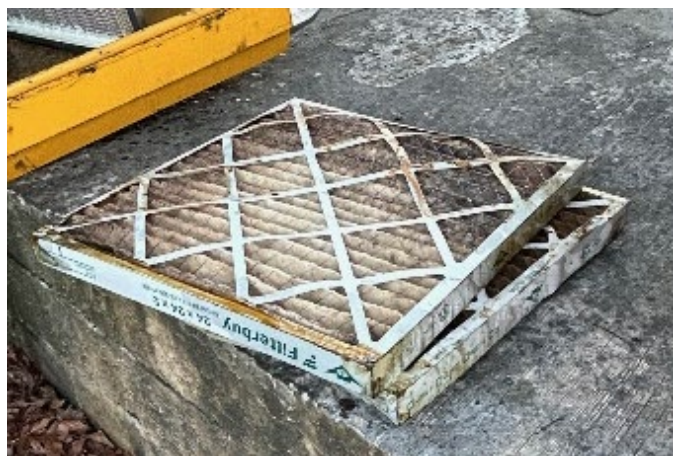
Figure B9. Dirty pre-filter. Photo by NIOSH.

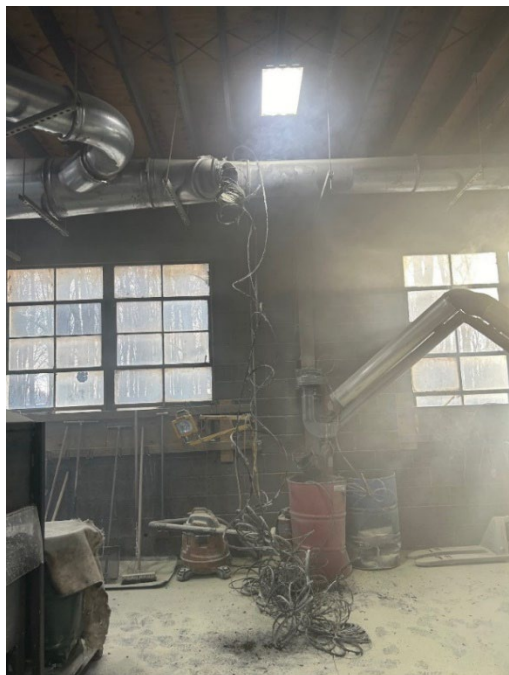
On Day 2 of the second site visit, at approximately 2:20 p.m., the arm of the elephant trunk-style ventilation hood caught fire. Something in the copper drum flared up and a spark or ember was pulled into the LEV. The plastic components of the LEV caught fire and rapidly disintegrated (Figure B10). The employees turned off the LEV, used fire extinguishers to put out the fire, removed a propane tank from the area, and then evacuated the area. The entire warehouse area was filled with smoke and remained smoky for the remainder of the day. The main ductwork of the LEV continued to smoke. Employees and management explained that a fire of this magnitude had never occurred before.

Figure B10. Ventilation ductwork after catching fire. Photo by NIOSH.

In addition, when used, the moveable elephant trunk-style hood should be placed directly above a hot process facing downward as to take advantage of the convective current created by the heat, not to the side of the process. Lastly, the corrugated design of the flexible duct also contributes to decreased airflow through the duct, increased friction inside the duct, and increased turbulence of the airflow inside the duct. All these factors could potentially cause the deposition of fine lead particles within the duct, further decreasing ventilation effectiveness and increasing fire risk.

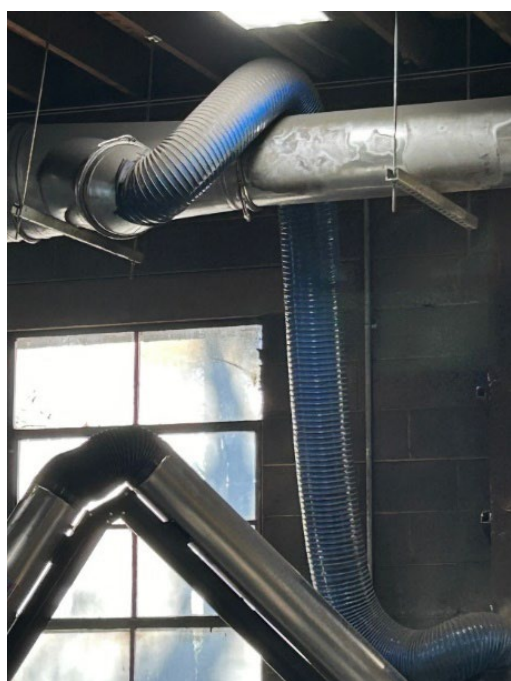
Figure B11. Flexible ductwork. Photo by NIOSH.

in this facility is not recommended. Flexible ductwork is prone to have kinks and sharp turns like what is seen in Figure B11. This often occurs when excess duct is installed or is not removed. Another common problem with flexible ductwork is long, unsupported runs.

Engineering controls are key to preventing lead fumes from escaping the furnace area and exposing employees. Improvements in the LEV system are the first line of defense for employee protection. Although flexible ductwork can be useful in many situations, especially as a temporary measure, its use

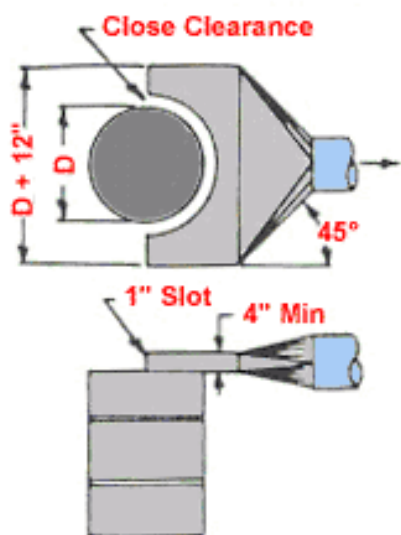
Figure B12. Barrel specific LEV [OSHA 2024].

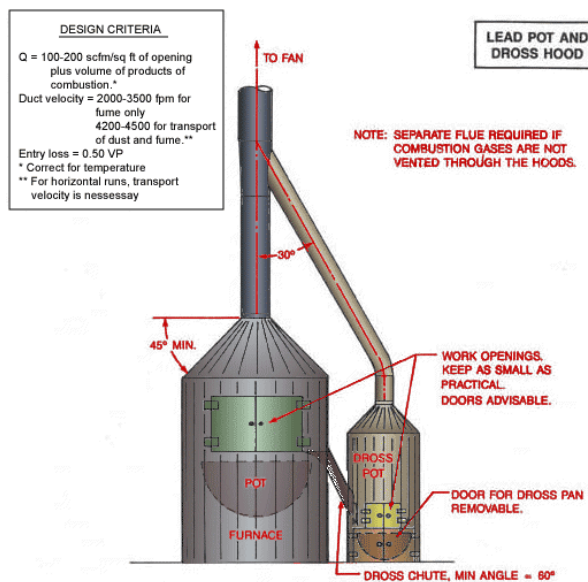
Figure B13. Enclosed lead pot and dross hood [OSHA 2024].
