## Evaluation of a High-Efficiency, Filter-Bank System

This document details the findings from three separate evaluations of prototype VFSs for the USPS; Survey 1 took place in October 2002 at the USPS Processing and Distribution Center (P&DC) in Merrifield, Virginia, Survey 2 occurred in October 2002 at the USPS P&DC in Dulles, Virginia, and Survey 3 took place in March 2003 at the USPS P&DC in Cleveland, Ohio. These surveys were conducted at the urgent request of the USPS and required a rapid response. The methods in this article describe field tests and should not be considered as a new proposed standard test method or a proposed replacement to any existing standard test method. Publication of the results is intended to demonstrate how this method was rapidly deployed and how OPCs were effectively used to measure the entire filtration component of overall VFS performance.

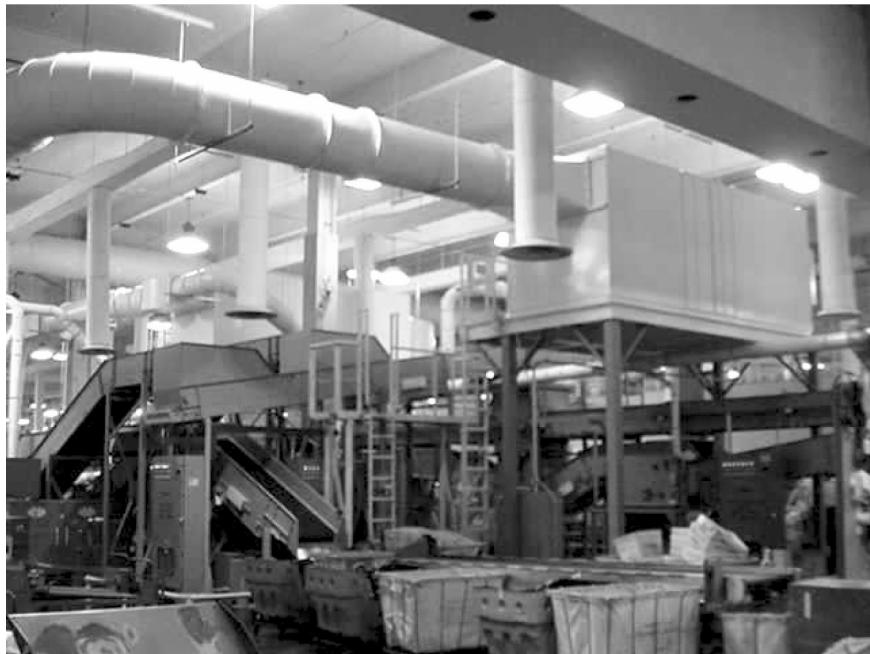
**FIGURE 1.** Part of the ventilation and filtration system installed on a USPS 010 Culling System. The large white filter/fan housing (upper right) was one of the 18,000 cfm (8.5 m<sup>3</sup>/sec) units tested as part of this study.

The USPS 010 Culling System (Figures 1 and 2) comprises two conveyor systems that separate the collected mail into letters, flats (magazine size), and parcels. The first system is called the Dual Pass Rough Cull (DPRC) and the second is the Loose Mail Distribution System (LMDS). Hampers of raw mail are loaded into the DPRC. Flats and parcels are separated from the letter mail and sent to the appropriate areas for processing. Letter mail remains on the LMDS where it is sent to the next processing stage, the Advanced Facer Canceller System (AFCS).<sup>(8)</sup>

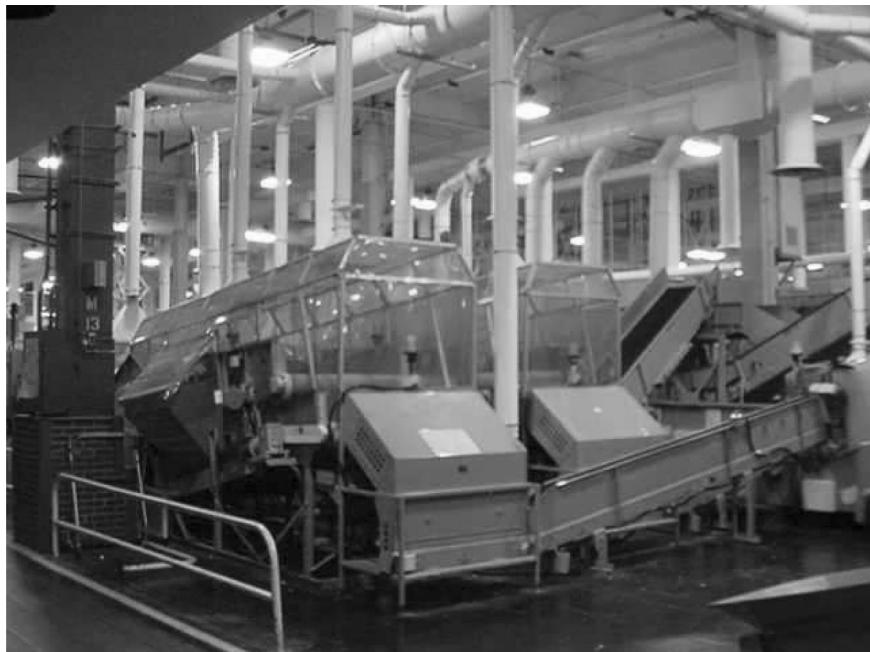
**FIGURE 2.** Part of the ventilation and filtration system installed on a USPS 010 Culling System. Note the numerous small ducts leading from individual local exhaust ventilation hoods placed above critical areas of the system. All of the small ducts lead back to one of the 18,000 cfm (8.5 m<sup>3</sup>/sec) units tested as part of this study.

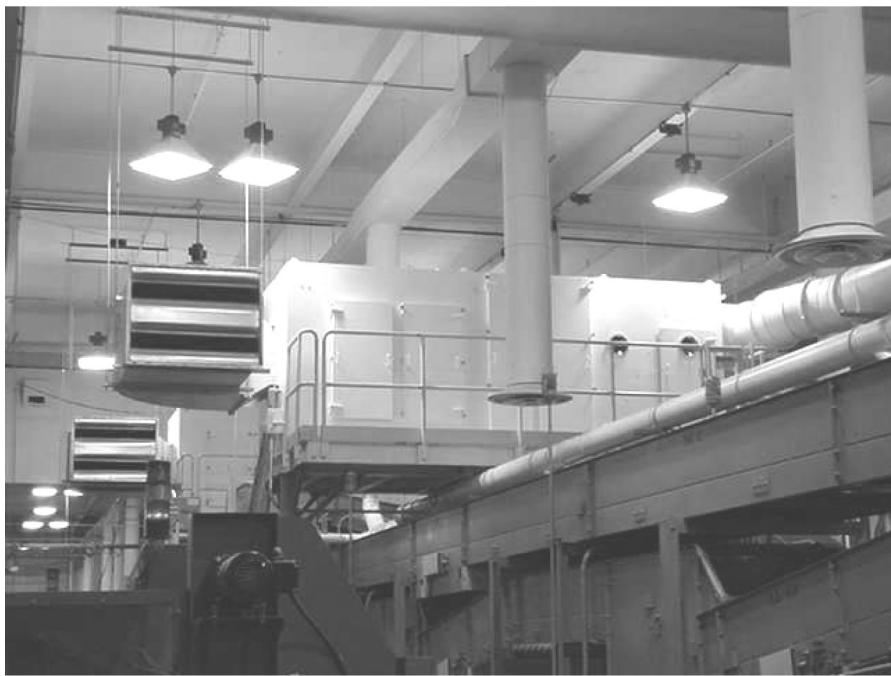
**FIGURE 5.** Part of the ventilation and filtration system installed on a USPS 010 Culling System. The large white filter/fan housing suspended above a Loose-Mail Distribution System is one of the 18,000 cfm (8.5 m<sup>3</sup>/sec) units tested as part of this study.

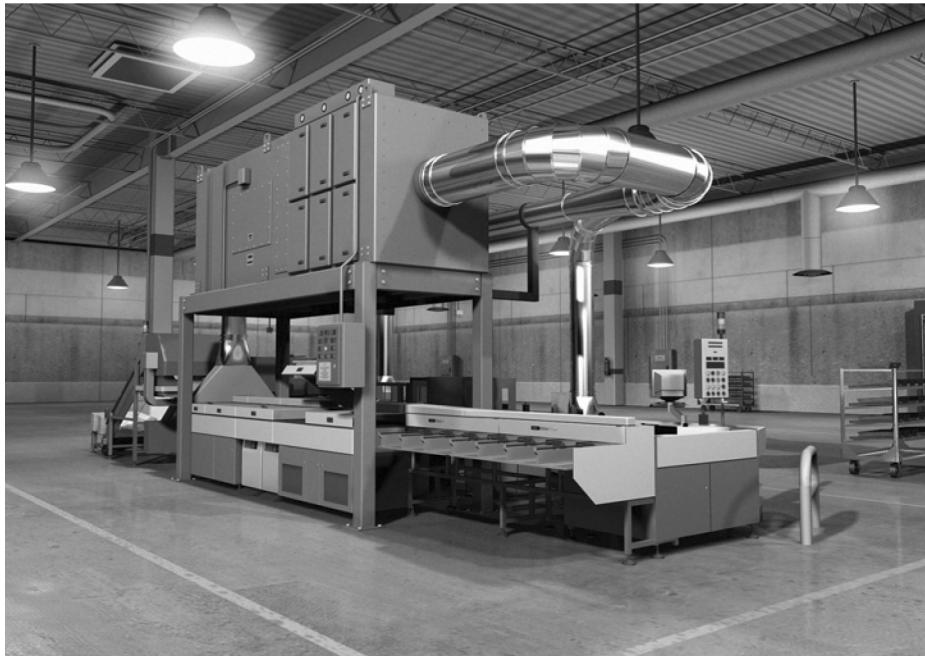
unit (Unit B1; see Figure 6). Again, the filter face velocity was approximately 500 ft/min (2.5 m/sec). In this instance, Unit B1 was designed similarly to the filtration units evaluated in Survey 1, except that the VFS was installed on an AFCS. The

**FIGURE 6.** Ventilation and filtration system installed on a USPS Advanced Facer Canceller System (AFCS). The filter/fan housing suspended above the AFCS has a total airflow of 8000 cfm (3.8 m<sup>3</sup>/sec).

same basic testing procedure for the filtration units evaluated in Survey 1 was employed here. The test was run for a total of 455 min. As shown in Table II, Unit B1 did not meet the minimum criteria requiring all mean efficiencies and lower 95% confidence limits to be  $\geq 99.97\%$ , as mandated by the USPS. The mean efficiency values for the various particle sizes ranged from a low of 98.463% to 99.591%. Because HEPA filter media ( $\geq 99.97\%$  efficient at  $0.3\text{ }\mu\text{m}$ ) was employed in the system, it can be assumed that either the media was damaged or a leak site existed, which allowed air to bypass the filters or enter the filter housing downstream of the filters. The fact that high downstream particle counts in the size ranges above  $0.65\text{ }\mu\text{m}$  were noticed is further evidence of this. Although

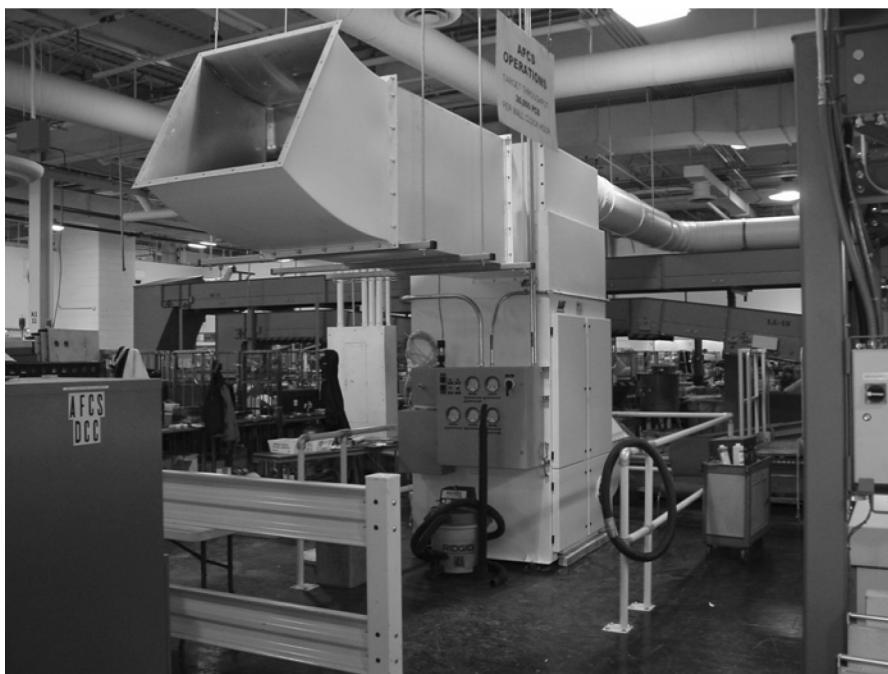
During Survey 3, a new, smaller floor version of Unit A (Unit A-Floor) was also evaluated. The Unit A-Floor was installed on a 010 Culling System positioned on the floor, rather than being suspended overhead. Furthermore, it was not as large as the other A units (only 8000 cfm [3.8 m<sup>3</sup>/sec] with a filter face velocity of approximately 500 ft/min [2.5 m/sec]), and its placement was vertical with respect to the larger 18,000 cfm (8.5 m<sup>3</sup>/sec) units. Unit A-Floor is shown in Figure 7. The one difference that influenced the evaluation of this unit was that it lacked an access door to the downstream filter chamber making it impossible to place the OPC inside the unit. To compensate,

**FIGURE 7.** Part of the ventilation and filtration system installed on a USPS 010 Culling System. The white filter/fan housing is the 8000 cfm (3.8  $\text{m}^3/\text{sec}$ ) unit (Unit A-Floor) tested as part of this study.

system integrity, as demonstrated by mean efficiencies as low as 96.156% and broad 95% confidence intervals. Again, as was noticed during Survey 2, high downstream particle counts in size ranges larger than 0.65  $\mu\text{m}$  were noticed.

Because the evaluation of the Unit A-Floor showed that the system did not meet the strict USPS criteria, the system was completely dismantled to find possible leakage sites. An evaluation of the system design suggested a manufacturing defect in one or more of the metal duct seals, which could allow particle infiltration downstream of the filters. Such leakage, in turn, could result in contamination of the system downstream of the HEPA filters. Unit A-Floor was reconstructed, and enhanced measures taken to completely seal the system at all metal-to-metal joints. After reconstruction, Unit A-Floor was re-evaluated, and these data are also presented in Table III. The mean efficiency values all exceeded 99.989% and the lowest minimum 95% confidence limit was 99.986%, at the 0.3–0.4  $\mu\text{m}$  size range. It was obvious that the modifications made to Unit A-Floor during the system reconstruction brought the system into compliance with the USPS acceptance criteria.
