## Research Article

# Inward Leakage in Tight-Fitting PAPRs

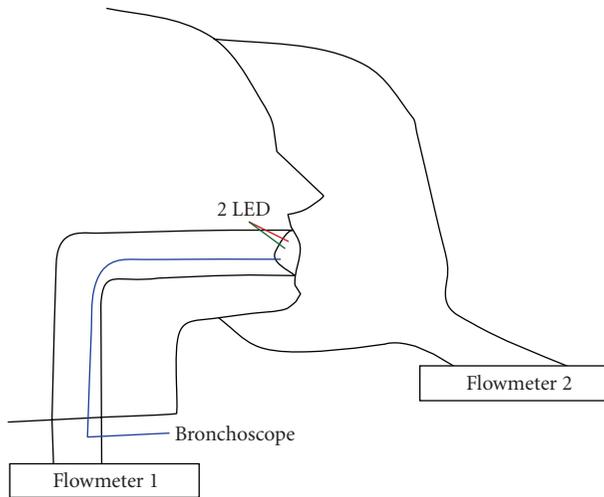
FIGURE 1: Schematic diagram of the experimental arrangement with flow meters, light-emitting diodes, PAPR, head form, and bronchoscope.

Both PAPRs were installed, in turn, on the head form and the head straps adjusted for tight, uniform fits (Figure 1). One set of measurements was made on each PAPR in this unmodified condition. However, the surface of the head form is hard and smooth, certainly not like the flesh of the face. Because of this, any leakage that would occur around the periphery of the head form would not necessarily be indicative of leakage that would occur around the periphery of a human wearer. Therefore, two additional sets of measurements were made with ample modeling clay applied around the facepiece periphery to obstruct any inadvertent leaks formed at the face seal. One of these compared blower and breathing machine flow rates, and the other focused on the exhalation valves as the most likely sources of external leakage.

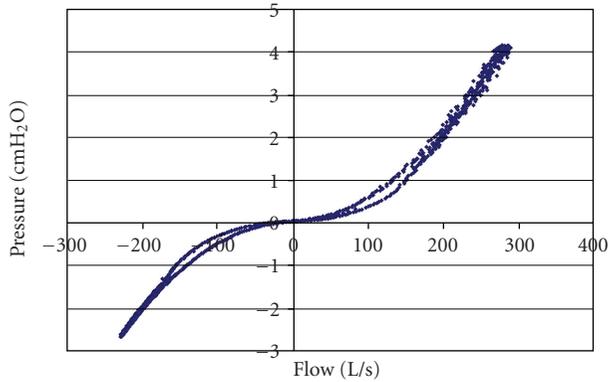
FIGURE 2: Pressure-flow relation for one of the Medgraphics flow meters used in this study. There is a small amount of hysteresis present in the data, but the hysteresis was the same for both flow meters.

Flow meter calibration required extra care. In Figure 2 is shown the relation between pressure and flow for one of the flow meters. A Pitot-tube flow meter should theoretically relate pressure to the square of the flow. When negative calibration pressures were inverted, a complete parabola resulted (Figure 3). A quadratic regression equation forced through the origin gave a very high correlation coefficient. In order to check that both flow meters had identical characteristics, the two flow meters were connected in series to the breathing machine. The ideal regression line relating the two flow meters would be  $y = x$ , a line with slope of 1.0 and zero intercept of 0.0. From Figure 4, it can be seen that readings from both flow meters were nearly perfectly correlated.

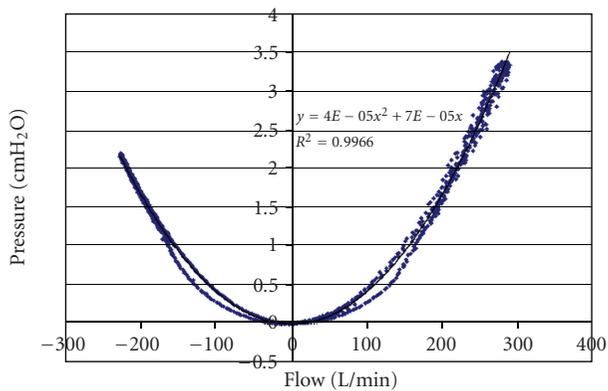
FIGURE 3: Pressure-flow relation for the flow meter with negative pressures inverted. The result is a parabola that can be used to describe calibration results mathematically. Hysteresis was present in these data, but a parabola was fitted to only one set of data. Both flow meters exhibited the same amount of hysteresis and so gave the same relative flow reading.

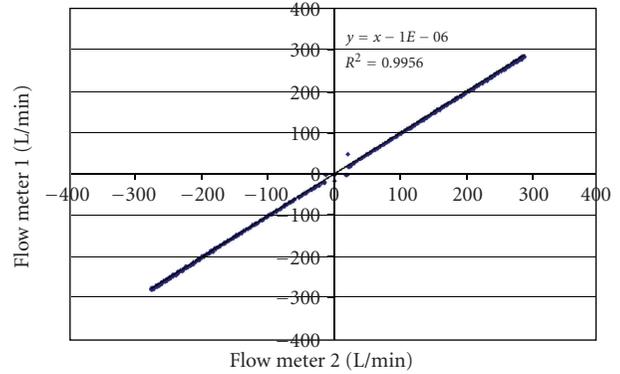
FIGURE 4: Plot of readings from the two flow meters. With an intercept of zero and a slope of one, it can be seen that both flow meters gave nearly identical results. This is important when differences between the two measured flow rates were calculated. Hysteresis data points are included in the line.

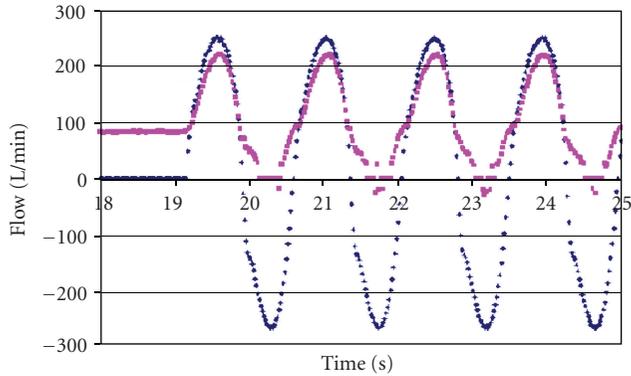
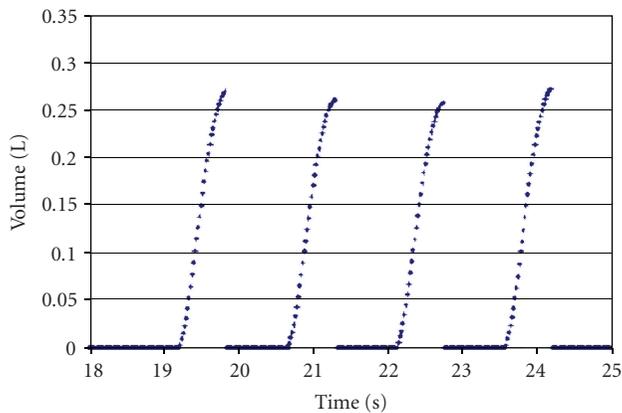
FIGURE 5: Flow rates (a) and leakage volumes (b) are plotted with time for the 3M Breathe-Easy PAPR. Leakage volumes were accumulated during inhalation when blower flows were less than breathing machine flows. No clay was used to seal the periphery.

In Figure 5 are shown the results from the 3M Breathe Easy without clay sealing the facepiece to the head form. On the left, the breathing machine was off (no flow), and the blower supplied a constant flow of nearly 100 L/min. At 19 seconds, the breathing machine was turned on, and both flows increased. Breathing machine flow can be seen to be greater than blower flow during inhalation. The difference represents leakage. This difference was integrated to obtain leakage volume during the time that blower flow was less than breathing machine flow, and the results are shown in the lower diagram of Figure 5. This shows that nearly 0.26 L of outside air leaked into the facepiece during each inhalation. This air was presumably swept from the facial volume during exhalation.

Also to be noted here is that blower flow rate was not constant. It varied during the breathing cycle, becoming about 230 L/min during inhalation peaks and falling to nearly zero during exhalation. The power required to move the extra air through the filters must necessarily be coming from the breathing machine.

Figures 5–7 have been included in this paper despite the fact that leakages occurring at the face seal of the head form are not likely to resemble leakages that could occur at the face seal of a human. These figures have been meant to illustrate experimental techniques used and to show that face seal leakages do indeed occur on the head form. More valid to the meaning of this study are the figures of data obtained with clay sealing the peripheries of both devices. The clay was applied generously enough that no leakage could have occurred where it was used.

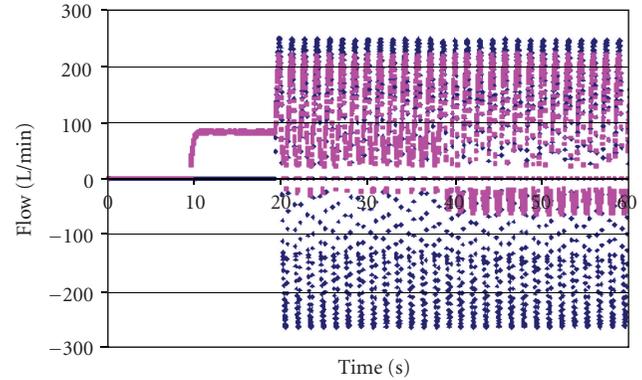
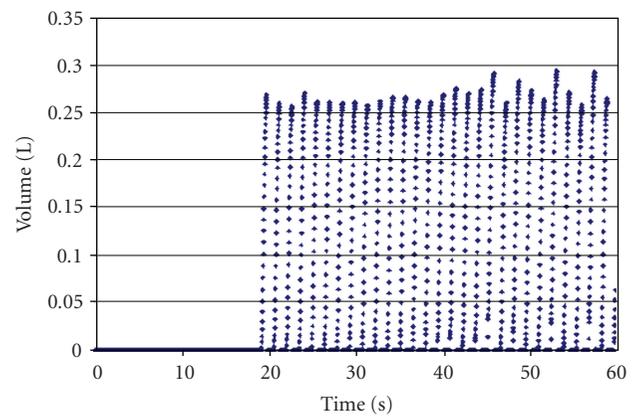
FIGURE 6: Flow rates (a) and leakage volumes (b) for the 3M Breathe-Easy PAPR shown in the previous figure. The time scale has been compressed to show effects of blower and breathing machine activity. The blower was turned on at the 10-second mark, the breathing machine was turned on at 20 seconds, and the blower was turned off at 40 seconds. The negative blower flow before and after the blower was turned off demonstrates that air was being forced backward through the blower and filter. No clay was used to seal the periphery.

In Figure 6 are shown the same two flow measurements (a) and the same volumes (b) as in the previous Figure, except that the time scale has been compressed. Both the blower and the breathing machine were off until 10 sec, when the blower was turned on. At 20 sec, the breathing machine was turned on. At about 40 sec, the blower was turned off. The same leakage volume seemed to occur whether the blower was on or off. There was more backflow of air through the filter when the blower was off.

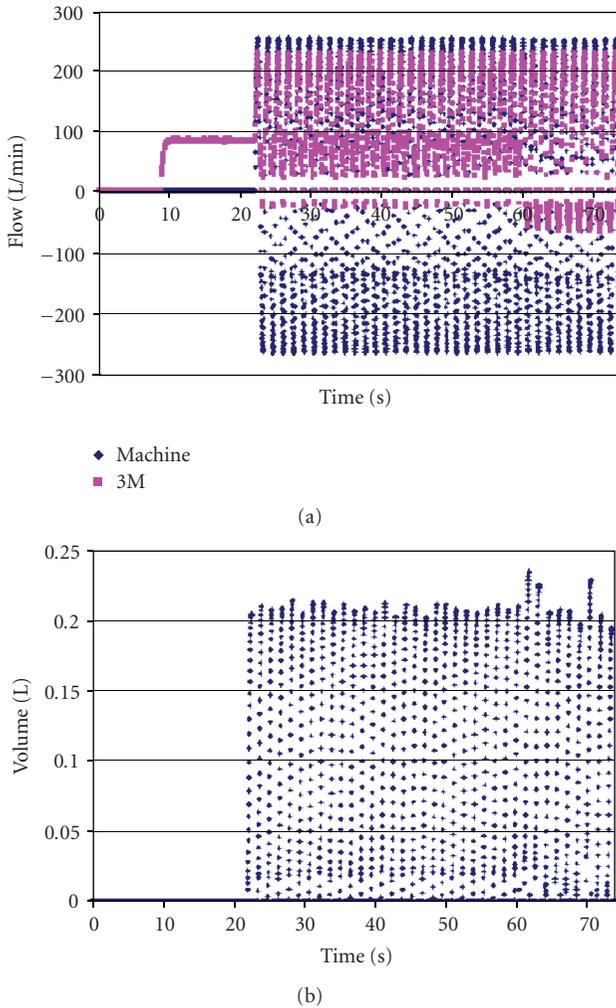
FIGURE 7: Results for the 3M Breathe-Easy PAPR when clay was carefully used to seal the periphery. The blower was turned on at about 10 seconds, the breathing machine was started at about 20 seconds, and the blower was turned off at about 60 seconds. Blower flow became negative, even while operating. Leakage volume decreased compared to the previous figure when no clay was used.

When clay was carefully used around the mask periphery, the leakage volume decreased to about 0.21 L to 0.24 L from 0.26 to 0.29 L for each inhalation (Figure 7). Again, the leakage volume did not depend upon blower activity. The bronchoscope showed no evidence of fog reaching the mouth.

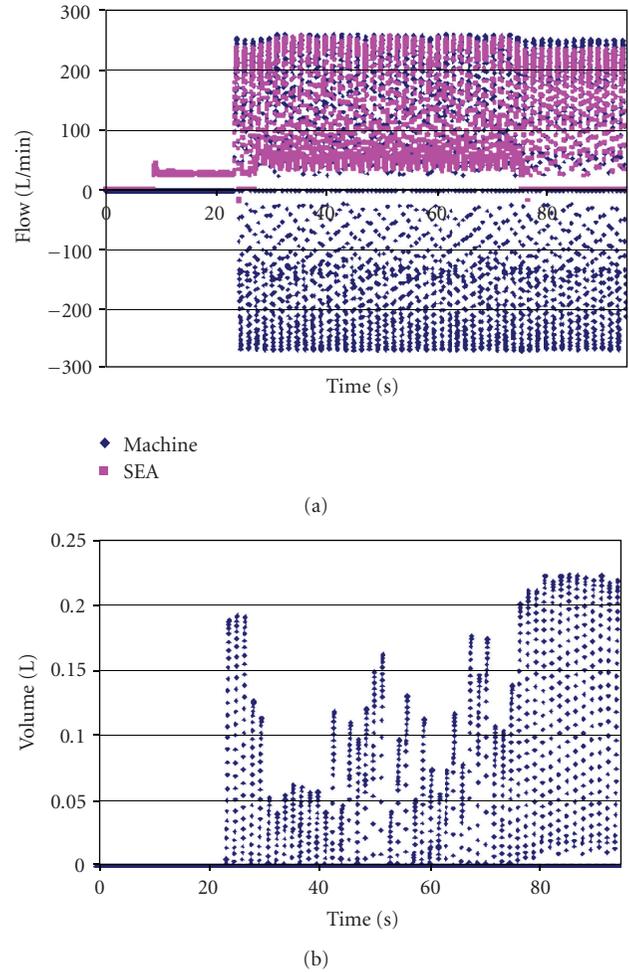
FIGURE 8: Flow rates (a) and leakage volumes (b) for the SE 400 PAPR with clay sealing the periphery. The blower was turned on just before the 10-second mark, the breathing machine was started after 20 seconds, and the blower was turned off at about 75 seconds. Except for a couple of short instances, blower flow never became negative. The extra positive blower flow when the blower was operating was used to maintain positive pressure inside the respirator. Even with the blower turned off, blower flow was not measured as less than zero.

Results for the SE 400 with clay around the face seal are shown in Figure 8. The blower was turned on at 10 seconds

and maintained a steady flow rate of about 25 L/min until the breathing machine was turned on at about 25 seconds. This PAPR had an active blower control that was adjusted to breathing demand. For the first few breaths after the breathing machine was turned on, leakage volume was about 0.19 L. It subsequently decreased and varied throughout the range of 0.04 to 0.18 L. The leakage volume value seemed to depend on whether the blower was actively increasing or decreasing speed, but the exact dependence was not determined. When the blower was turned off at about 75 seconds, leakage volume increased to 0.22 L. Again, the bronchoscope detected no fog at the mouth.
