# **RISK ASSESSMENT OF PANELIZED WALL SYSTEMS IN RESIDENTIAL CONSTRUCTION USING CRITICAL INCIDENT TECHNIQUE**

Hyung N. Kim, Maury A. Nussbaum, Hyang Seol, Sunwook Kim, and Tonya L. Smith-Jackson  
Grado Department of Industrial and Systems Engineering  
Virginia Polytechnic Institute and State University  
Blacksburg, Virginia

Panelized wall systems are now extensively utilized in residential construction, which is recognized as a high-risk industry. A considerable number of construction injuries are reported every year. According to Occupational Safety & Health Administration (2005), 38,000 construction injuries occur each year. Safety on construction sites may not have the highest priority, as emphases of the construction industry are more on speed, efficiency, and economy. Furthermore, panelized wall systems have not been investigated in terms of hazard analysis. The primary purpose of the study was to identify the hazards related to panelized wall systems and to provide recommendations to improve the construction work environment. A critical incident technique was used to identify hazards through video-based observation, and the identified hazards were classified into five ca

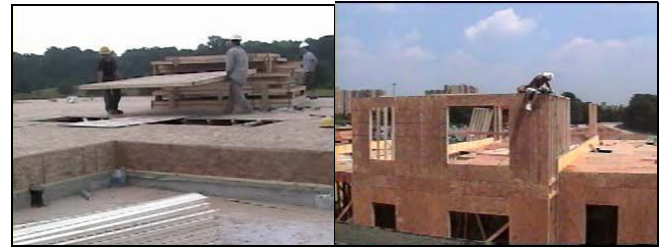
Figure 1. Samples of video captured incidents at the residential construction sites. Carrying over uncovered holes on the work site (left) and fixing on the top without a life line (right)

In addition, according to the results of the risk assessment in this study, the hoisting and holding activities were recognized as high risk in comparison with other activities (i.e., lifting, carrying, and fixing). For instance, some workers worked on the top floor to hoist/hold the heavy panels; however, they were not provided with a life line to hold their body when they were working at the edge of the floor. Furthermore, irrelevant people were allowed near the workplace while a heavy panel was hoisted or held. A fallen panel could hurt the individuals passing by. Thus, a barrier needs to be installed to keep out other people (e.g., non-workers). The barrier and life belt are the minimal proactive protection from injuries/death, which even a small-sized residential construction company should provide for their workers.
